# Webster Elementary School Facility Assessment

March 12, 2026

PREPARED BY DSGW ARCHITECTURE

# PROJECT OVERVIEW

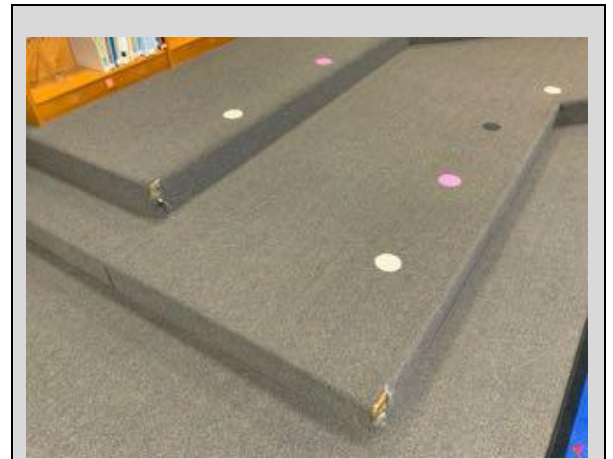
| Flooring |
|---|
| Carpet is of varying vintages ranging from critical to good condition. Broadloom areas are the worst with carpet tile areas being better. |

Broadloom carpet wear

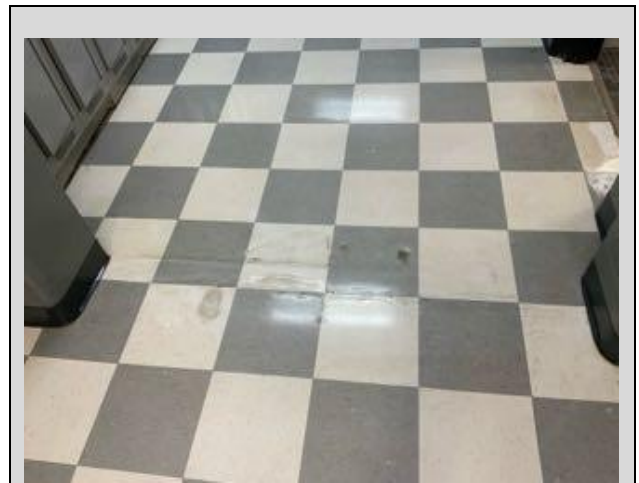
| Flooring |
|---|
| VCT is overall in poor condition. It is cracking and various areas have been replaced. Newer tiles are a different color than the existing tiles. VCT in classrooms where traffic is more limited was in better condition. |

VCT cracking

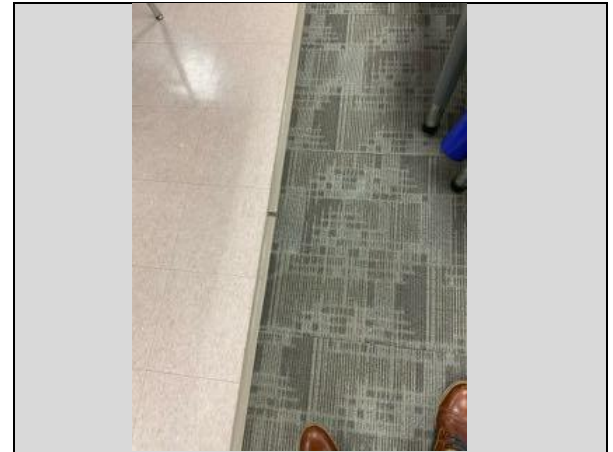
| Transitions |
|---|
| Transition strips between carpet and VCT had inconsistent seams. |

Inconsistent transition strip

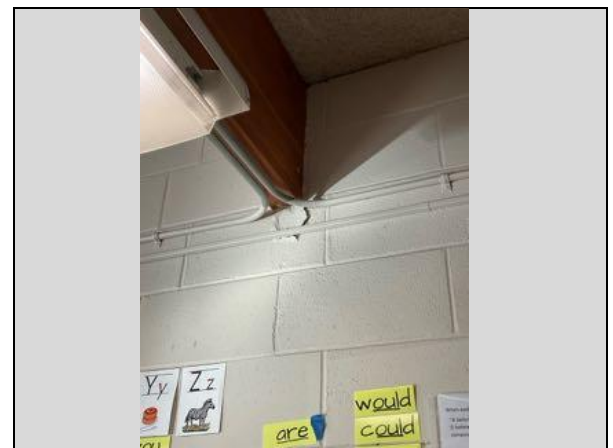
| Walls |
|---|
| Interior concrete masonry walls are in fair condition. In classrooms with glulam beams, many instances of spalling were observed directly under the beam pockets. Paint observed suggests spalling is not a new issue. Minor cracking was also observed in some classrooms at wall corners. Major separation cracking was observed in the corner of the kindergarten addition, teacher informed us that cold air used to flow through crack until silicone was used to seal crack closed. |

CMU spalling below beam

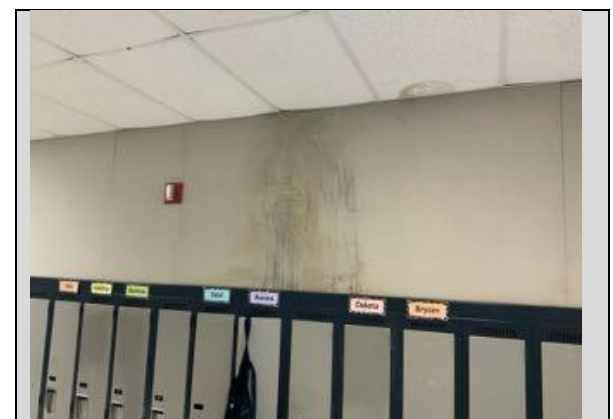
| Walls |
|---|
| Acoustic panels above black and gray lockers have significant staining from an obvious water leak. |

Staining on acoustic wall panel

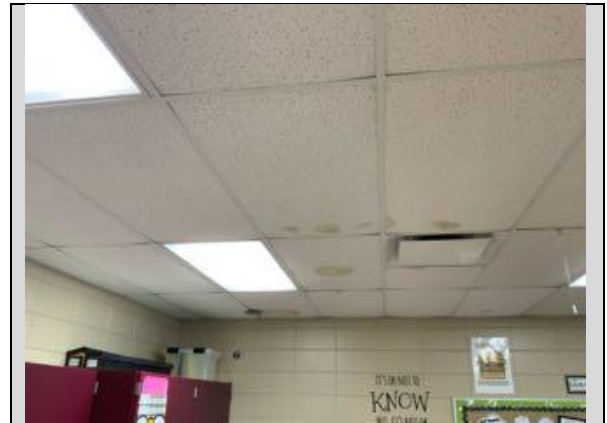
| Ceilings |
|---|
| Suspended acoustical ceiling tiles ranged from poor to good condition, depending on location. Tiles appeared to have been replaced periodically with varying styles/brands of ceiling tile leading to a mismatched patchwork of tiles in some locations. Some ceiling tiles are sagging. Sagging can be a result of age and humid conditions. |

Typical water damage and sagging of acoustical tiles.

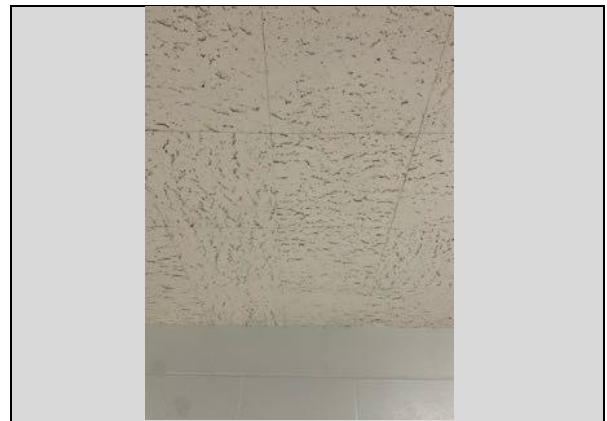
| Ceilings |
|---|
| Concealed spline ceiling tiles in the hallway link outside the kindergarten looked like it could potentially contain asbestos. Recommend testing. |

Concealed spline ceiling tiles.

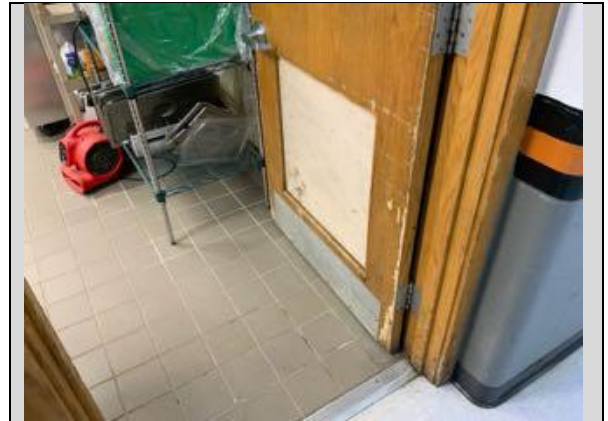
| Doors & Hardware |
|---|
| Wood doors show varying amounts of wear. Some are severely worn but appear to be in good operating condition. Some doors have wood frames, but most have hollow metal frames. |

Worn wood door with wood door frame.

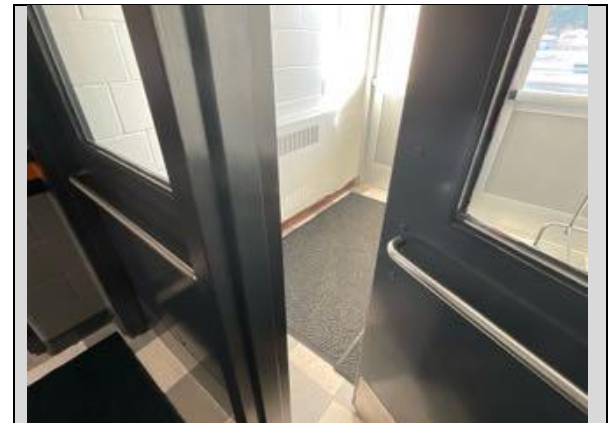
| Doors & Hardware |
|---|
| Hollow metal doors at interior vestibules are in good condition. |

Hollow metal doors.

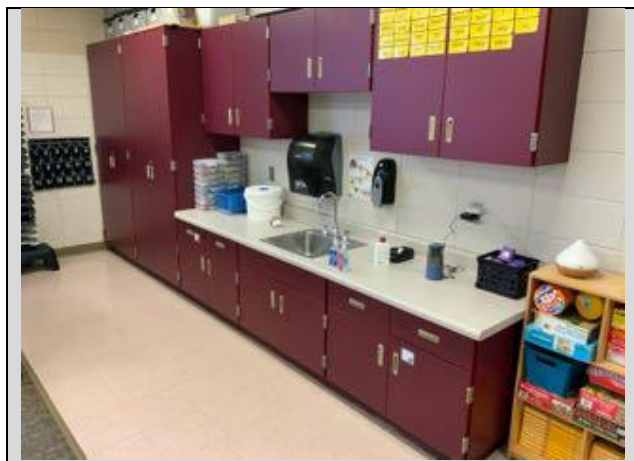
Casework in good condition.

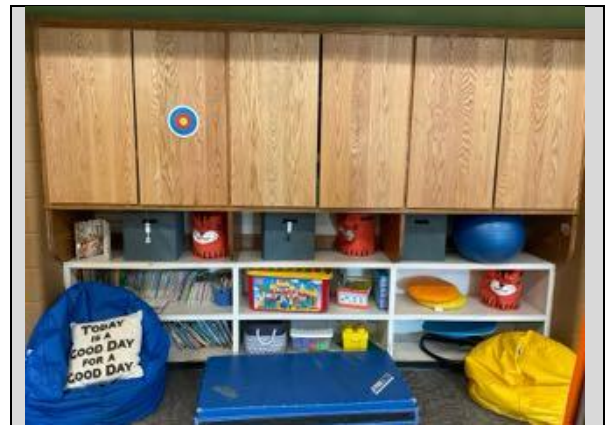
| Casework |
|---|
| Wood cabinets in some of the old classrooms appear to have been renovated with new subframes and doors. Some doors did not fully close and none had door pulls |

Wood casework with new doors – no handles.

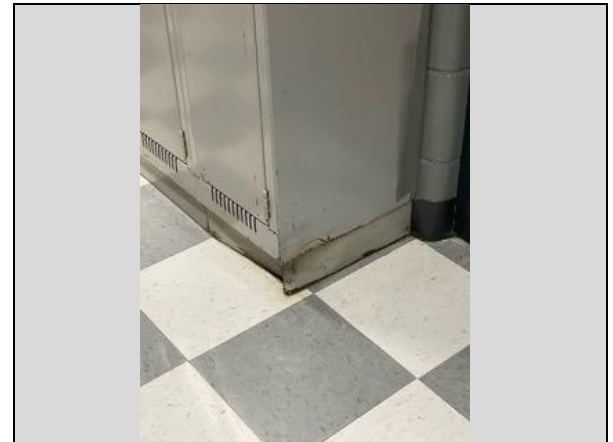
| <b>Lockers</b> |
|---|
| Solid Gray metal lockers are in poor condition showing a lot of rust and dents. |

Damaged lockers

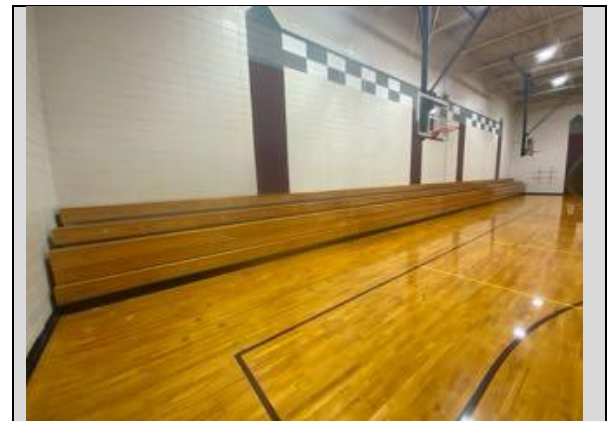
| <b>Gym Equipment</b> |
|---|
| Gym bleachers are aging and do not have accessibility. Operation was not observed |

Wood gym bleachers.

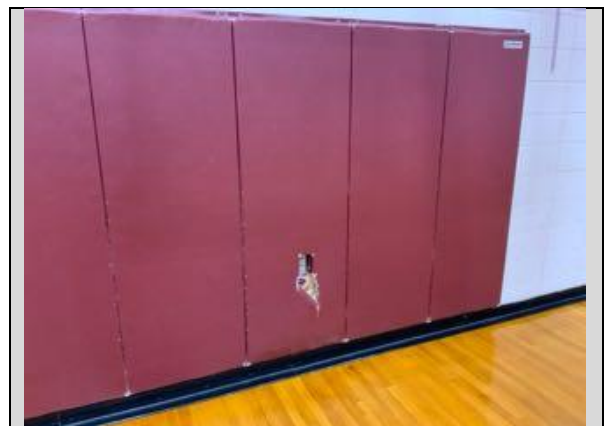
| <b>Gym Equipment</b> |
|---|
| Gymnasium wall pads are well worn, have holes, and are in poor condition. |

Worn crash pads.

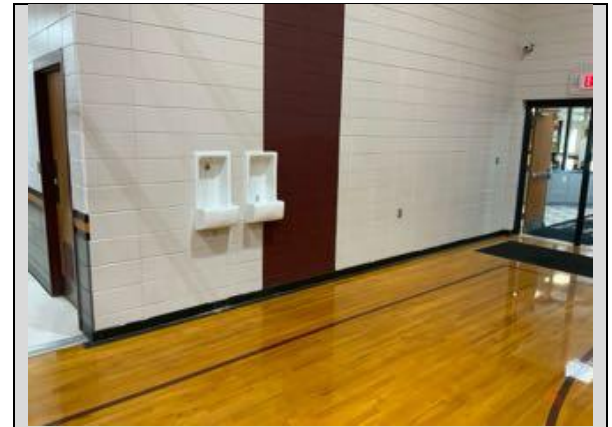
| Accessibility |
|---|
| Drinking fountains in gym are not accessible. |

Non-accessible drinking fountains.

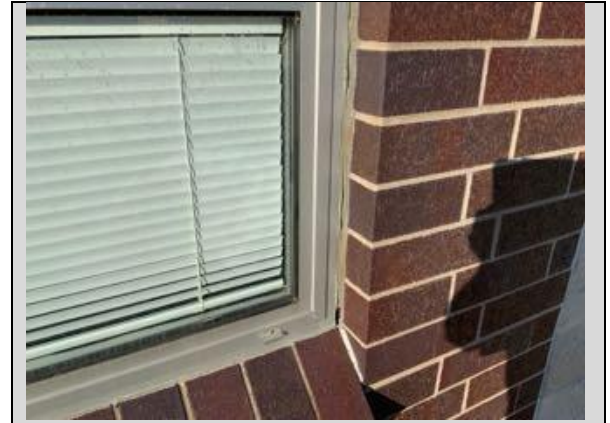
| Exterior Walls | |
|---|--|
| All exterior sealant is in poor to critical condition and needs replacement in the next 6 months. | |

Typical sealant joint failure at windows

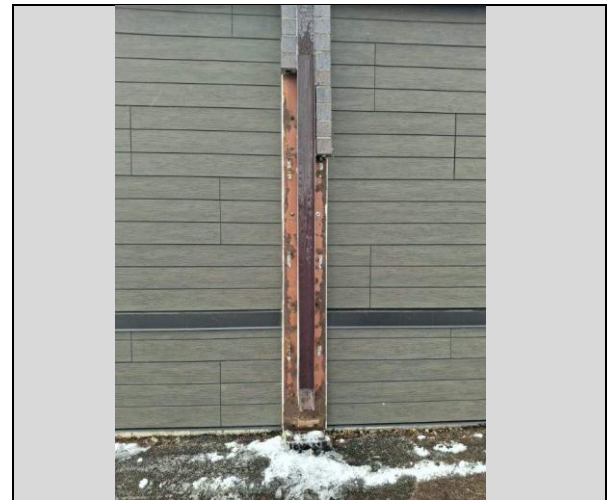
| Exterior Walls | |
|---|--|
| <p>Some efflorescence was observed in the brick as a result of water getting behind the brick. Immediate causes appear to be severely deteriorated sealant joints.</p> <p>Brick at inset downspouts is severely deteriorated and, in some locations, completely dislodged or missing. This is due to poor downspout design allowing water around and behind the brick.</p> <p>Masonry at the bottom of surface mounted downspouts is deteriorating due to poor drainage away from the wall, frequent splashing and freeze/thaw cycles.</p> <p>At entry and other locations where salting has occurred, concrete block at the sidewalk has deteriorated.</p> | |

Fully dislodged brick, rusting steel gutter and brick anchors.

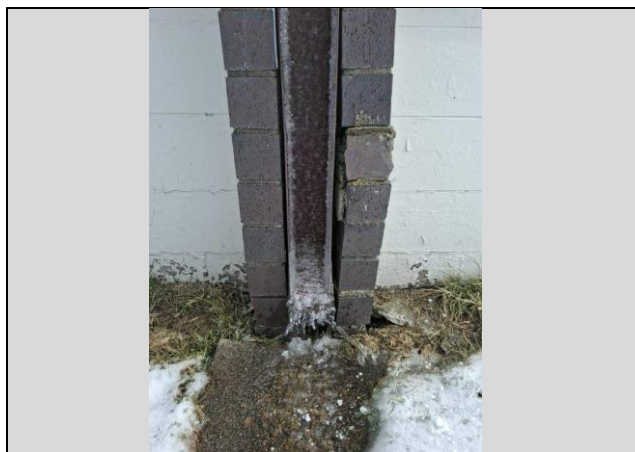
Brick crumbling and getting dislodged from freeze/thaw cycles.

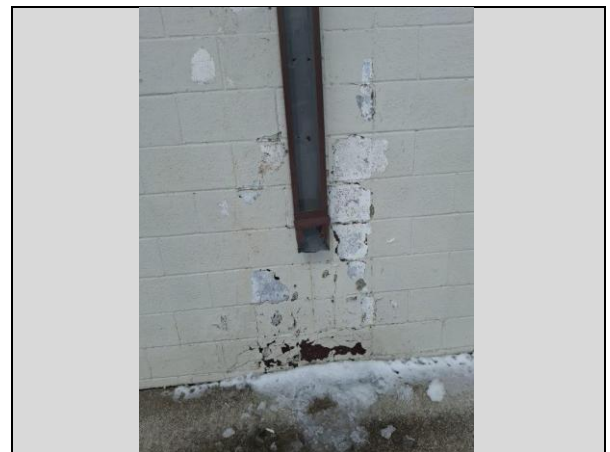
Water damage to CMU below gutter

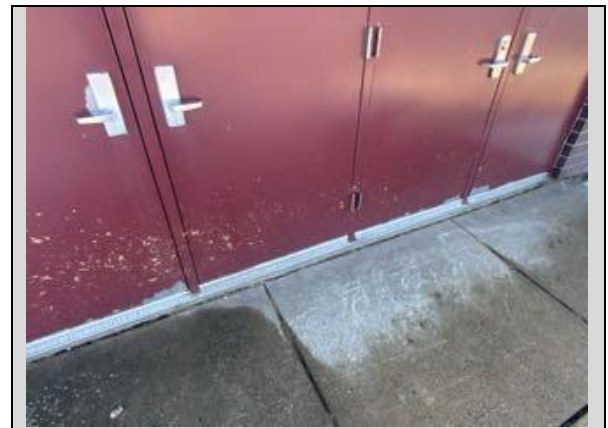
| Exterior Doors |
|---|
| Hollow metal exterior doors are in fair condition with paint falling off at the bottom of the door. |

Hollow metal doors – paint peeling at the bottom.

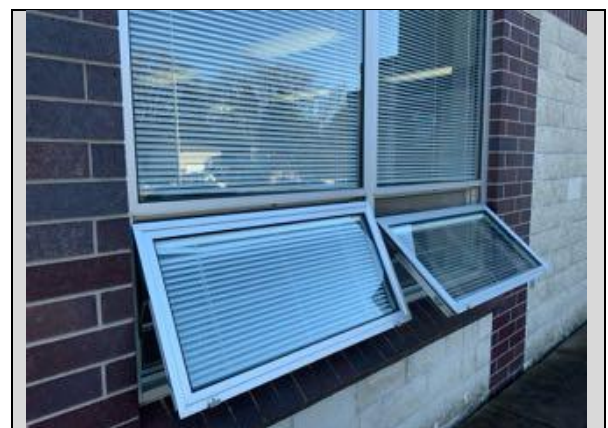
| Exterior Windows |
|---|
| Aluminum dual-pane windows are in fair to good condition overall. Exterior perimeter sealant is in immediate need of replacement. |

Operable aluminum windows with integral blinds.

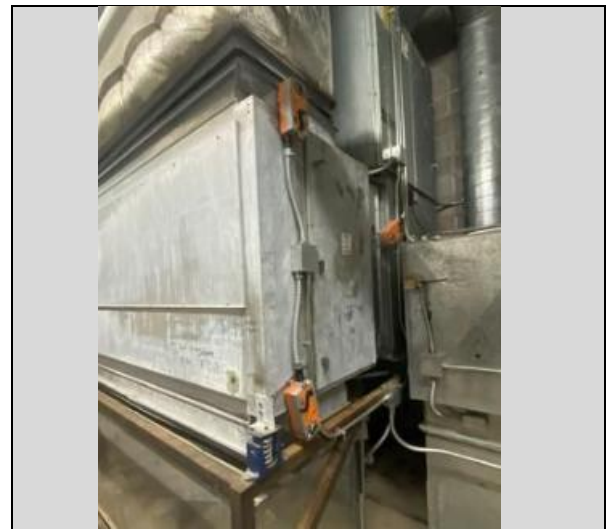
| HVAC Systems<br>(Heating Ventilation and Air Conditioning) | |
|---|--|
| Equipment is generally in poor condition and beyond its useful life based on ASHRAE recommendations. | |

Aged mechanical equipment

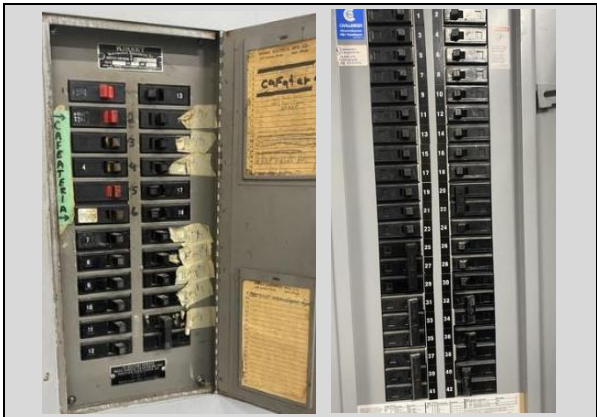
| Electrical Systems |
|---|
| Panelboards and primary service equipment serving the building addition and remodeled areas are in fair condition with no reported failures or repairs needed.<br>Panelboards serving areas that are not remodeled are in poor condition. |

Various aged electrical panels

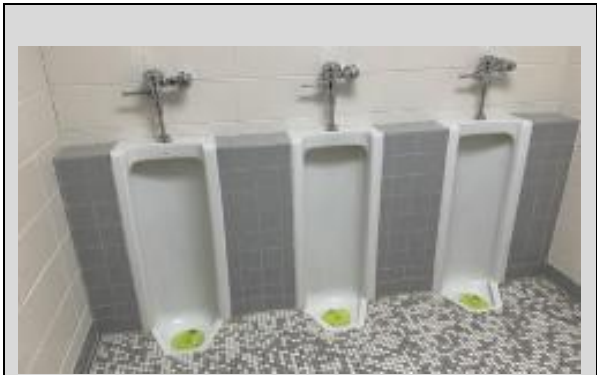
| Plumbing Systems and Fixtures |
|---|
| Plumbing fixtures, flush valves and faucets in building addition and remodeled areas are in fair condition.<br>Plumbing fixtures in spaces and rooms that were not remodeled are in poor condition. |

Floor mounted urinals

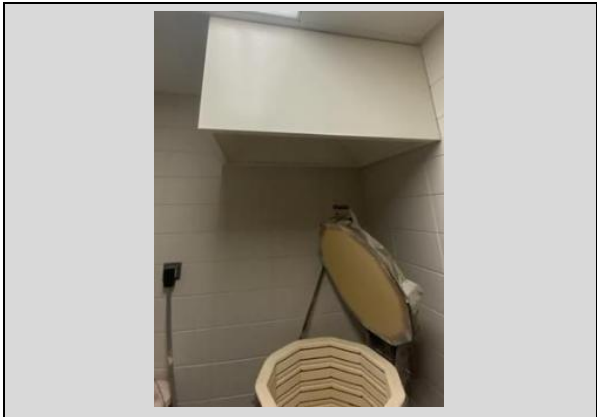
| Specialized Equipment |
|---|
| Kiln was not observed in operation.<br>Superficially the kiln and exhaust system appeared to be in good condition. |

Kiln and Exhaust hood
