WEBSTER SCHOOL DISTRICT

Facility Audit
October 2018

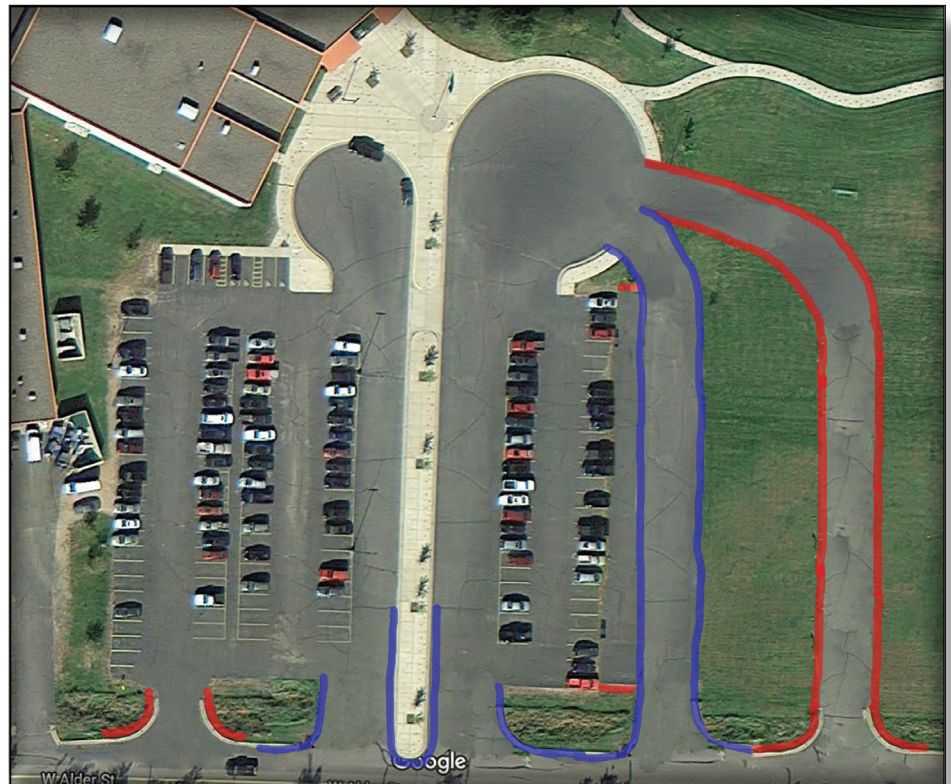
▲ The current parking lot offers two entrances, which allows traffic to cross, causing congestion, confusion, and accidents.

After extensive research, the district should pursue a solution that not only eliminates the cross traffic concerns but deals with the drainage issues in the driveway and ditches that are highlighted on page 42. CESA FM recommends either constructing two separate exits to the parking lot. The parent drop off/pick up and student parking lot could exit to the west end of their parking lot, while the district could put a new route through the existing field area back to W Alder Street and the buses could exit to the east of the existing parking lot. This solution would allow for all vehicles to utilize the same entrance, but avoid crossing paths upon exiting the space. Another option would be to extend the concrete divider in the parking lot to the road and widen the entrances on both sides. The district would construct two separate exits through this option as well. This would also alleviate the cross traffic issues the district is currently encountering. The picture below depicts the first option in red and the second option in blue. If the district were to pursue the first option (red) then an extra lane of parking stalls would be constructed as well.

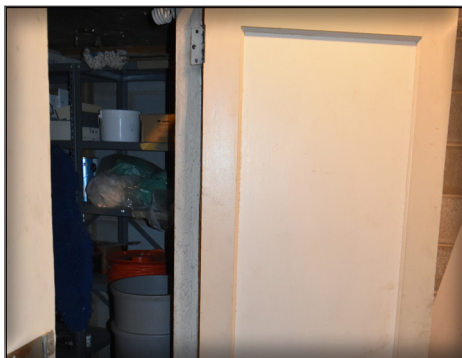
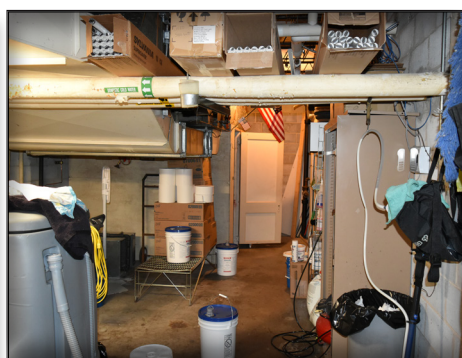
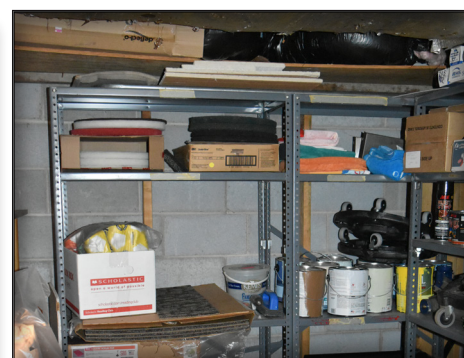
INSPECTION GROUP: VENTILATION

During the audit, there didn't appear to be any dedicated ventilation exhausts for corrosive chemicals in the chemical supply room. Schools need special exhaust ventilation in areas that generate large amounts of odors, moisture, heat, or toxic materials. Due to the corrosive nature of the chemicals stored in this location, the district should install exhaust ventilation in this area.

▲ The district should install a dedicated exhaust somewhere in the chemical supply room, preferably in close proximity to the corrosive chemical cabinet.

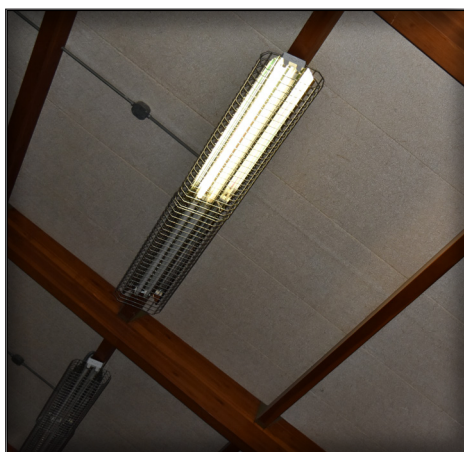
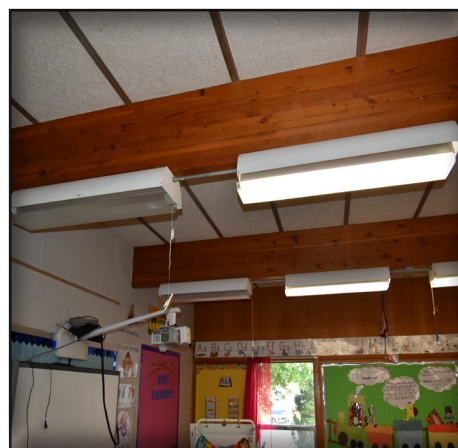
INSPECTION GROUP: INTERIOR LIGHTING

◀ Multiple fixtures were broken or missing lights during the walkthrough. The district should replace these fixtures and lights first. ▶

The conversion to LED bulbs in the existing fixtures is good for energy efficiency and durability. The remainder of fluorescent bulbs should be slated for replacement. The District should install new drop ceilings during the time they are upgrading the lighting. Estimated costs include installing a suspended ceiling grid.

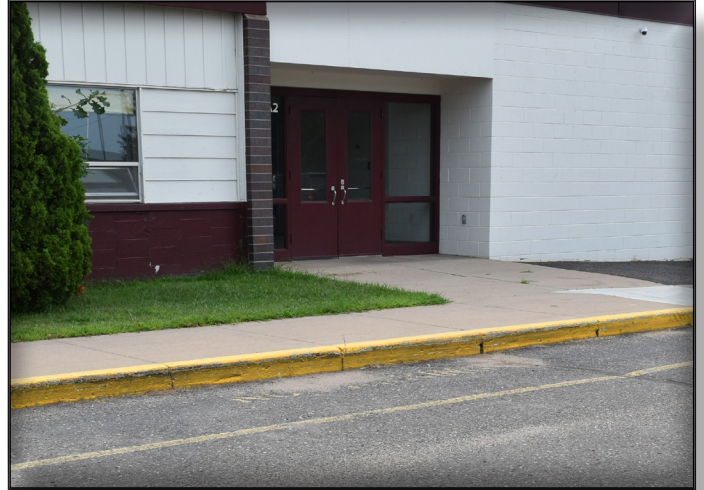
INSPECTION GROUP: CONCRETE

Some separation of sidewalks and areas of repair were noted during the audit. The ADA defines a trip hazard as any vertical change of over 1/4 or more at any joint or crack.

The District should perform site concrete grinding and resurface this area to prevent potential trip hazards and safety situations.

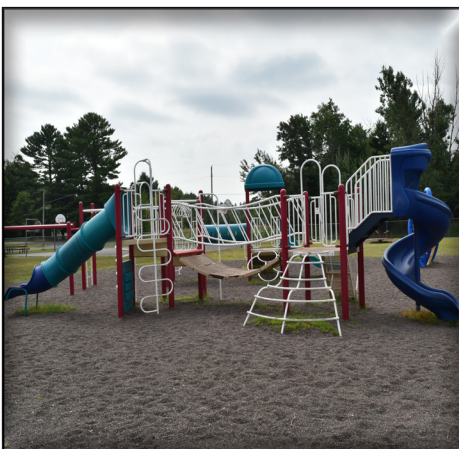
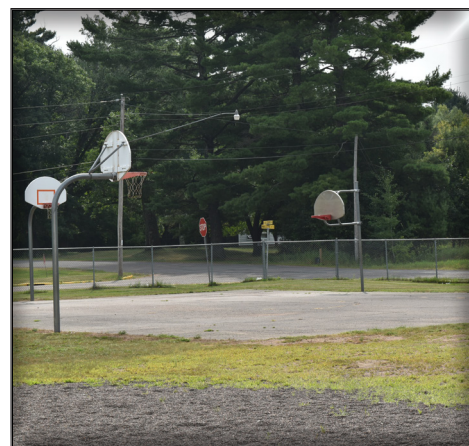
INSPECTION GROUP: PLAYGROUND

Several pieces of playground equipment were found to be rusty and aged, such as the swingset and the merry-go-round.

◀ Aged play structures pose a safety risk to students and a liability to the district. Dangerous and/or damaged structures should be replaced as needed. ▶

The District should schedule a replacement plan for all playground equipment and continue to monitor each piece individually for safety and compliance. The District should also replace or remove the damaged basketball nets.

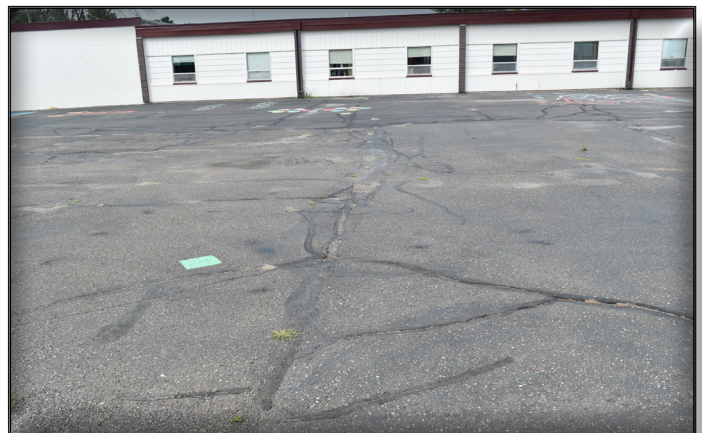
INSPECTION GROUP: PLAYGROUND

The asphalt leading up to the elementary playground has cracks and holes in multiple locations. The holes are a trip hazard and serve as a liability to the District.

The District should reseal or replace the playground asphalt in a timely manner to prevent trip hazards and prolong its useful life.

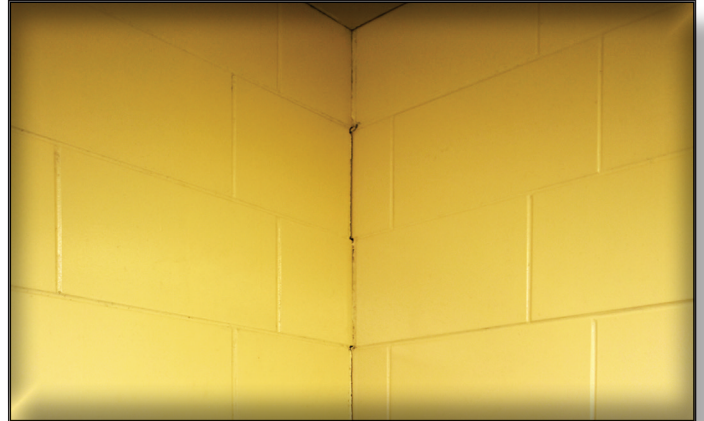
**INSPECTION GROUP:
STRUCTURAL**

Expansion joints were observed separating in several areas throughout the building.

The district should continue to monitor the situation. If cracking/settling becomes worse, major repairs may be needed. The district should also consider tuck pointing in the next five years.

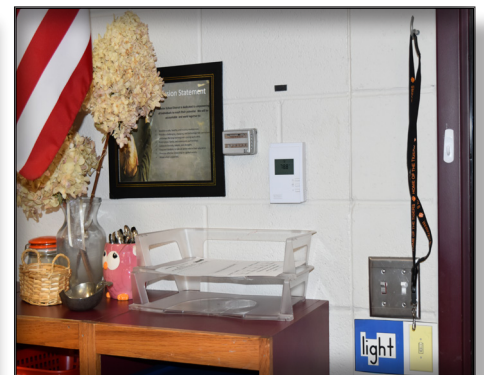
**INSPECTION GROUP:
HVAC**

There were two rooms with newer HVAC equipment that complained of uncomfortable conditions. After closer inspection, these rooms had their unit ventilators located near the far windows and the thermostats located clear across the room near the door. This distance from one another is making the ventilator pump a lot of air before the thermostat can sense the change. This is leading to uncomfortable conditions for the room occupants.

▲ This project would have a short payback, as the energy saved in HVAC costs would quickly pay for the costs of moving the existing thermostat or installing a secondary one.

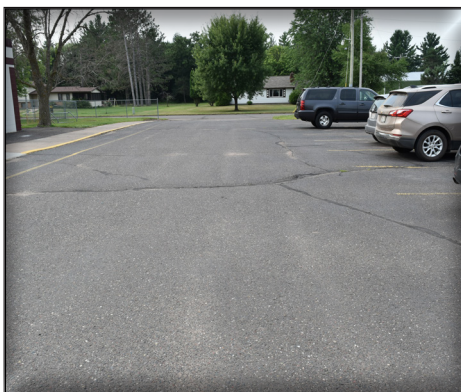
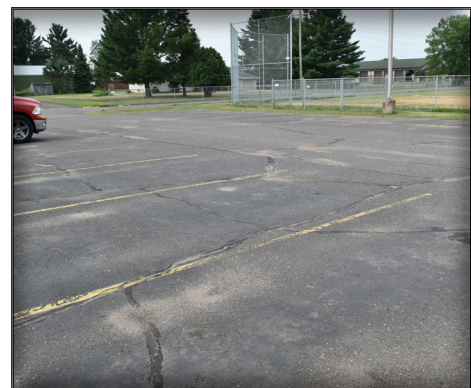
The staff and visitor parking lot is aged with numerous cracks and faded parking lines. Also, much of the paint on the curb has worn off, which presents a trip hazard for students, staff, and visitors. This safety concern poses a liability to the district.

◀ The District should reseal the parking lot and repaint the lines to prolong its useful life. Resealing the main lot may be an option to prolong life. The District should also repaint the curbs where the paint has worn off over the past year. ▶

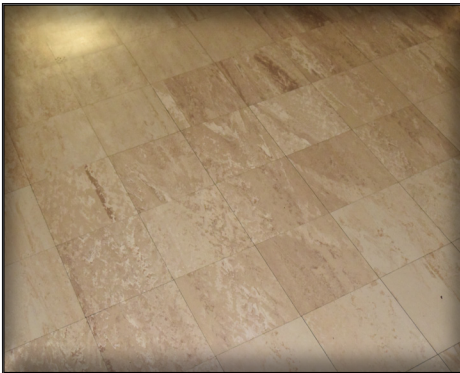
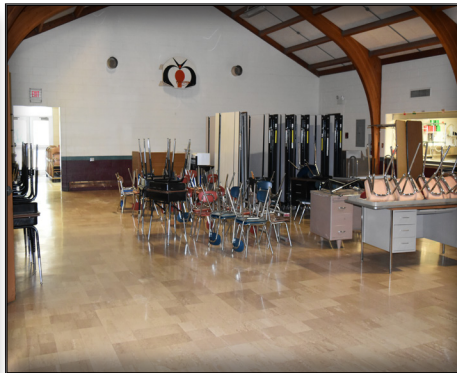
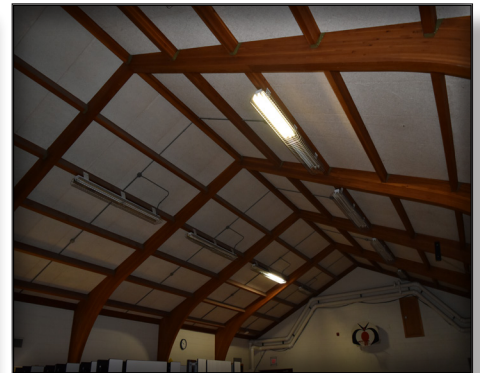
**INSPECTION GROUP:
CAFETERIA**

▲ Environmental contingencies can greatly affect project budgets and timelines. Proper planning for environmental hazards, such as asbestos, will benefit the district.

The district should create a schedule for replacement for the flooring and ceiling within the next five years. Since these materials are most likely asbestos-containing, environmental testing and potential issues should be factored into the project budget.

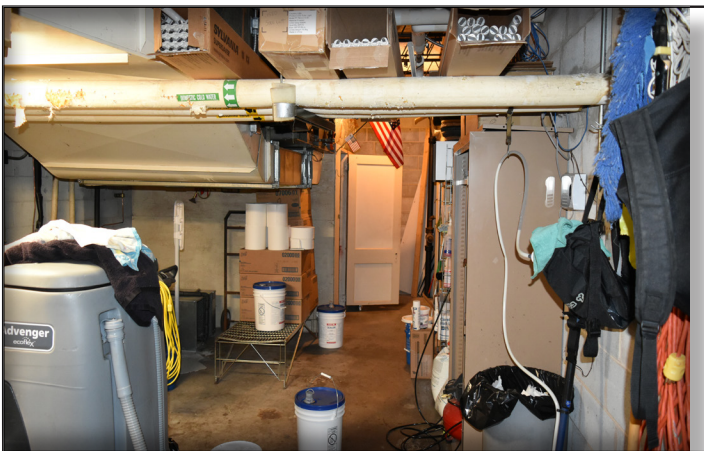
INSPECTION GROUP: AIR HANDLING EQUIPMENT

◀ Similar to much of the district's HVAC equipment, the air handling equipment is in good working order at this time, but should be placed on an equipment replacement schedule and budgeted for accordingly.

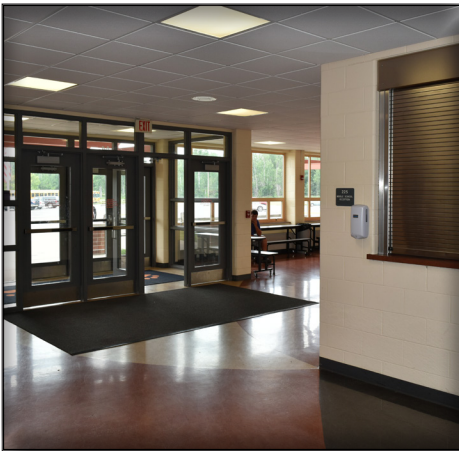
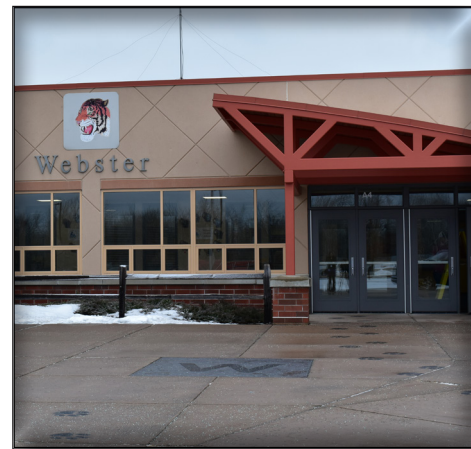
**INSPECTION GROUP:
MAIN OFFICE**

◀ The current entrance allows visitors to bypass the main office and gain immediate access to student-occupied areas. This is a safety concern. ▶

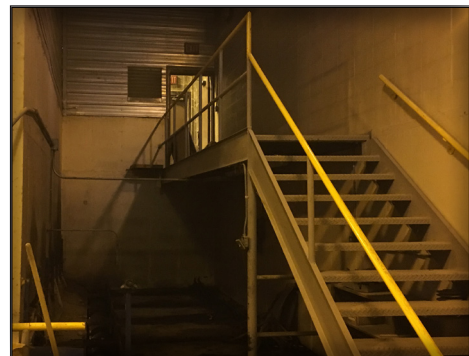
INSPECTION GROUP: OUTBUILDING

◀ A vacant building can attract rodents as well as provide a hiding area for unauthorized individuals. Plus, the district is paying unnecessary funds to heat this space during the winter months. ▶
