Webster Middle School/High School Facility Assessment

March 12, 2026

PROJECT OVERVIEW

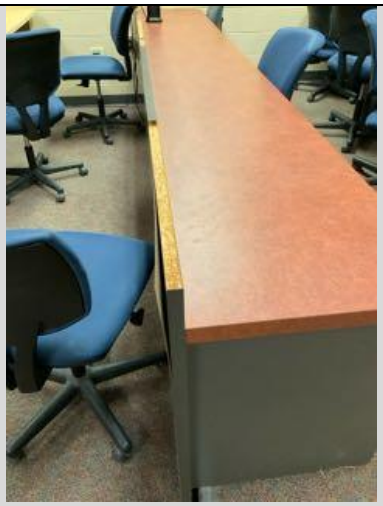
Casework
Plastic Laminate Counters
In high traffic and abuse locations, plam counters are in poor condition and are delaminating. In low traffic areas they are in fair to good condition. In FACE room and business/computer labs, plam counters were cracking in several locations.
Plastic Laminate Cabinets
Overall in fair to good condition. Middle school science casework is in fair condition, with several locations showing delaminated and broken face sheets.

Delaminating plastic laminate.

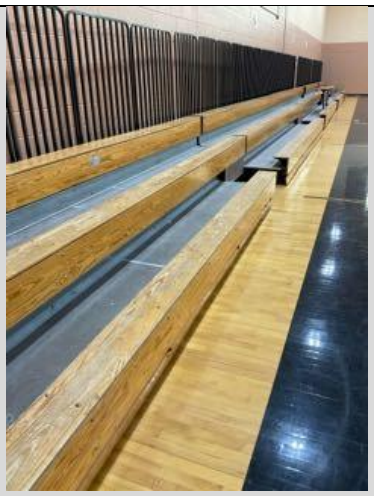
Bleachers
Gym Bleachers
Gym bleachers are aging. Operation was not observed. Wood on bleachers could be refinished.
Cafetorium Bleachers
Cafetorium bleachers were in the storage position and were not observed in operation. From what was observed, they appeared to be in good condition. These bleachers were the only access to the lighting/AV positions for the stage.

Wood gym bleachers.

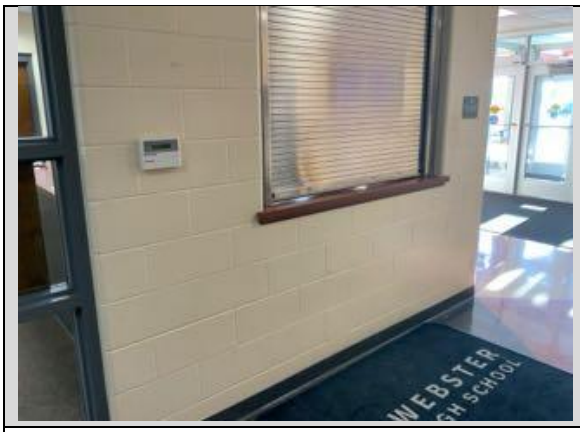
Accessibility
Counter height
Counters at concessions and student store are not accessible – too high. Accessibility requires a counter height of 2’-10” for a width of 30” minimum.
Accessible restrooms
Accessible stalls in all restrooms, including single-user restrooms (except auto-shop area) are inadequately sized.

Countertop too high for accessibility.

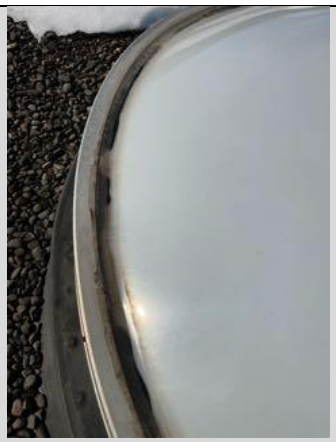
Exterior Windows
Operable Windows
Aluminum dual-pane windows are in fair condition overall. Several screens on the operable windows are damaged, making them inoperable or subject to insect intrusion. Perimeter sealant on exterior in immediate need of replacement.
Skylights
Two skylights in the hallway intersections are in fair condition. Silicone was present around the exterior perimeter suggesting previous leaks. No current leaks were observed, but there was standing water around the perimeter of the skylight curb. Interior damage was observed – see interior walls section. Skylight over library is in good condition. Flashings seemed to be installed correctly. Interior damage was observed – see interior walls section.

Skylight perimeter with silicone applied, standing water on the lip.

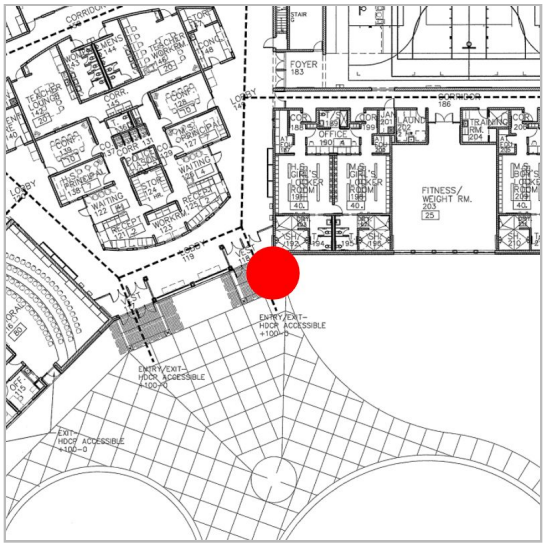
#3: Existing Condition

Description	—
Assigned to	—
Created by	Daniel Sieben
Created on	Feb 16, 2026
Location	—
Location details	Coil froze. Waiting for replacement
Due date	—
Start date	—
Placement	HS - Floor Plans.pdf
Root cause	—

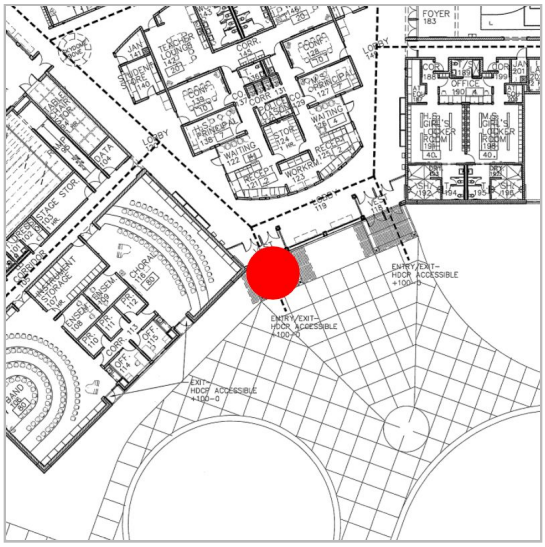
#4: CUH

Description	Fair condition
Assigned to	—
Created by	Daniel Sieben
Created on	Feb 16, 2026
Location	—
Location details	—
Due date	—
Start date	—
Placement	HS - Floor Plans.pdf
Root cause	—

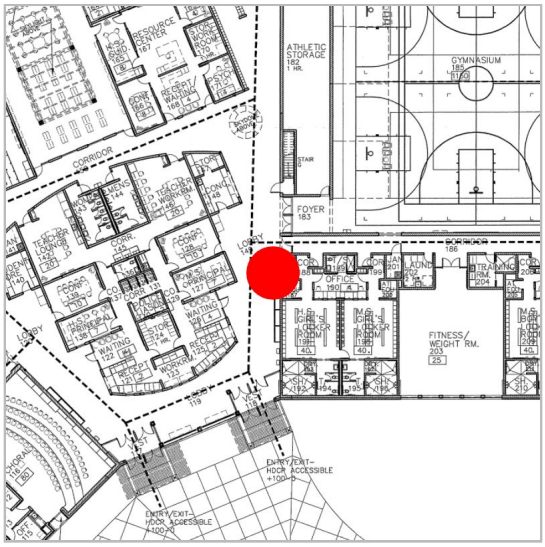
#5: CUH

Description	—
Assigned to	—
Created by	Daniel Sieben
Created on	Feb 16, 2026
Location	—
Location details	Fair condition
Due date	—
Start date	—
Placement	HS - Floor Plans.pdf
Root cause	—

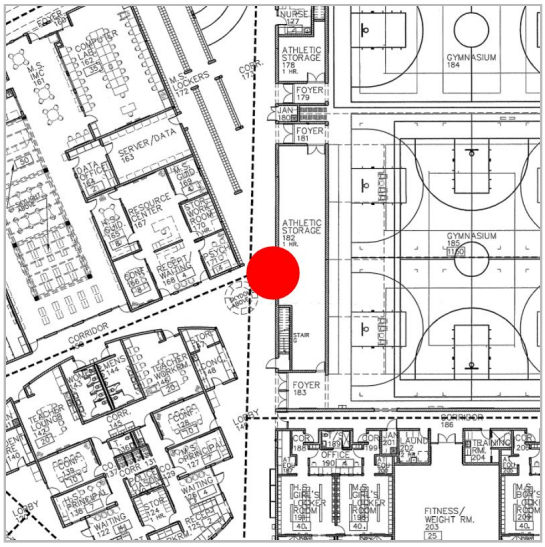
#6: CUH

Description	Fair condition
Assigned to	—
Created by	Daniel Sieben
Created on	Feb 16, 2026
Location	—
Location details	—
Due date	—
Start date	—
Placement	HS - Floor Plans.pdf
Root cause	—

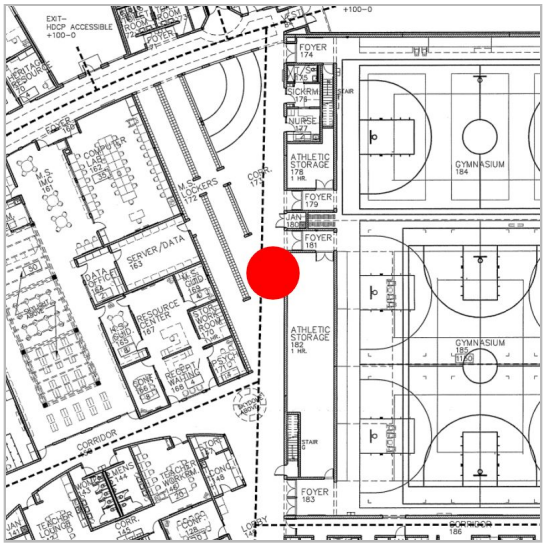
#7: CUH

Description	Fair condition
Assigned to	—
Created by	Daniel Sieben
Created on	Feb 16, 2026
Location	—
Location details	—
Due date	—
Start date	—
Placement	HS - Floor Plans.pdf
Root cause	—

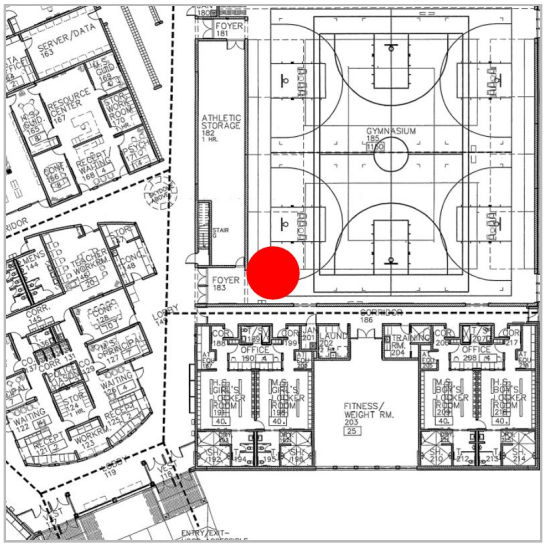
#8: EWC

Description	With bottle filler. Fair condition
Assigned to	—
Created by	Daniel Sieben
Created on	Feb 16, 2026
Location	—
Location details	—
Due date	—
Start date	—
Placement	HS - Floor Plans.pdf
Root cause	—

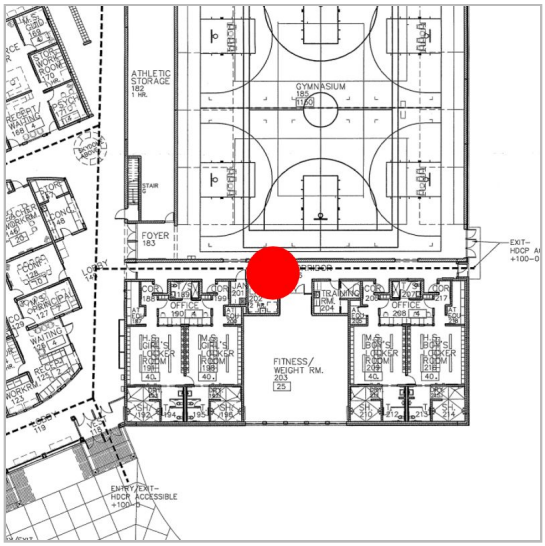
#9: Controller cabinet

Description	—
Assigned to	—
Created by	Daniel Sieben
Created on	Feb 16, 2026
Location	—
Location details	Fair condition
Due date	—
Start date	—
Placement	HS - Floor Plans.pdf
Root cause	—

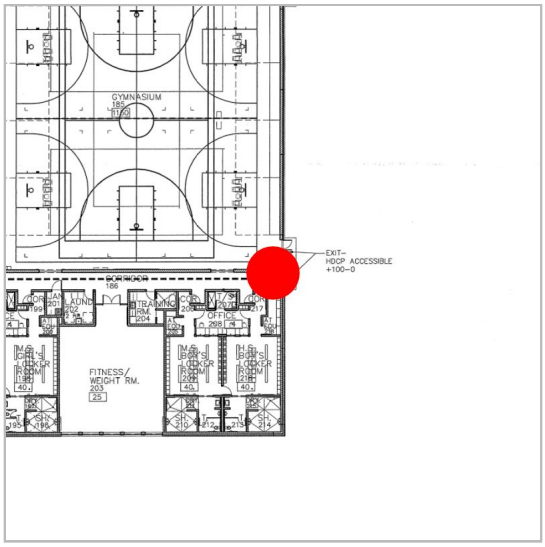
Description	Fair condition. Repair anchors and paint
Assigned to	—
Created by	Daniel Sieben
Created on	Feb 16, 2026
Location	—
Location details	—
Due date	—
Start date	—
Placement	HS - Floor Plans.pdf
Root cause	—

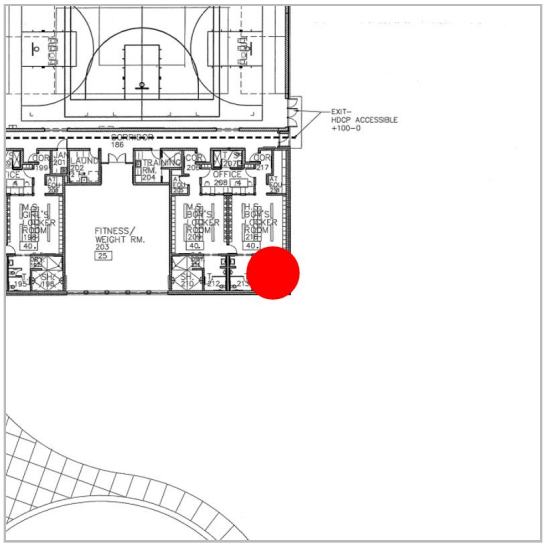
#11: Shower toilet area

Description	Fair condition
Assigned to	—
Created by	Daniel Sieben
Created on	Feb 16, 2026
Location	—
Location details	—
Due date	—
Start date	—
Placement	HS - Floor Plans.pdf
Root cause	—

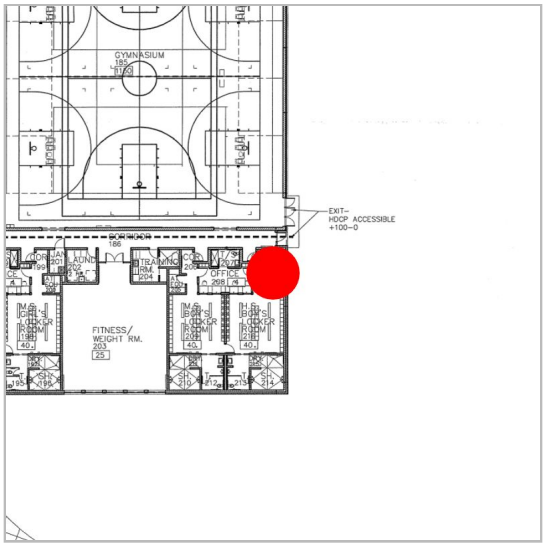
#12: FTR

Description	Fair condition
Assigned to	—
Created by	Daniel Sieben
Created on	Feb 16, 2026
Location	—
Location details	—
Due date	—
Start date	—
Placement	HS - Floor Plans.pdf
Root cause	—

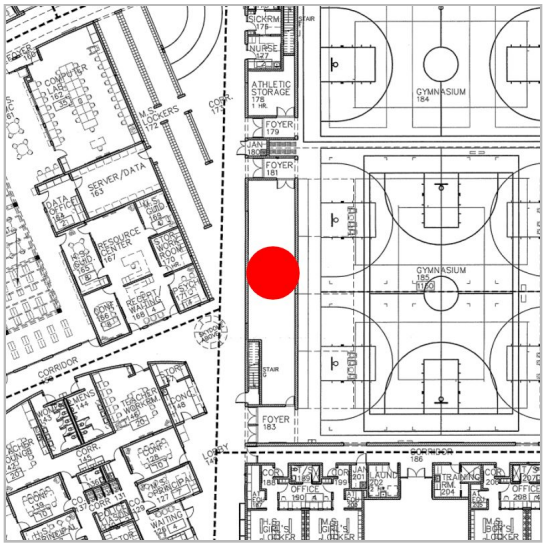
#16: Panel boards

Description	Fair condition
Assigned to	—
Created by	Daniel Sieben
Created on	Feb 16, 2026
Location	—
Location details	—
Due date	—
Start date	—
Placement	HS - Floor Plans.pdf
Root cause	—

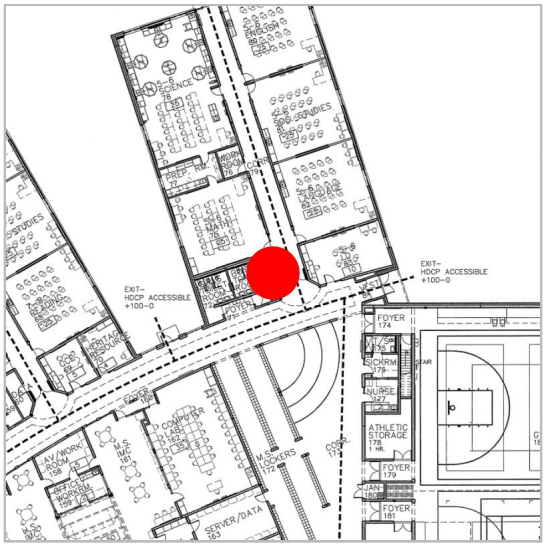
#18: Panel boards mop drain

Description	Fair condition
Assigned to	—
Created by	Daniel Sieben
Created on	Feb 16, 2026
Location	—
Location details	—
Due date	—
Start date	—
Placement	HS - Floor Plans.pdf
Root cause	—

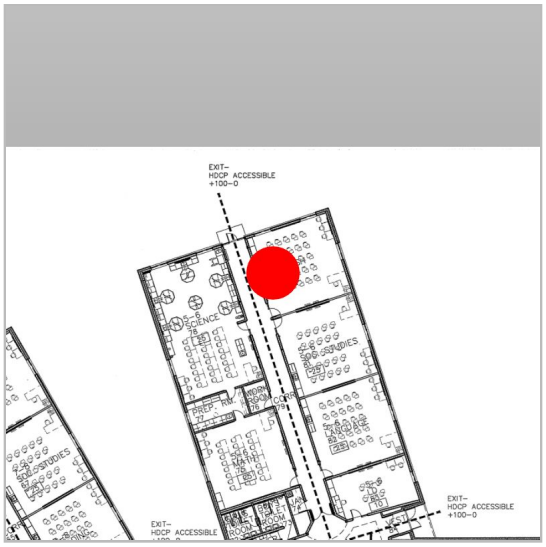
#20: Class room sink

Description	Fair condition, typical
Assigned to	—
Created by	Daniel Sieben
Created on	Feb 16, 2026
Location	—
Location details	—
Due date	—
Start date	—
Placement	HS - Floor Plans.pdf
Root cause	—

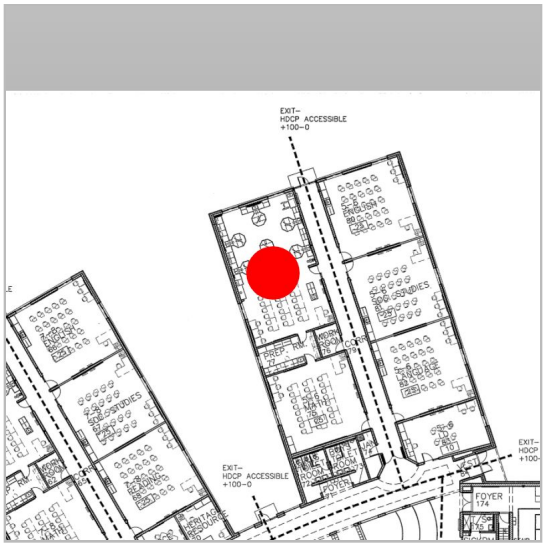
#21: Lab sinks

Description	Fair condition
Assigned to	—
Created by	Daniel Sieben
Created on	Feb 16, 2026
Location	—
Location details	—
Due date	—
Start date	—
Placement	HS - Floor Plans.pdf
Root cause	—

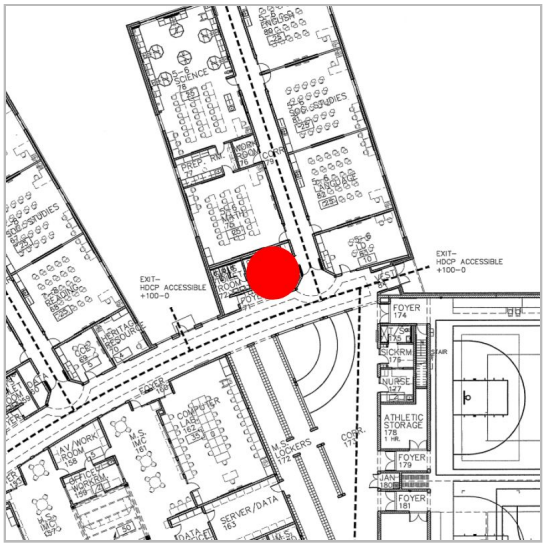
Description	Fair condition, rusty CUH cover
Assigned to	—
Created by	Daniel Sieben
Created on	Feb 16, 2026
Location	—
Location details	—
Due date	—
Start date	—
Placement	HS - Floor Plans.pdf
Root cause	—

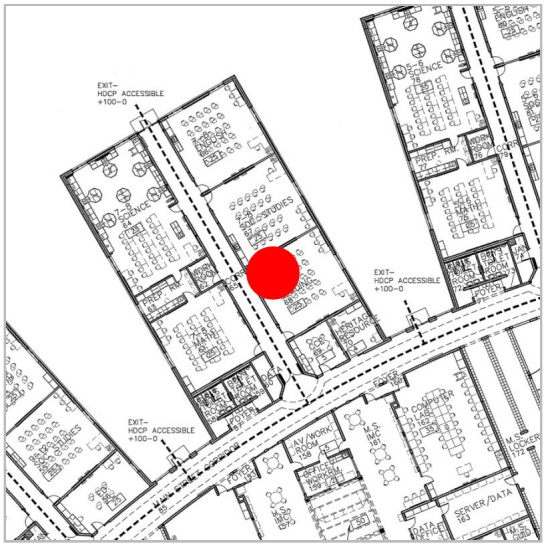
#26: Sink, room control

Description	Fair condition, typical
Assigned to	—
Created by	Daniel Sieben
Created on	Feb 16, 2026
Location	—
Location details	—
Due date	—
Start date	—
Placement	HS - Floor Plans.pdf
Root cause	—

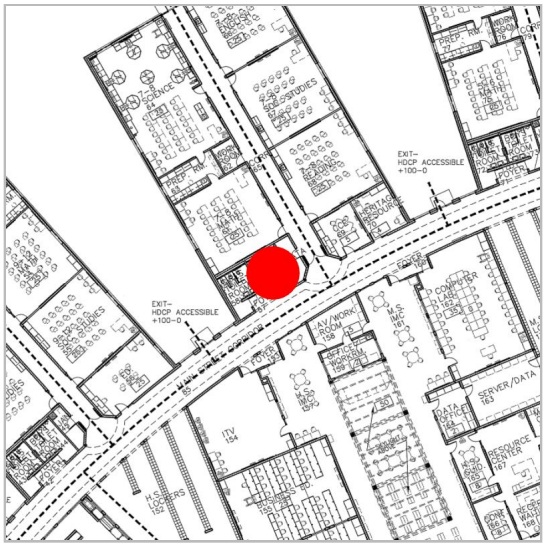
#30: Fixtures

Description	Fair condition, older EWC, rusty CUH
Assigned to	—
Created by	Daniel Sieben
Created on	Feb 16, 2026
Location	—
Location details	—
Due date	—
Start date	—
Placement	HS - Floor Plans.pdf
Root cause	—

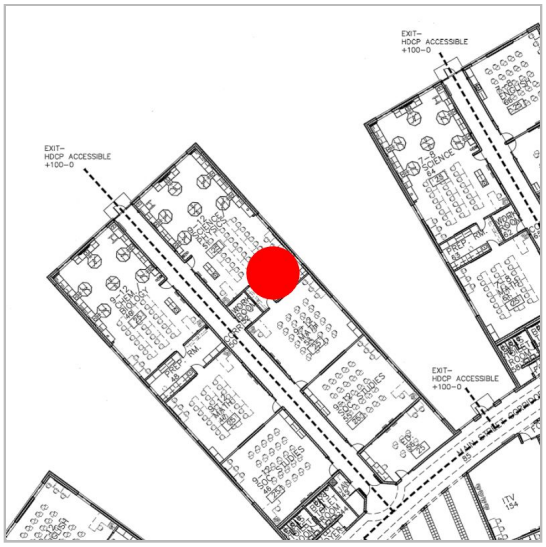
#35: Prep room

Description	Fair condition
Assigned to	—
Created by	Daniel Sieben
Created on	Feb 16, 2026
Location	—
Location details	—
Due date	—
Start date	—
Placement	HS - Floor Plans.pdf
Root cause	—

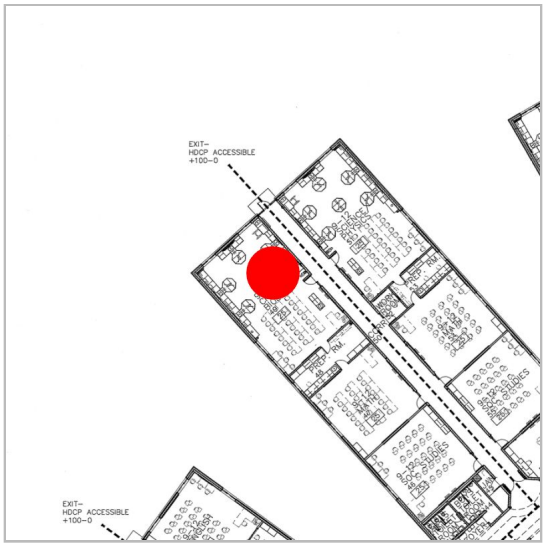
#36: Lab equipment

Description	Good condition, cold water eye wash shower Maybe swap out heavier used chemistry lab stuff
Assigned to	—
Created by	Daniel Sieben
Created on	Feb 16, 2026
Location	—
Location details	—
Due date	—
Start date	—
Placement	HS - Floor Plans.pdf
Root cause	—

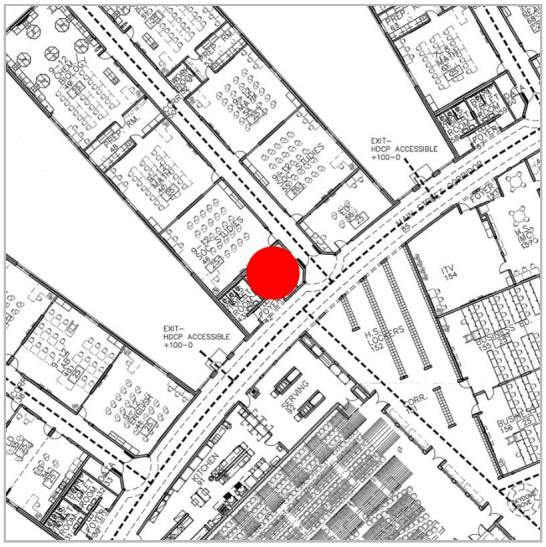
#37: Fixtures

Description	Fair condition, rusty CUH grille
Assigned to	—
Created by	Daniel Sieben
Created on	Feb 16, 2026
Location	—
Location details	—
Due date	—
Start date	—
Placement	HS - Floor Plans.pdf
Root cause	—

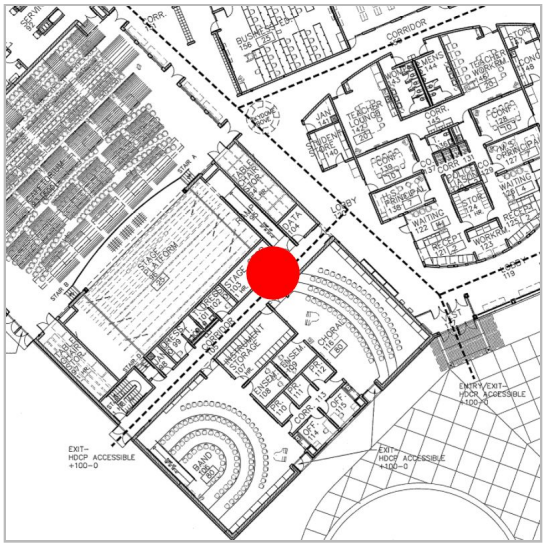
#38: Mechanical mezz AHUs

Description	AHUs fair condition
Assigned to	—
Created by	Daniel Sieben
Created on	Feb 16, 2026
Location	—
Location details	—
Due date	—
Start date	—
Placement	HS - Floor Plans.pdf
Root cause	—

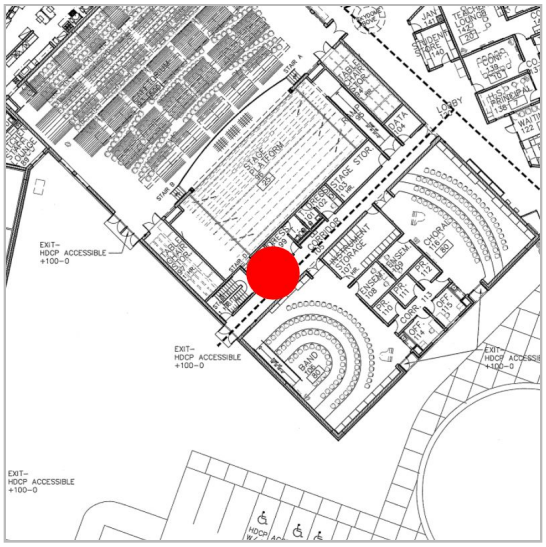
#39: Mezzanine electric main service

Description	Fair condition
Assigned to	—
Created by	Daniel Sieben
Created on	Feb 16, 2026
Location	—
Location details	—
Due date	—
Start date	—
Placement	HS - Floor Plans.pdf
Root cause	—

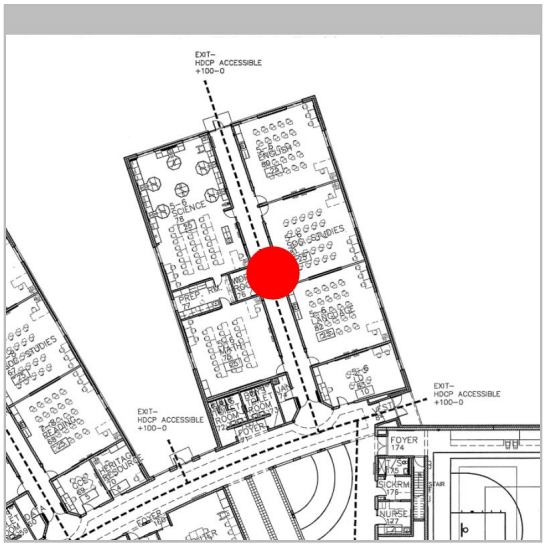
#40: Roof

Description	Fair condition
Assigned to	—
Created by	Daniel Sieben
Created on	Feb 16, 2026
Location	—
Location details	—
Due date	—
Start date	—
Placement	HS - Floor Plans.pdf
Root cause	—

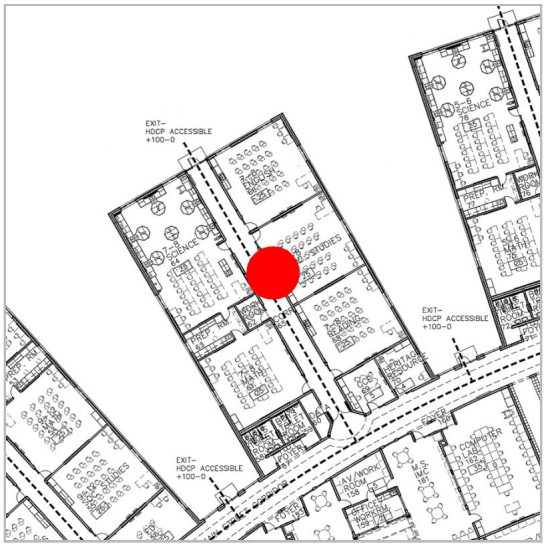
#41: Roof

Description	Fair condition
Assigned to	—
Created by	Daniel Sieben
Created on	Feb 16, 2026
Location	—
Location details	—
Due date	—
Start date	—
Placement	HS - Floor Plans.pdf
Root cause	—

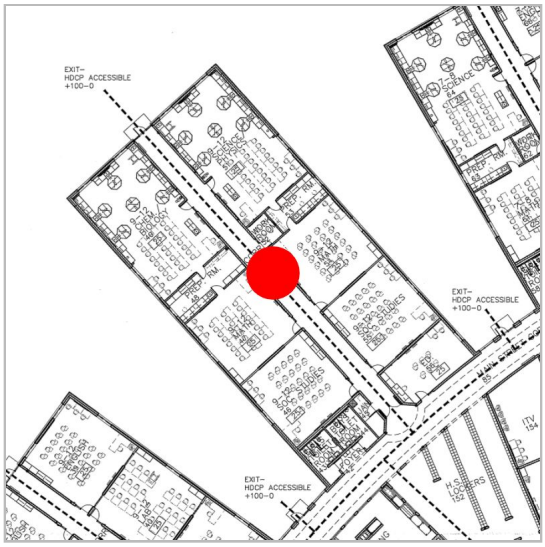
#42: Roof

Description	Fair condition
Assigned to	—
Created by	Daniel Sieben
Created on	Feb 16, 2026
Location	—
Location details	—
Due date	—
Start date	—
Placement	HS - Floor Plans.pdf
Root cause	—

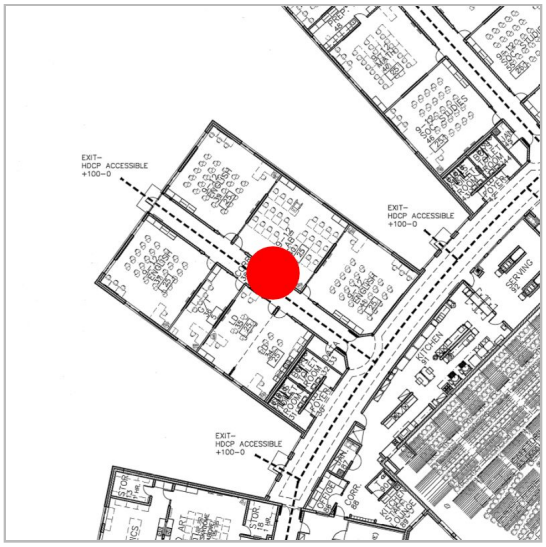
#43: Roof

Description	Fair condition u
Assigned to	—
Created by	Daniel Sieben
Created on	Feb 16, 2026
Location	—
Location details	—
Due date	—
Start date	—
Placement	HS - Floor Plans.pdf
Root cause	—

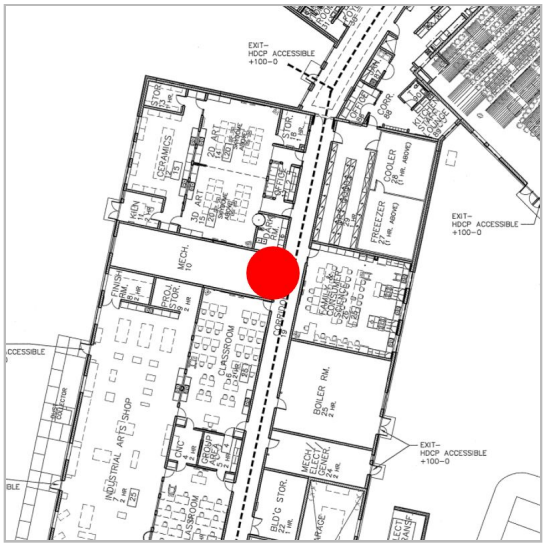
#44: Roof

Description	Good condition except split system CU
Assigned to	—
Created by	Daniel Sieben
Created on	Feb 16, 2026
Location	—
Location details	—
Due date	—
Start date	—
Placement	HS - Floor Plans.pdf
Root cause	—

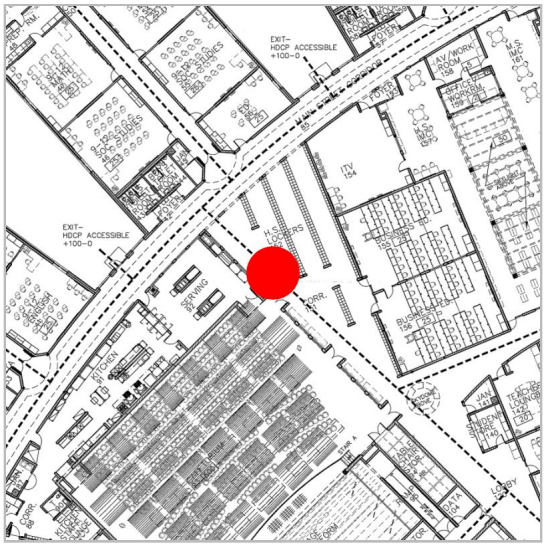
#45: CUH

Description	Fain condition
Assigned to	—
Created by	Daniel Sieben
Created on	Feb 16, 2026
Location	—
Location details	—
Due date	—
Start date	—
Placement	HS - Floor Plans.pdf
Root cause	—

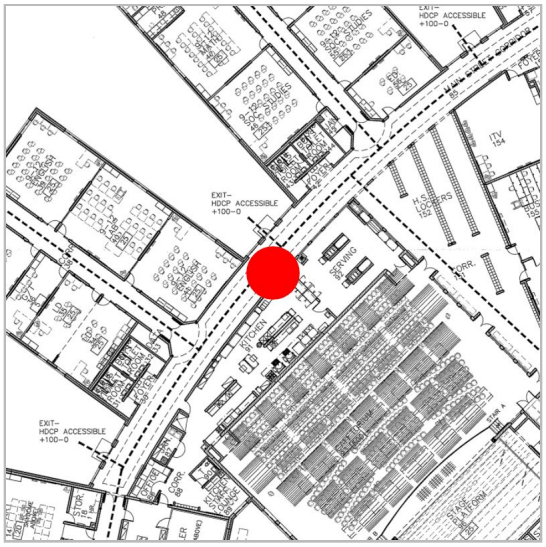
#46: CUH

Description	Fair condition
Assigned to	—
Created by	Daniel Sieben
Created on	Feb 16, 2026
Location	—
Location details	—
Due date	—
Start date	—
Placement	HS - Floor Plans.pdf
Root cause	—

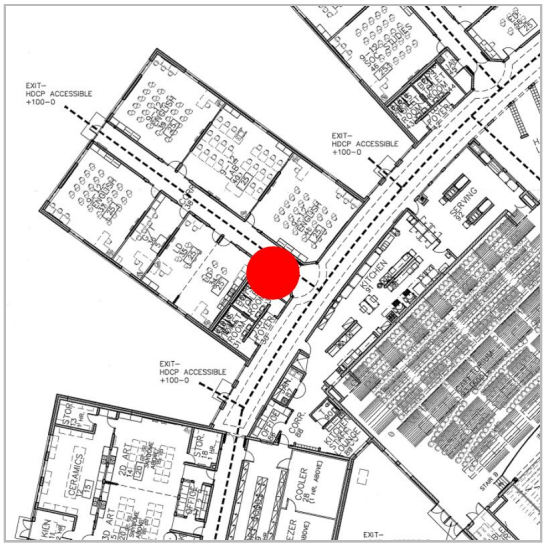
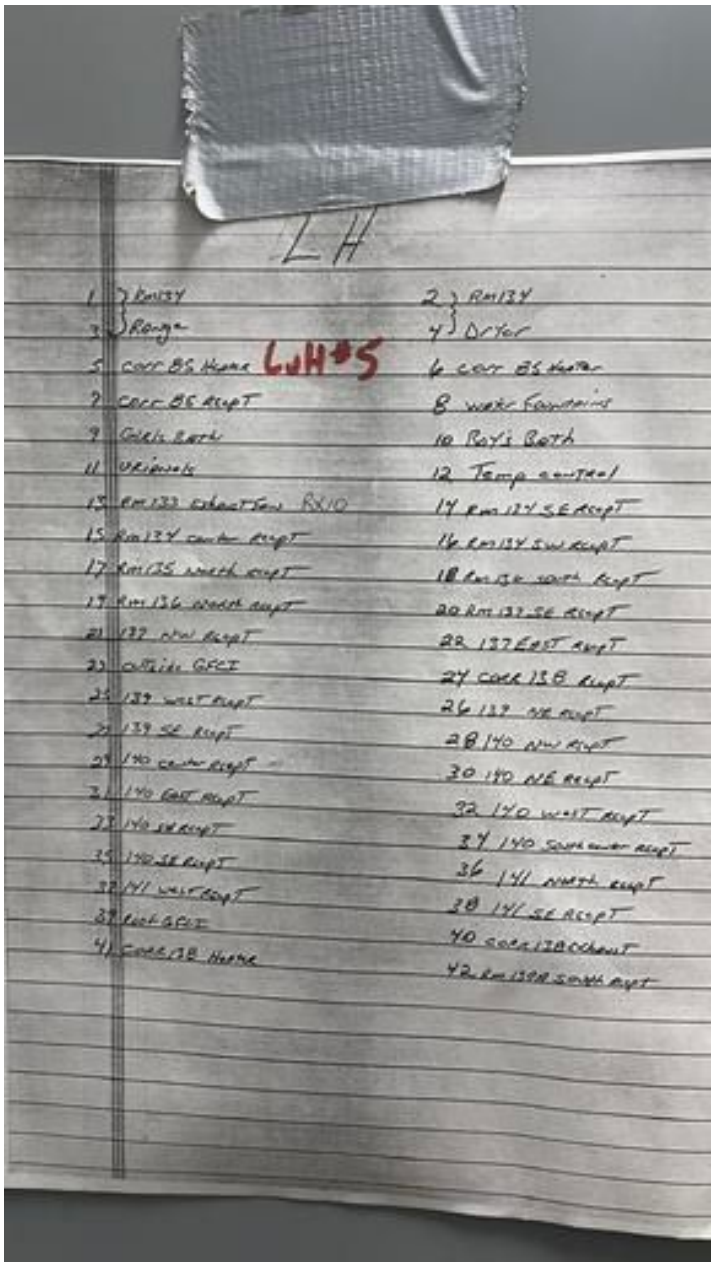
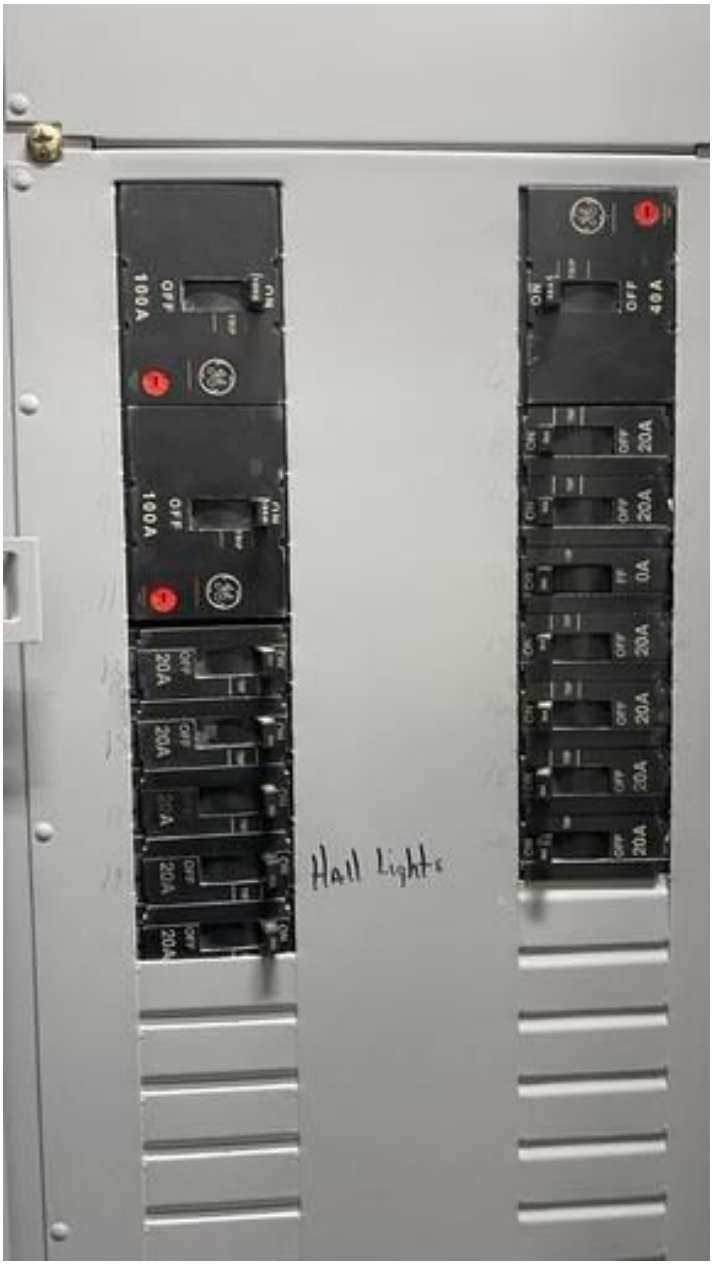
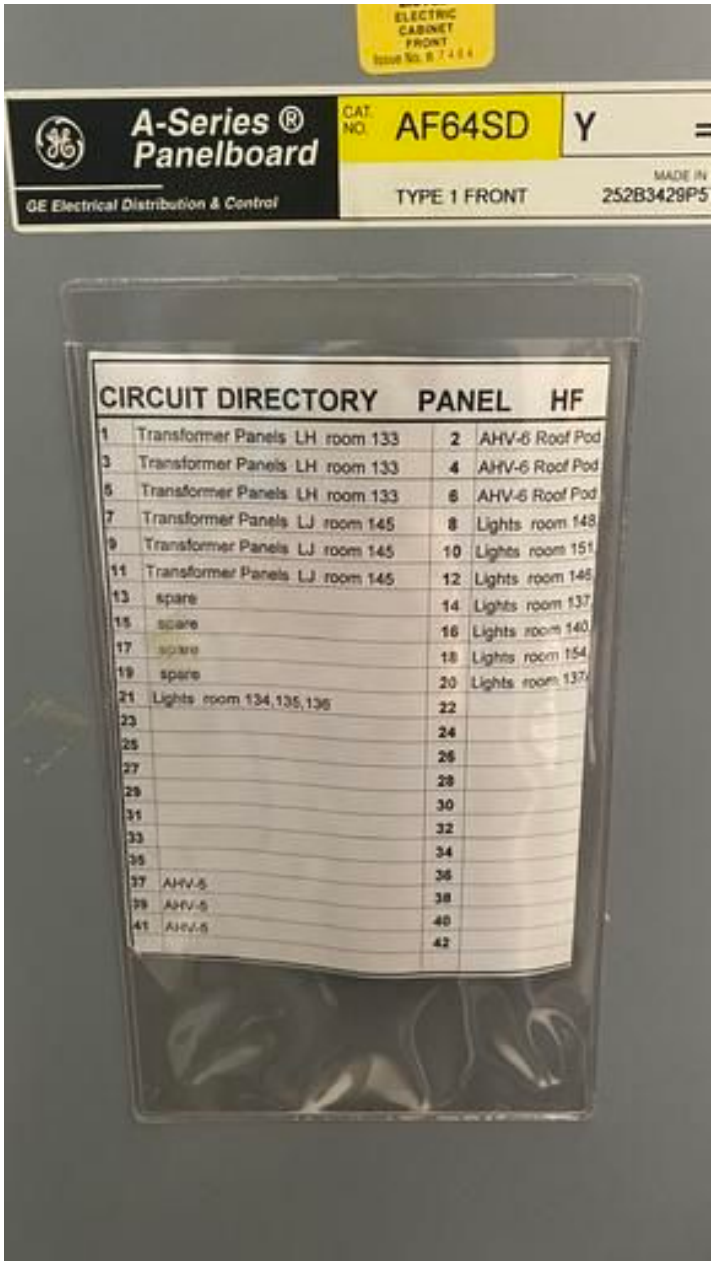
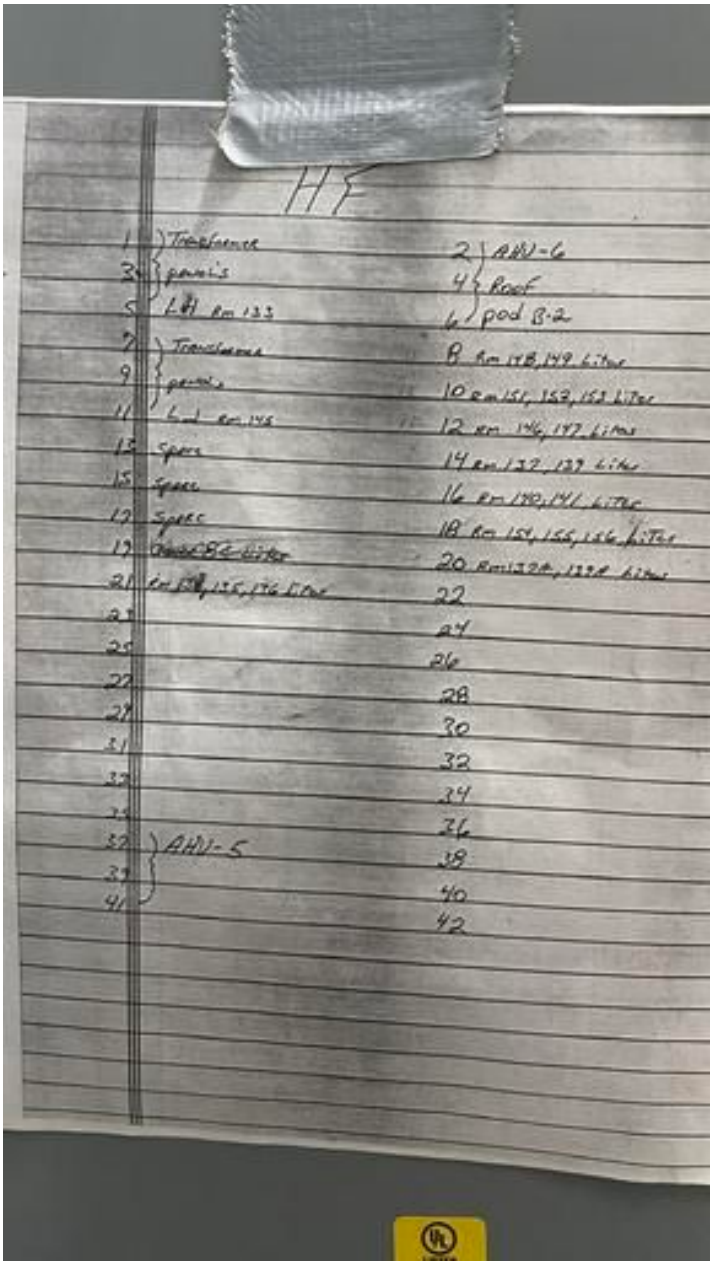
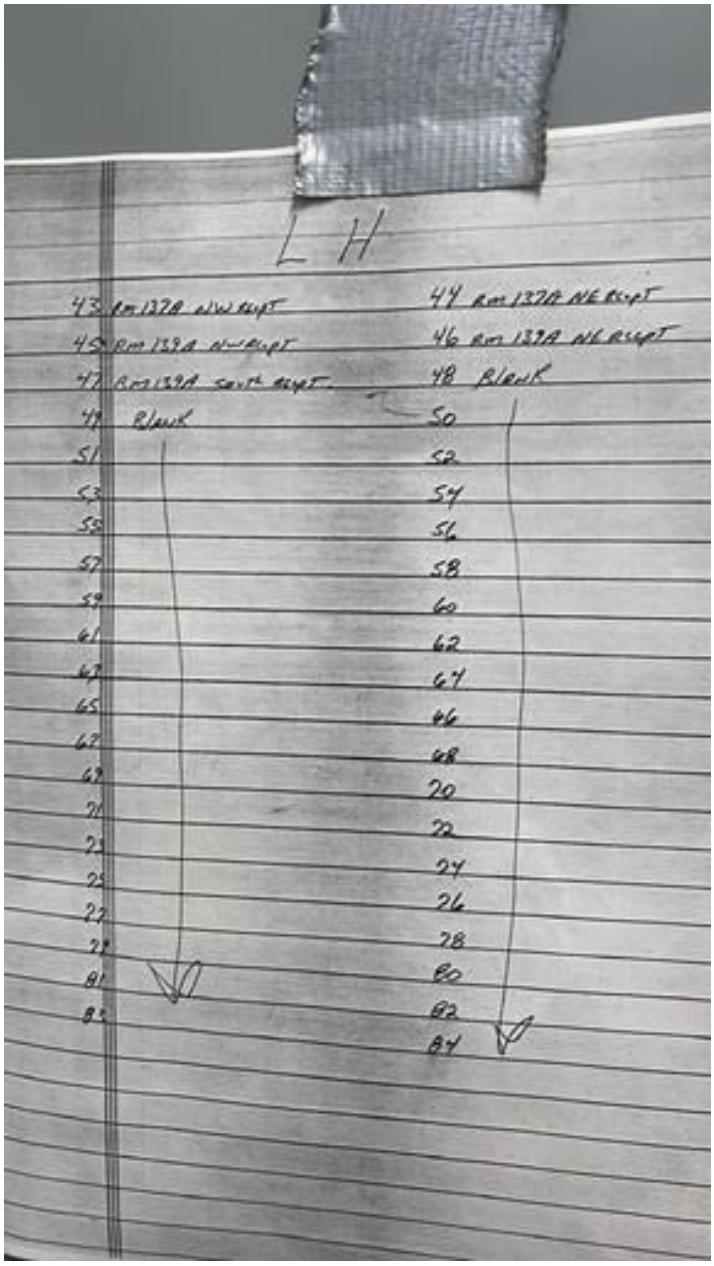
#47: Data and Power

Description	Fair condition
Assigned to	—
Created by	Daniel Sieben
Created on	Feb 16, 2026
Location	—
Location details	—
Due date	—
Start date	—
Placement	HS - Floor Plans.pdf
Root cause	—

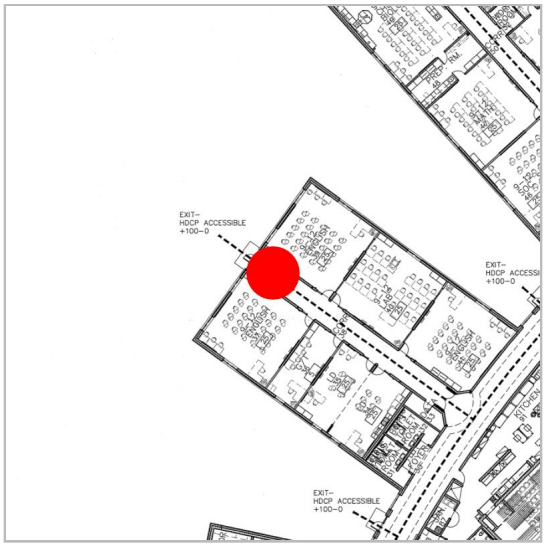
#48: CUH

Description	Fair condition
Assigned to	—
Created by	Daniel Sieben
Created on	Feb 16, 2026
Location	—
Location details	—
Due date	—
Start date	—
Placement	HS - Floor Plans.pdf
Root cause	—

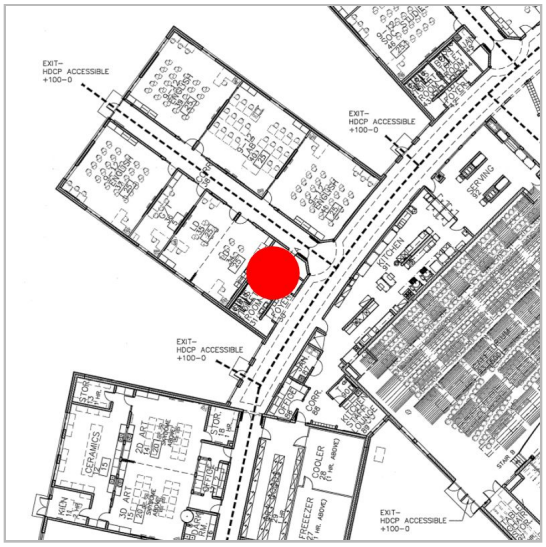
#49: Fixtures

Description	Fair condition, rusty CUH
Assigned to	—
Created by	Daniel Sieben
Created on	Feb 16, 2026
Location	—
Location details	—
Due date	—
Start date	—
Placement	HS - Floor Plans.pdf
Root cause	—

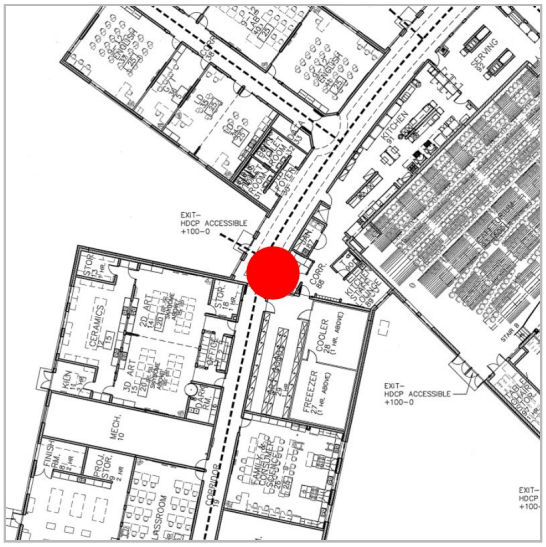
#50: CUH

Description	Fair condition
Assigned to	—
Created by	Daniel Sieben
Created on	Feb 16, 2026
Location	—
Location details	—
Due date	—
Start date	—
Placement	HS - Floor Plans.pdf
Root cause	—

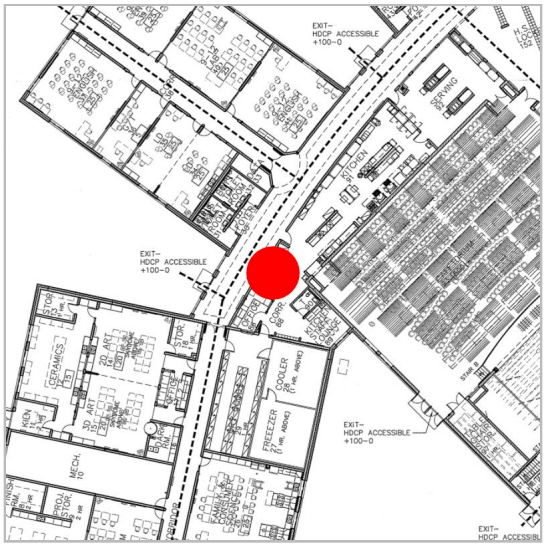
#51: Laundry

Description	Fair condition
Assigned to	—
Created by	Daniel Sieben
Created on	Feb 16, 2026
Location	—
Location details	—
Due date	—
Start date	—
Placement	HS - Floor Plans.pdf
Root cause	—

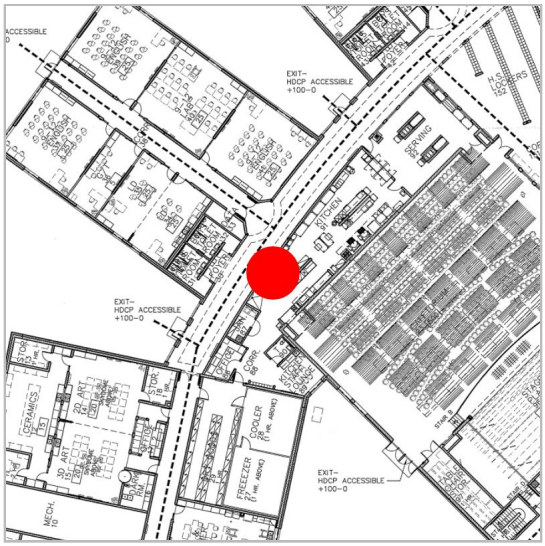
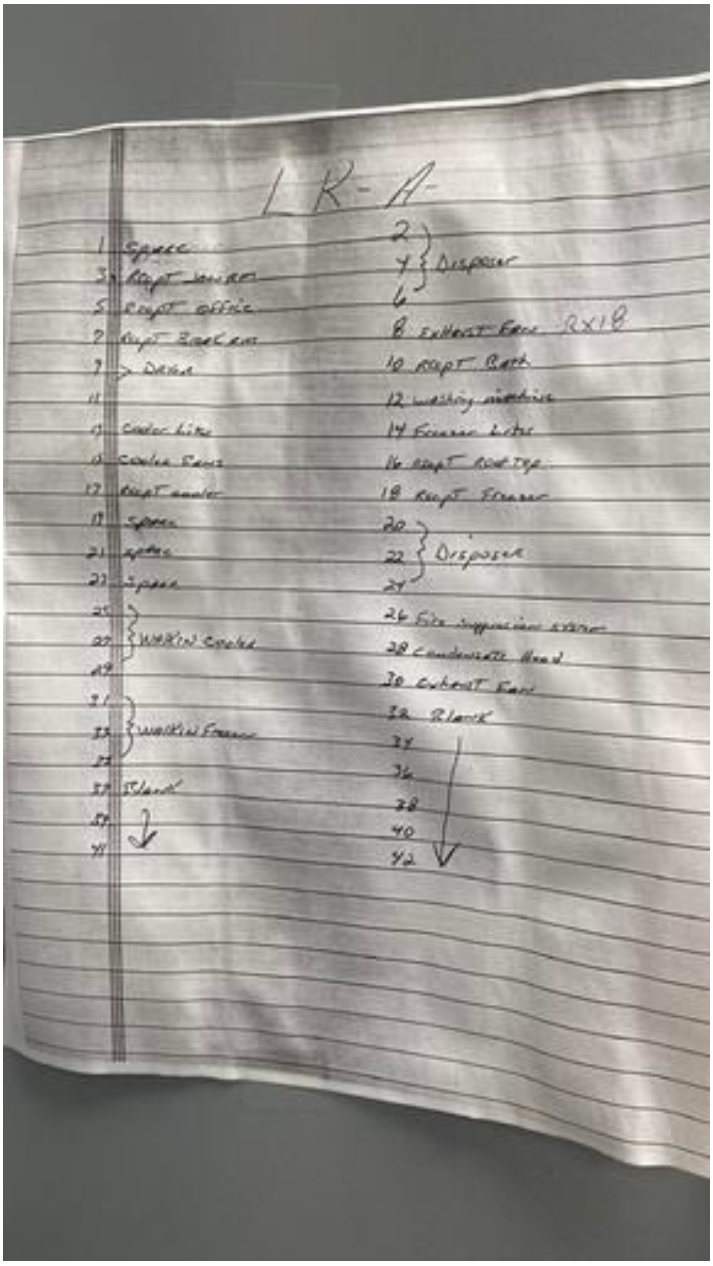
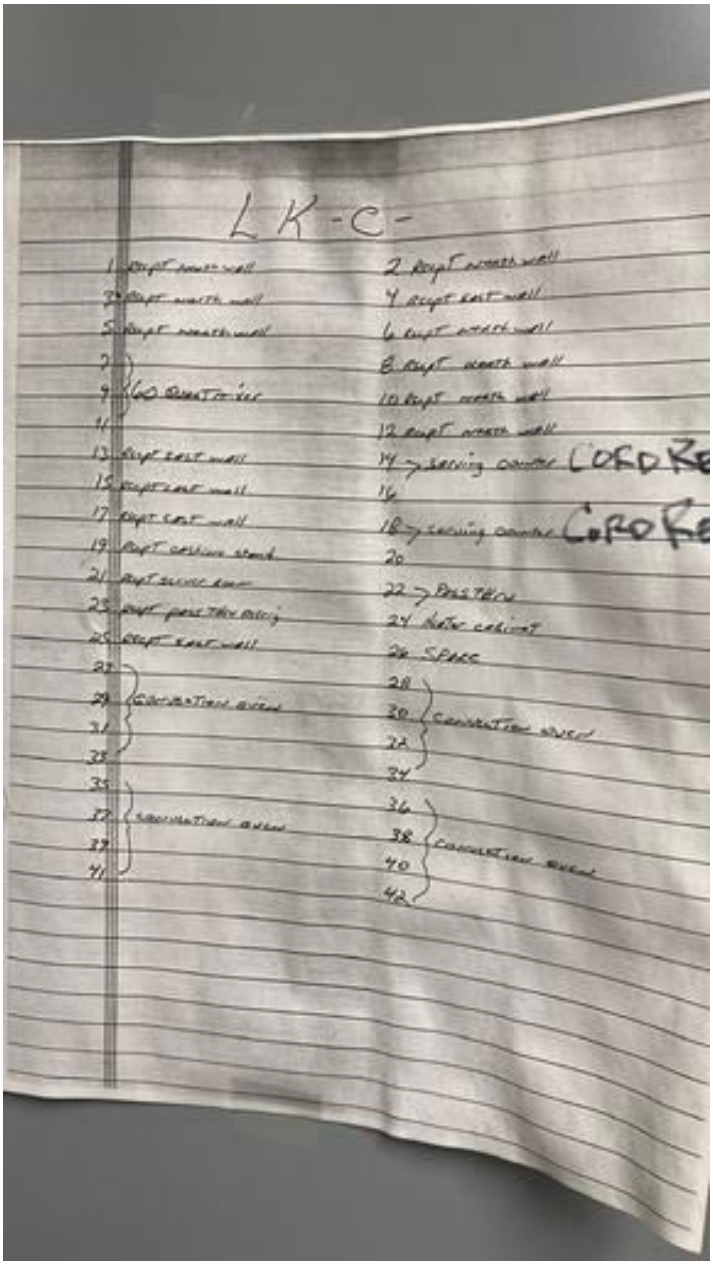
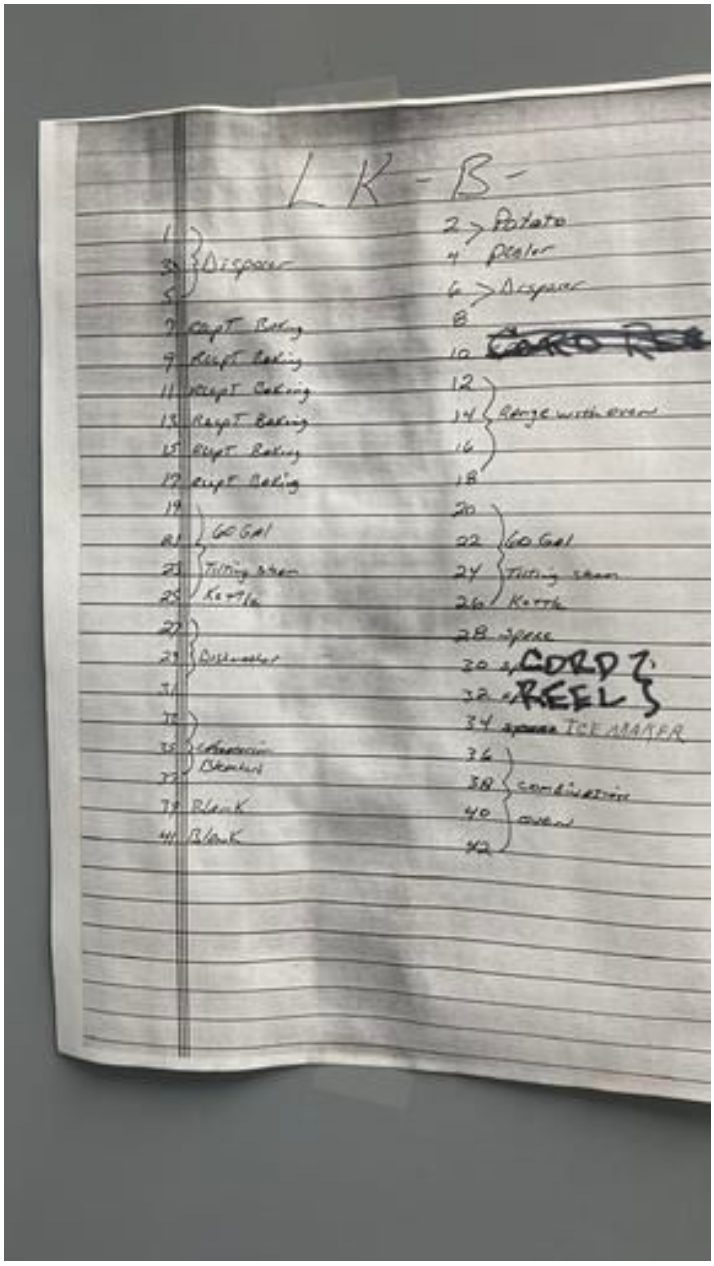
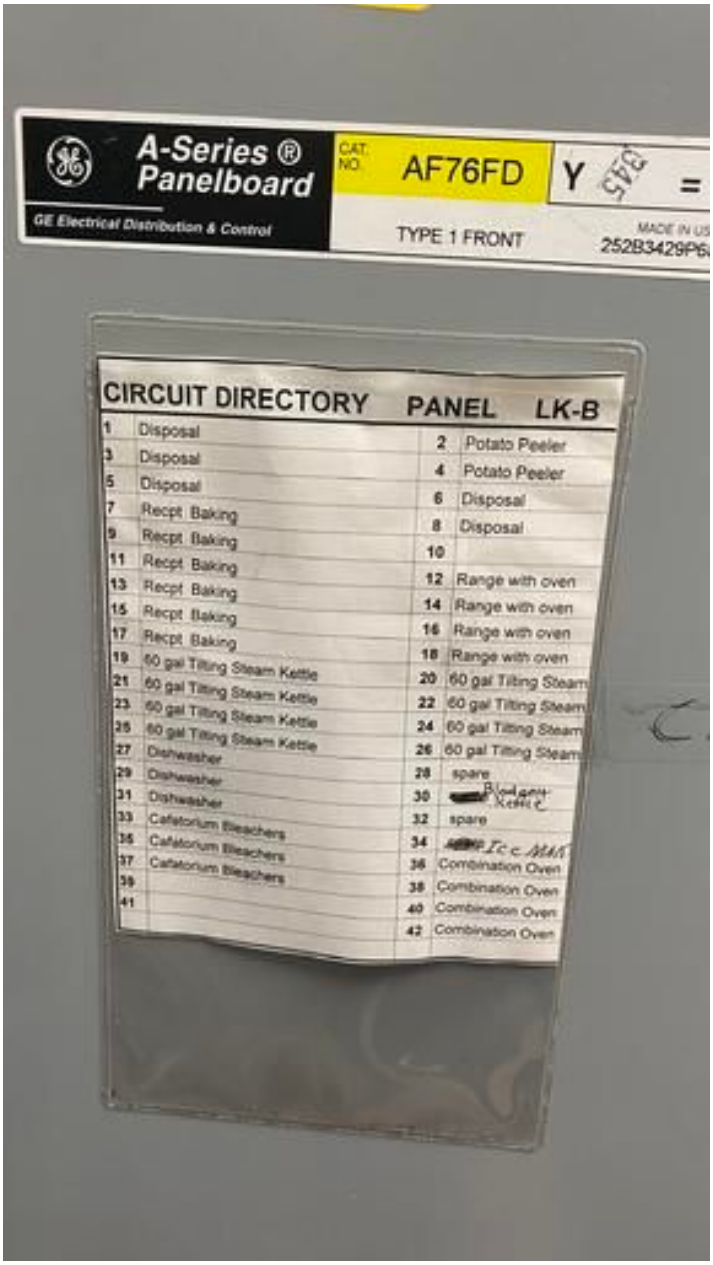
#52: Panel boards

Description	Fair condition
Assigned to	—
Created by	Daniel Sieben
Created on	Feb 16, 2026
Location	—
Location details	—
Due date	—
Start date	—
Placement	HS - Floor Plans.pdf
Root cause	—

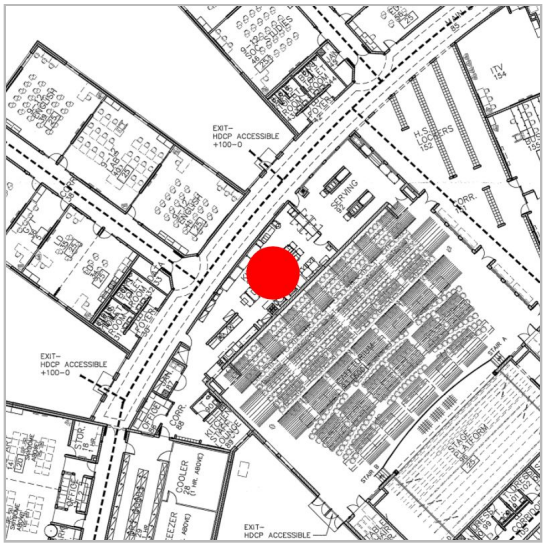
#53: Kitchen

Description	Good condition
Assigned to	—
Created by	Daniel Sieben
Created on	Feb 16, 2026
Location	—
Location details	—
Due date	—
Start date	—
Placement	HS - Floor Plans.pdf
Root cause	—
