Webster Middle School/High School Facility Assessment

March 12, 2026

PROJECT OVERVIEW

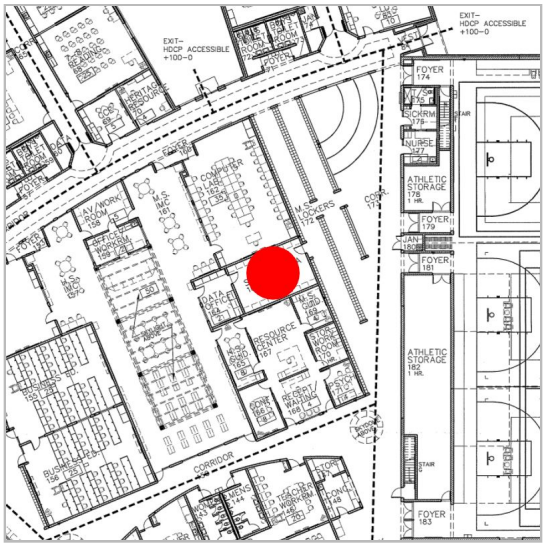
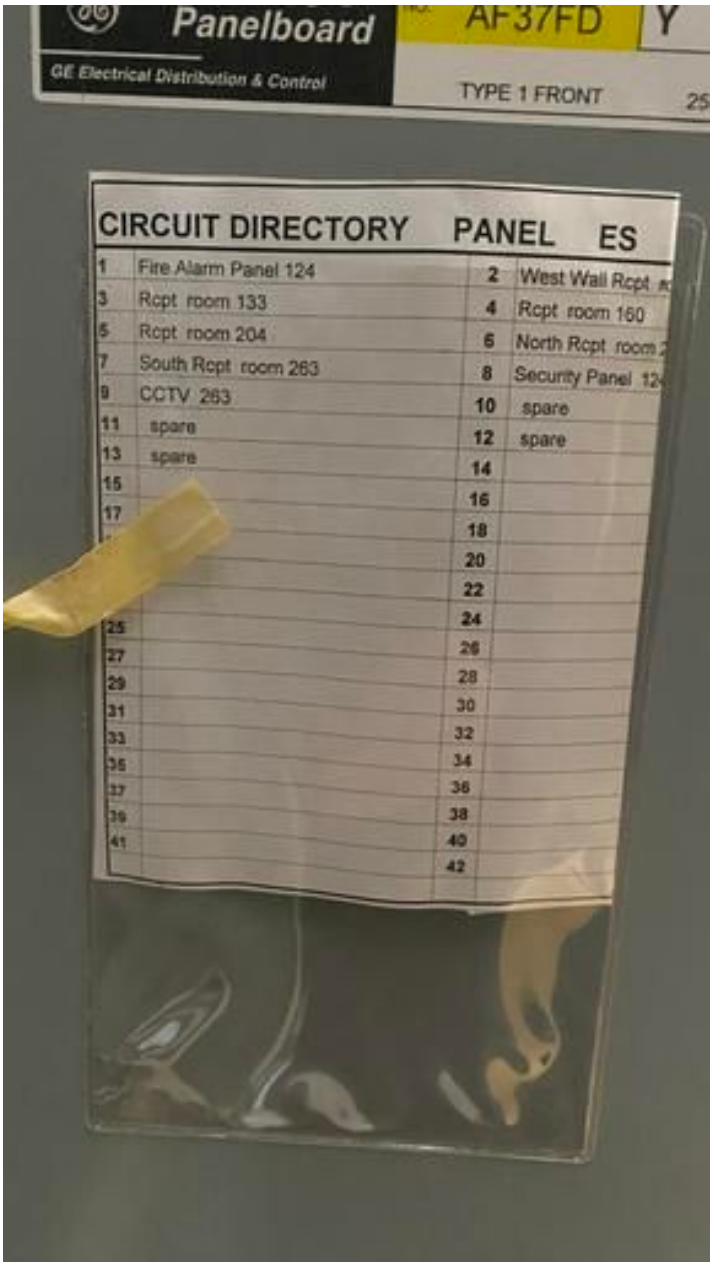
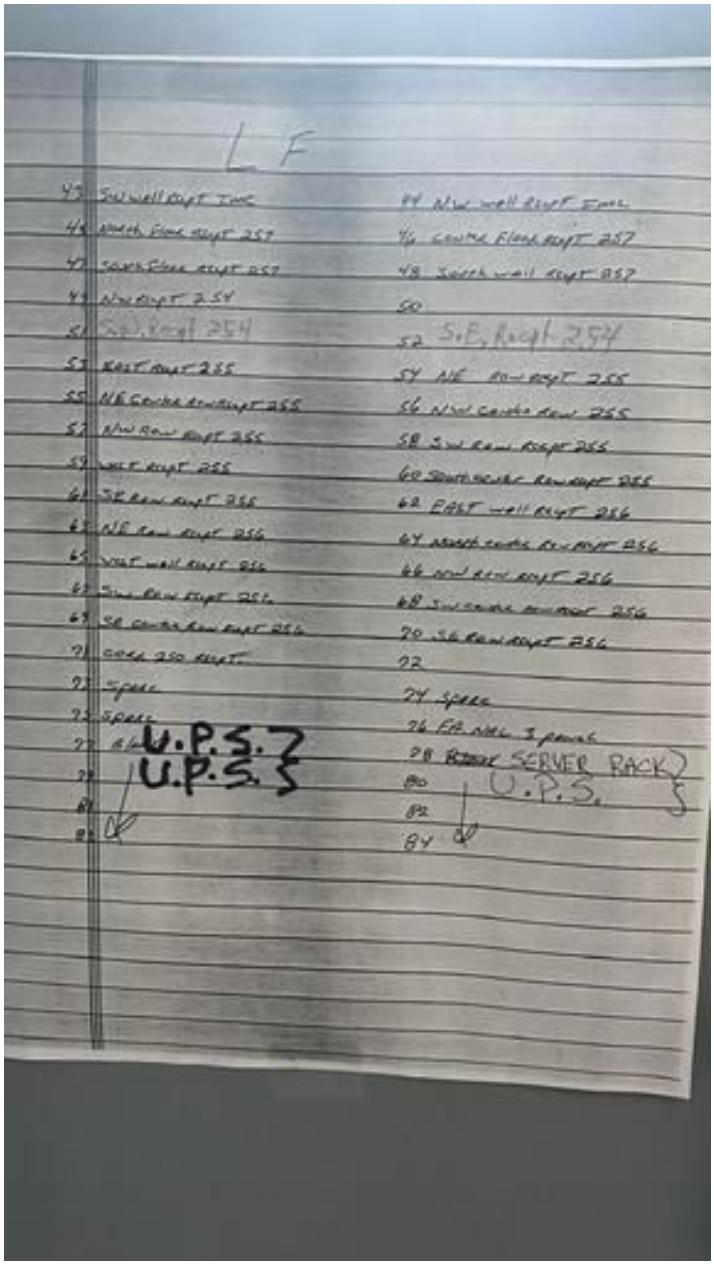
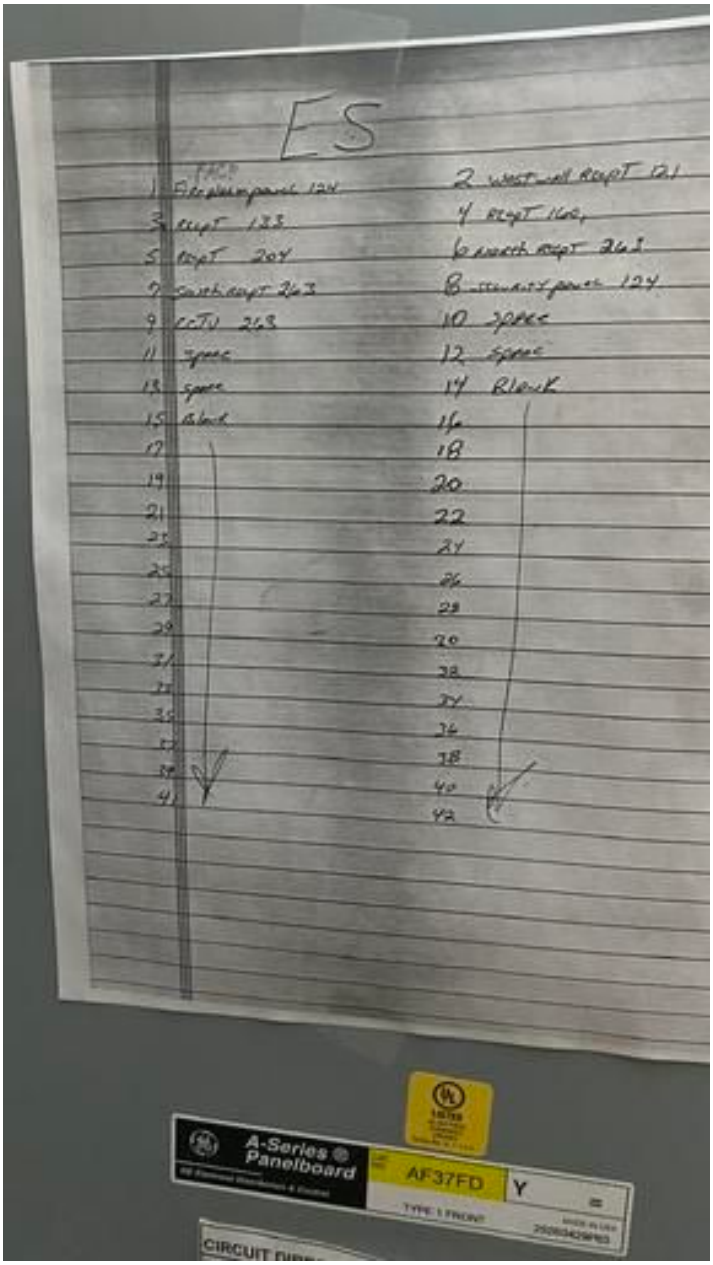
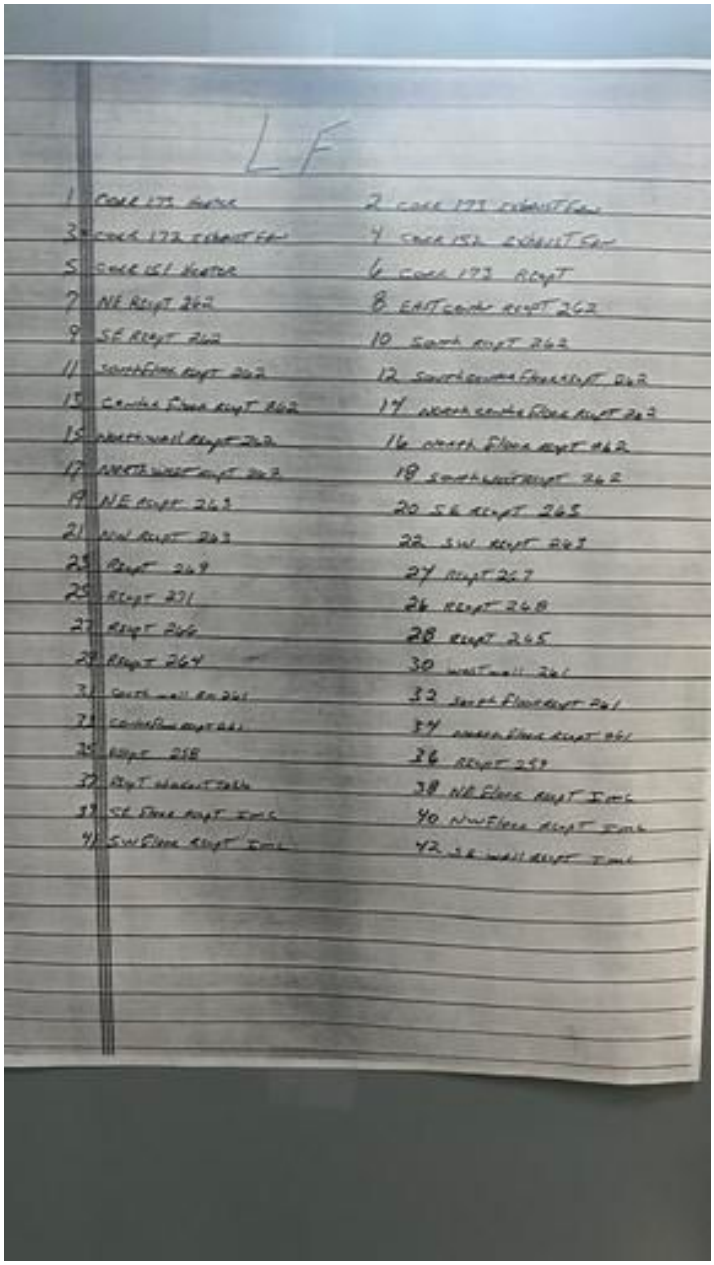
#54: Cooling and generator power

Description	Good condition
Assigned to	—
Created by	Daniel Sieben
Created on	Feb 16, 2026
Location	—
Location details	—
Due date	—
Start date	—
Placement	HS - Floor Plans.pdf
Root cause	—

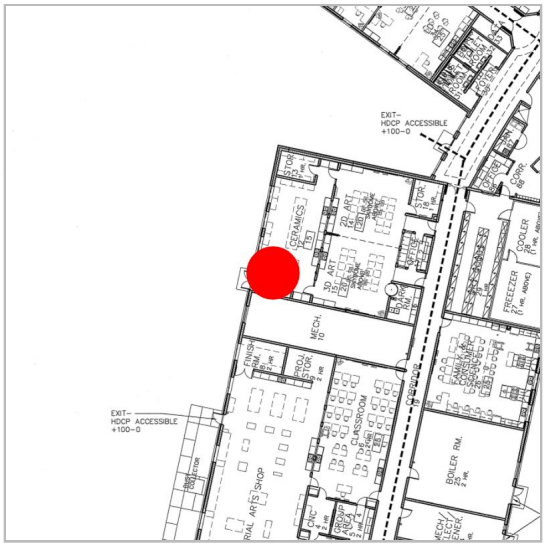
#55: Kiln

Description	Fair condition
Assigned to	—
Created by	Daniel Sieben
Created on	Feb 16, 2026
Location	—
Location details	—
Due date	—
Start date	—
Placement	HS - Floor Plans.pdf
Root cause	—

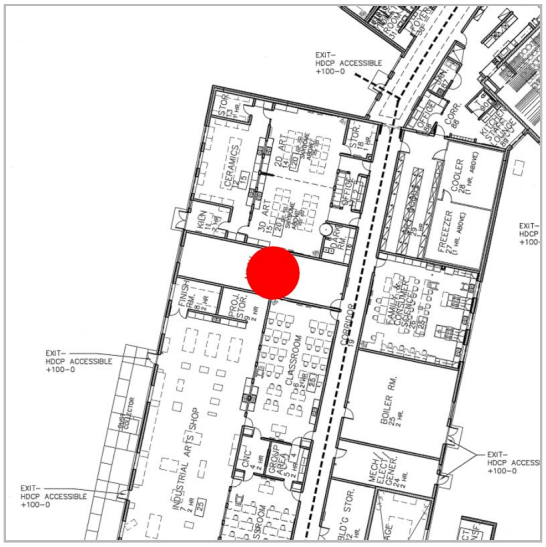
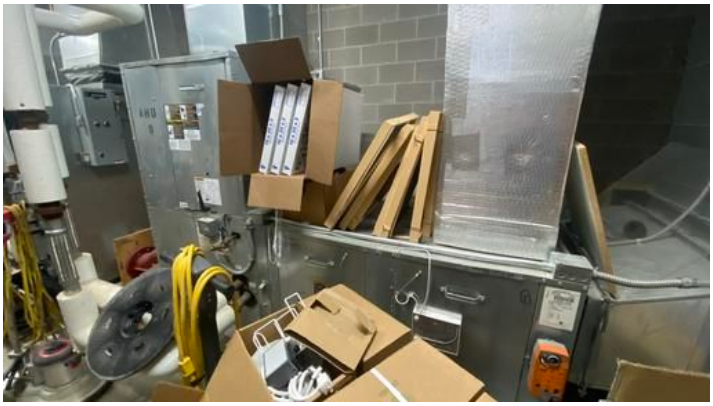
#56: AHUs

Description	Fair condition
Assigned to	—
Created by	Daniel Sieben
Created on	Feb 16, 2026
Location	—
Location details	—
Due date	—
Start date	—
Placement	HS - Floor Plans.pdf
Root cause	—

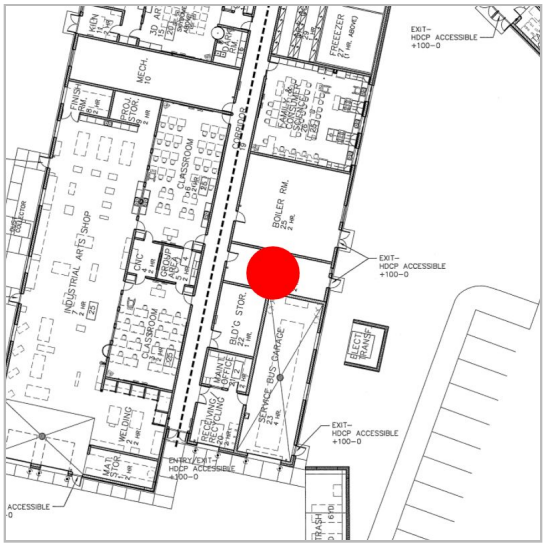
#57: Main service

Description	Good condition
Assigned to	—
Created by	Daniel Sieben
Created on	Feb 16, 2026
Location	—
Location details	—
Due date	—
Start date	—
Placement	HS - Floor Plans.pdf
Root cause	—

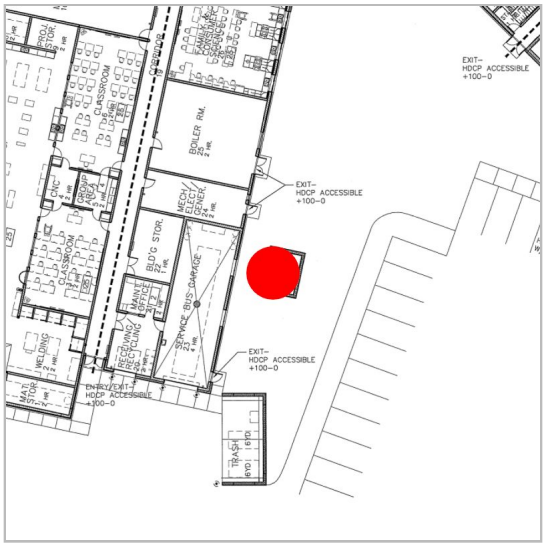
#58: Generator Gas service

Description	Good condition
Assigned to	—
Created by	Daniel Sieben
Created on	Feb 16, 2026
Location	—
Location details	—
Due date	—
Start date	—
Placement	HS - Floor Plans.pdf
Root cause	—

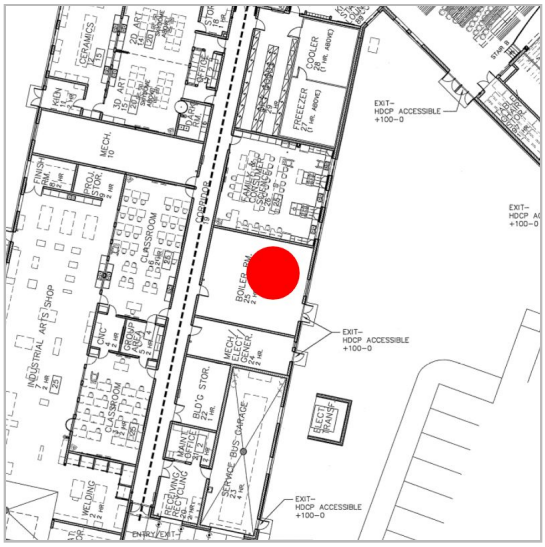
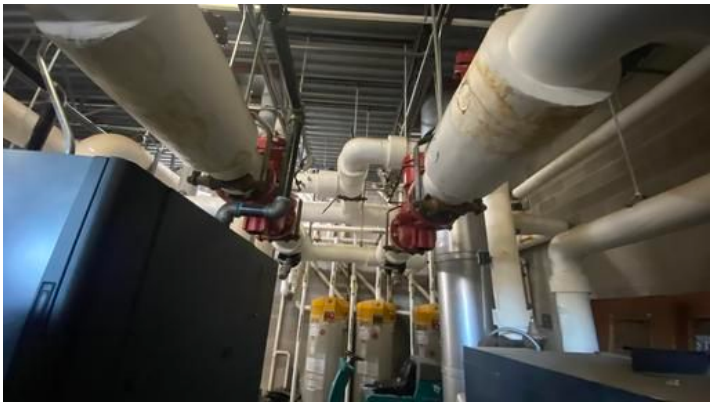
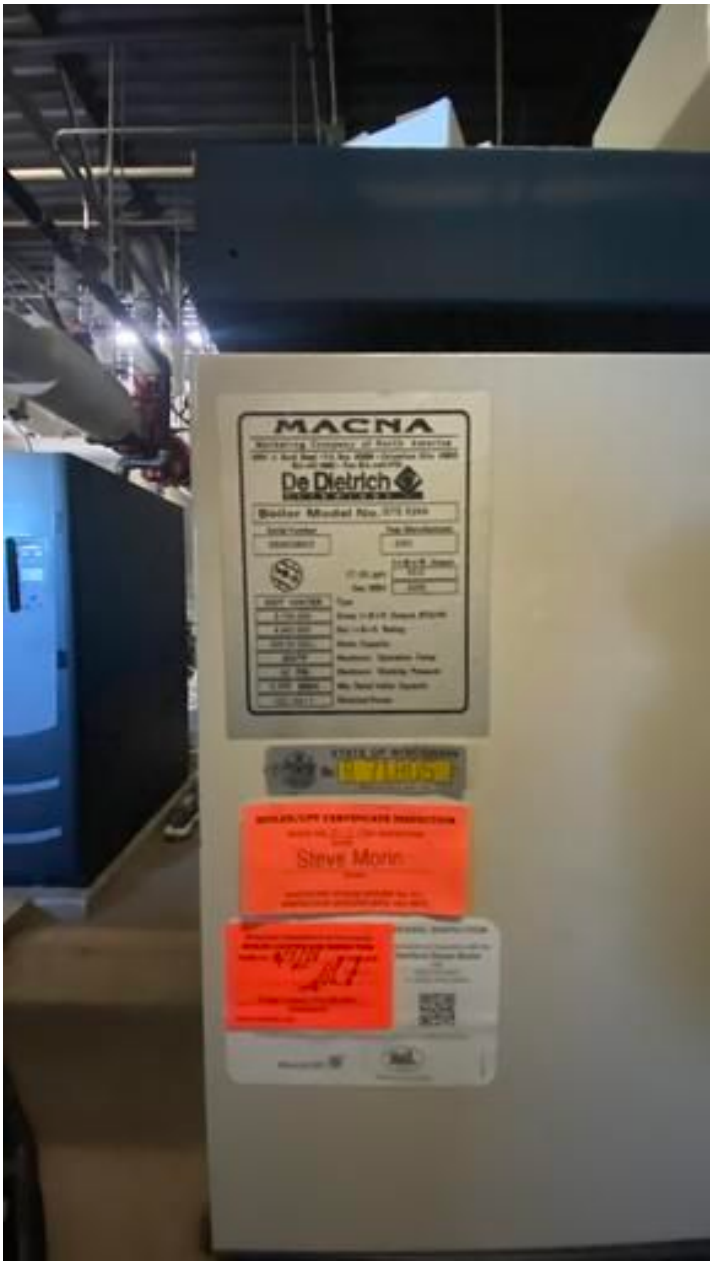
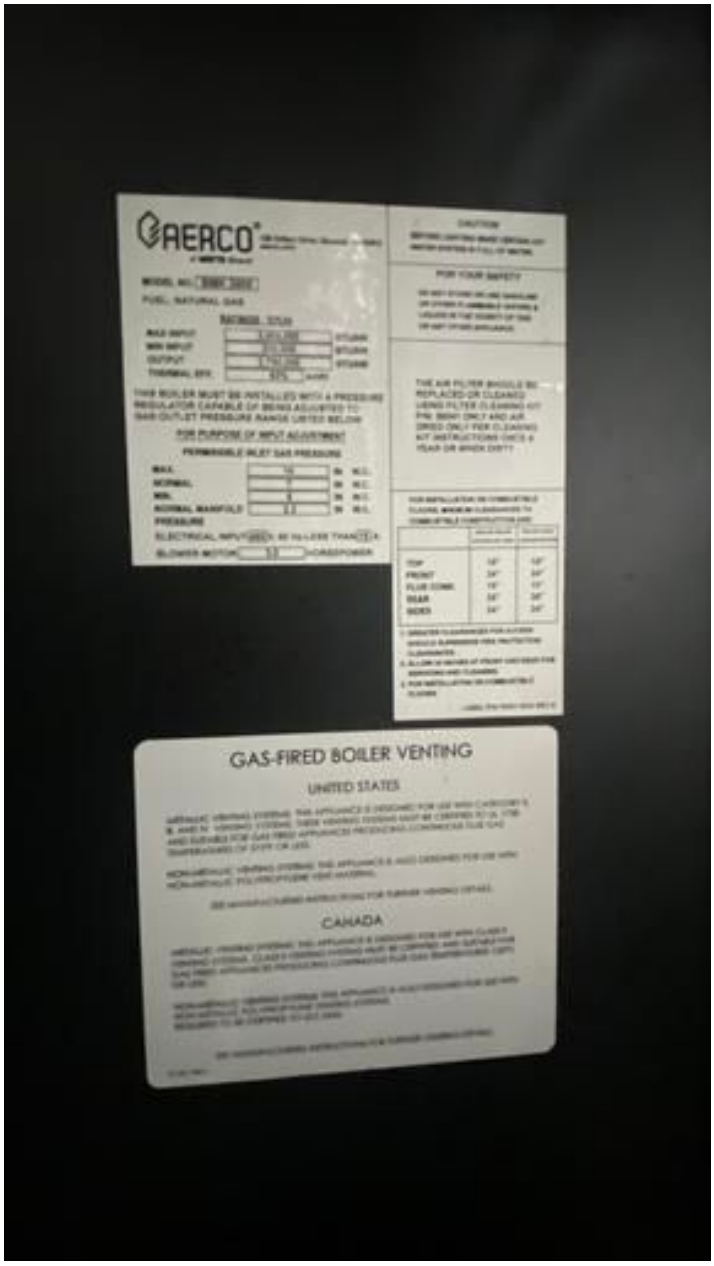
#59: Boilers, water heaters

Description	3-boilers 4-water heaters
Assigned to	—
Created by	Daniel Sieben
Created on	Feb 16, 2026
Location	—
Location details	—
Due date	—
Start date	—
Placement	HS - Floor Plans.pdf
Root cause	—

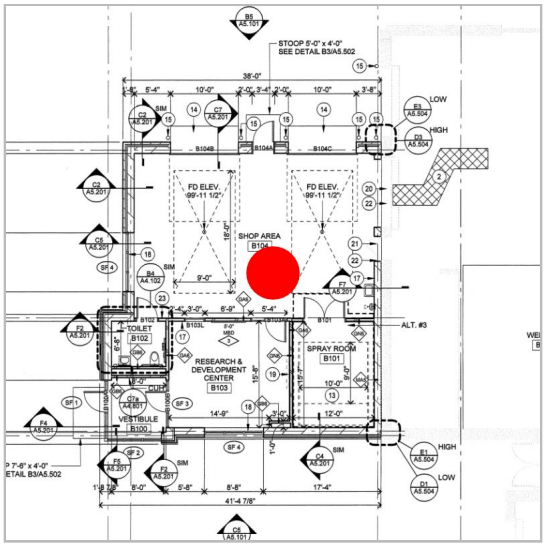
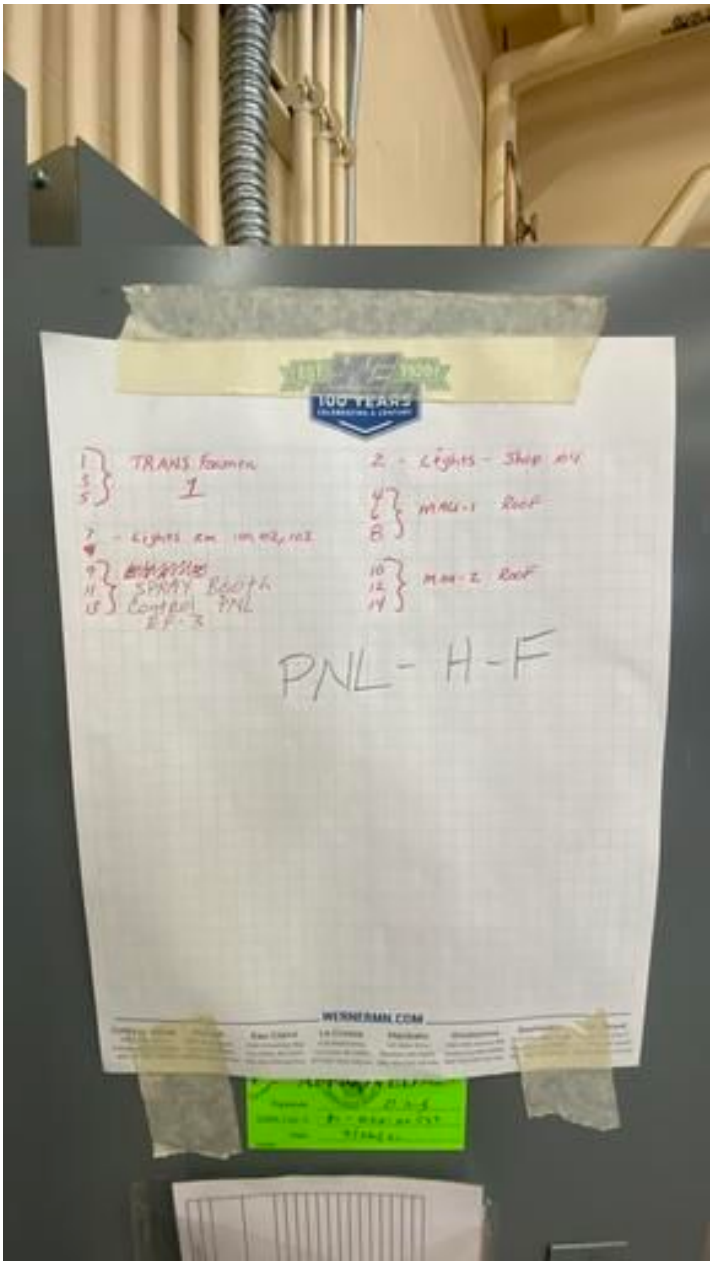
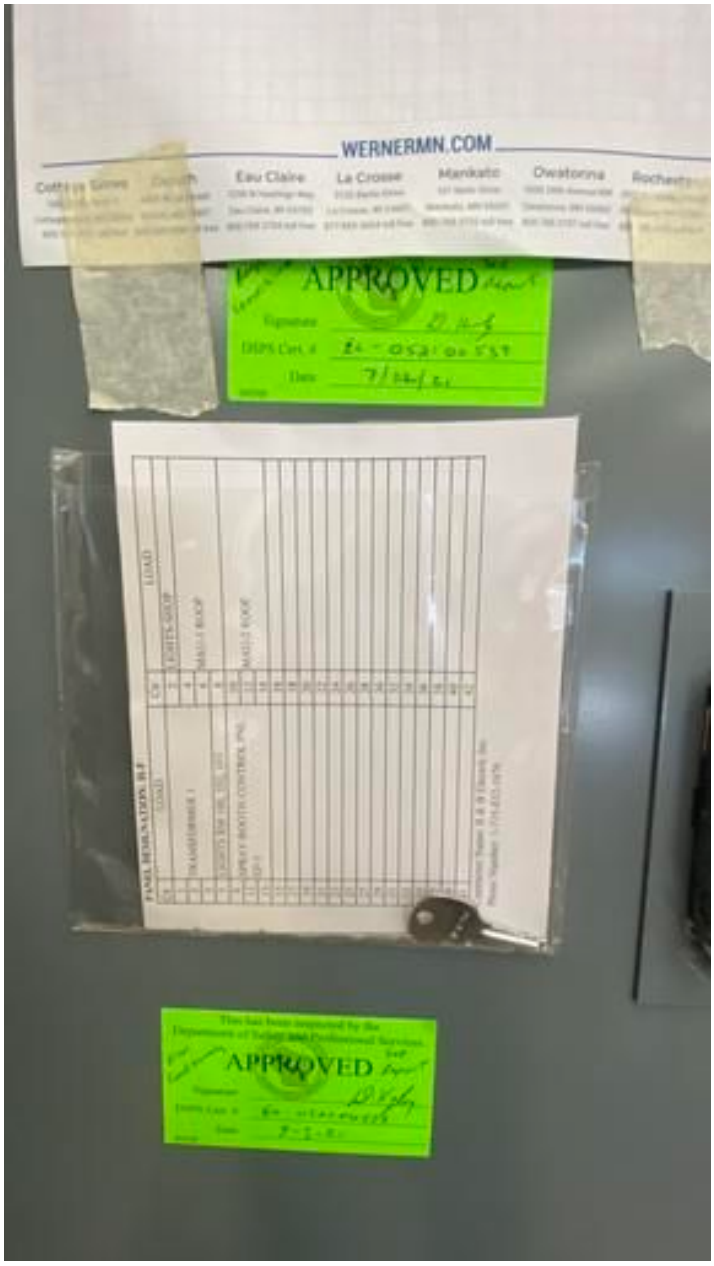
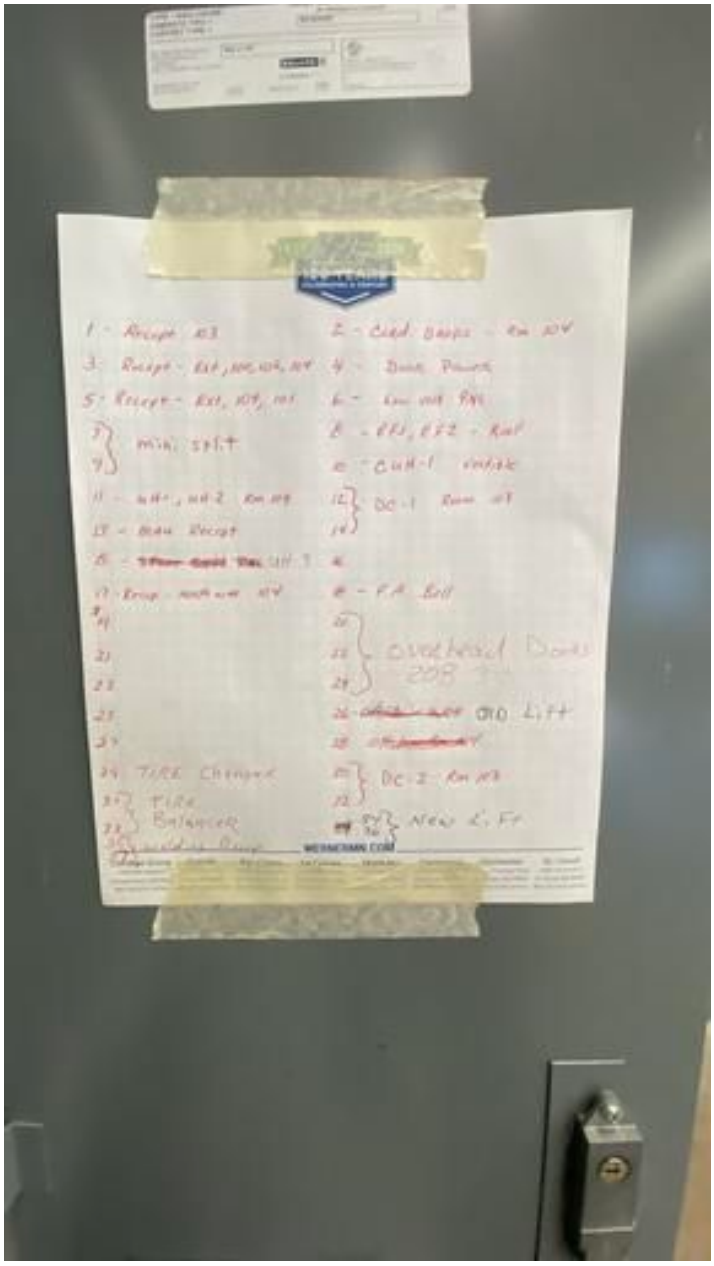
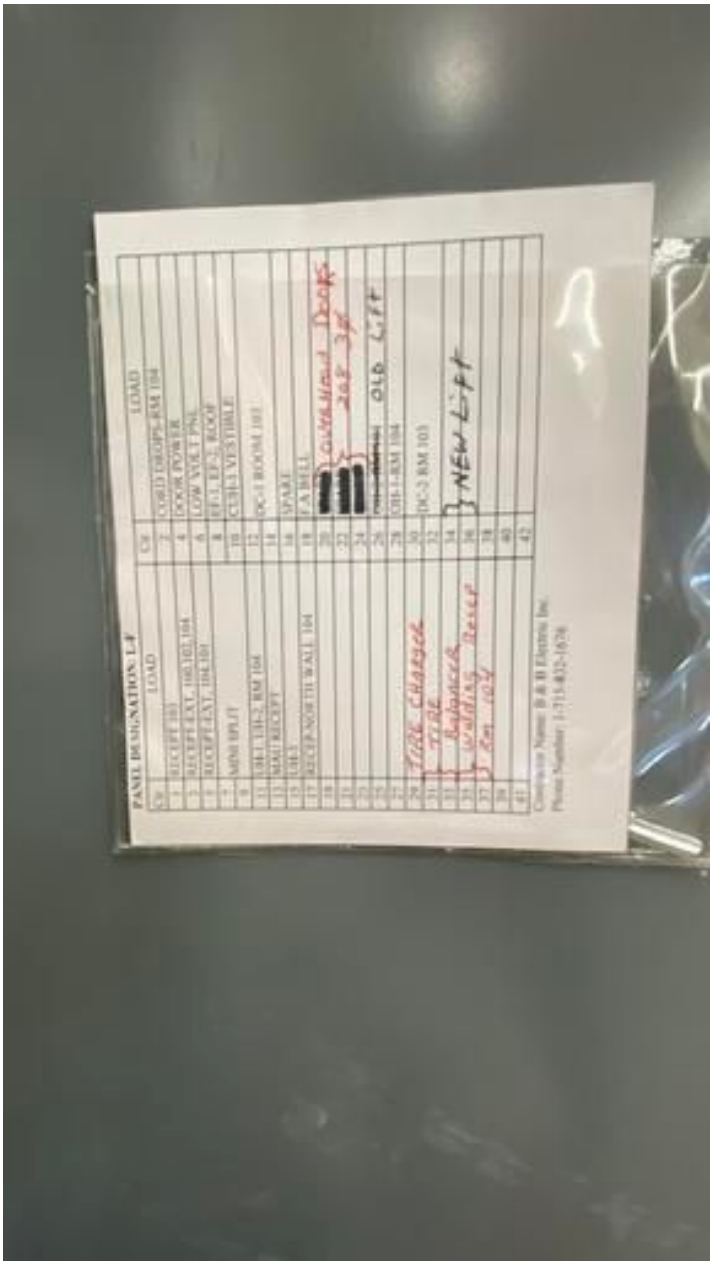
#60: Addition

Description	Good condition
Assigned to	—
Created by	Daniel Sieben
Created on	Feb 16, 2026
Location	—
Location details	—
Due date	—
Start date	—
Placement	HS - A2.0 - Auto Shop Addition .pdf
Root cause	—

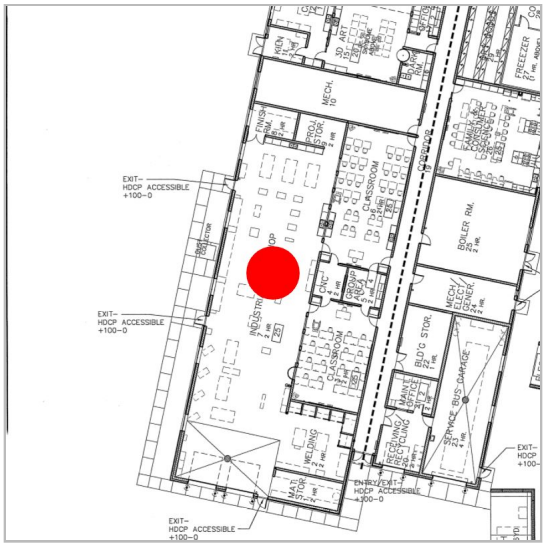
#61: Filter units

Description	Fair condition
Assigned to	—
Created by	Daniel Sieben
Created on	Feb 16, 2026
Location	—
Location details	—
Due date	—
Start date	—
Placement	HS - Floor Plans.pdf
Root cause	—

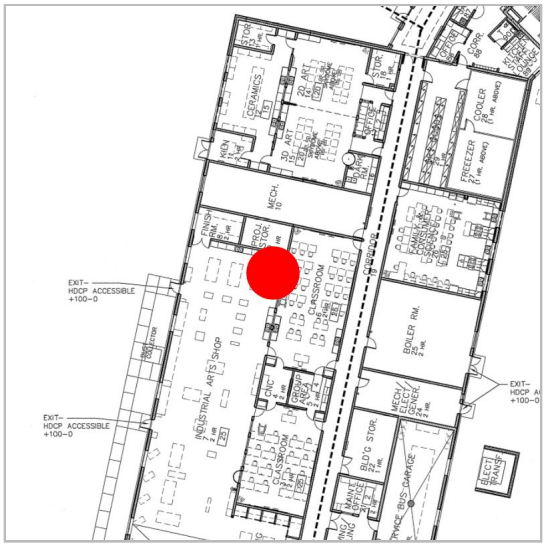
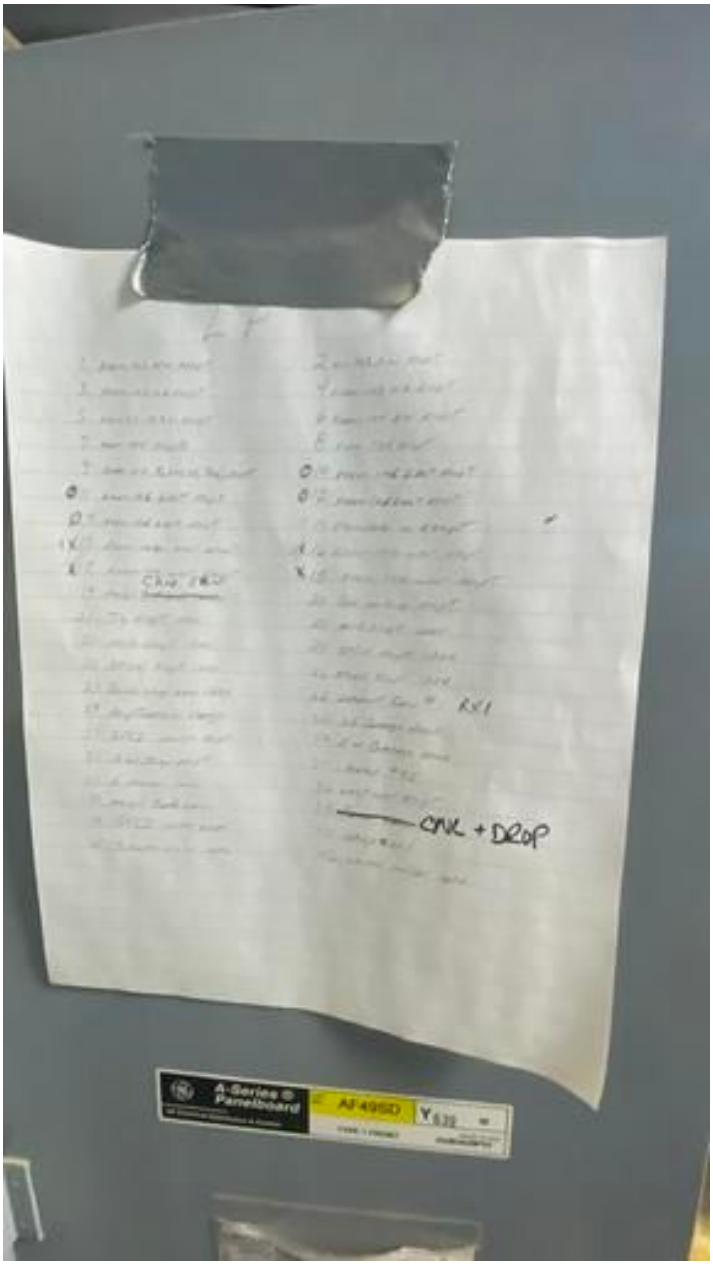
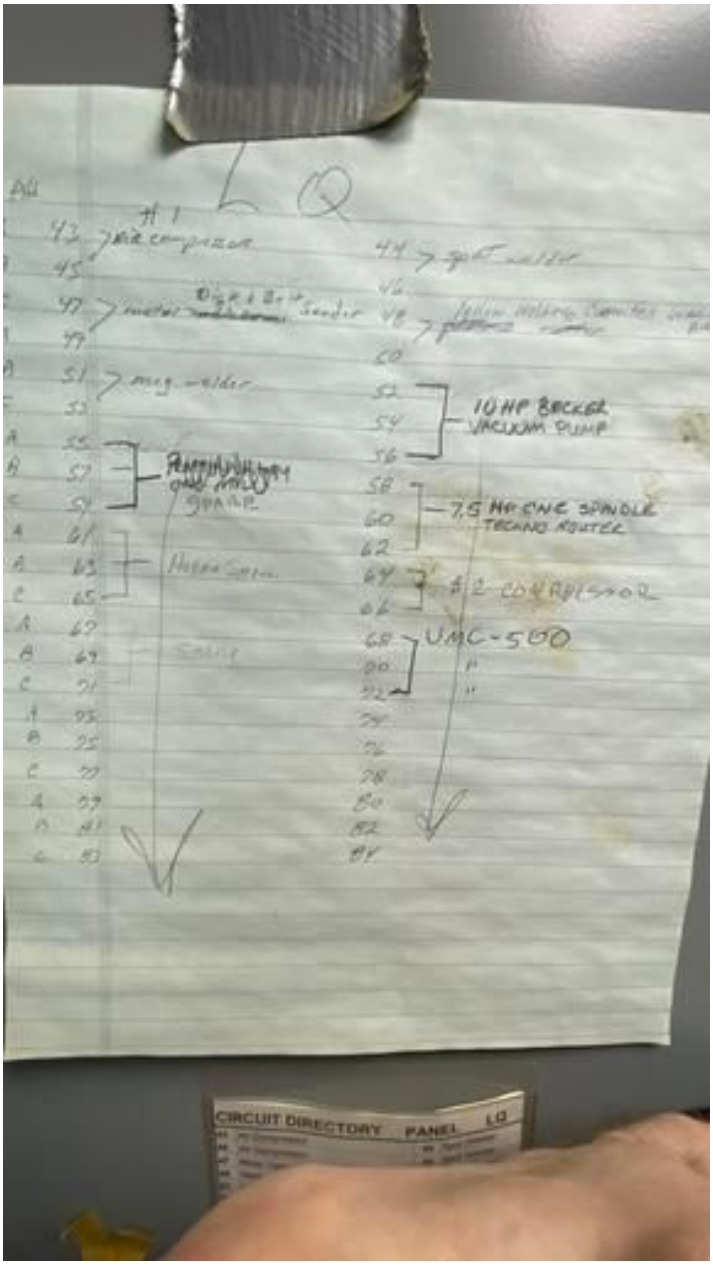
#62: Panel Boards

Description	Good condition
Assigned to	—
Created by	Daniel Sieben
Created on	Feb 16, 2026
Location	—
Location details	—
Due date	—
Start date	—
Placement	HS - Floor Plans.pdf
Root cause	—

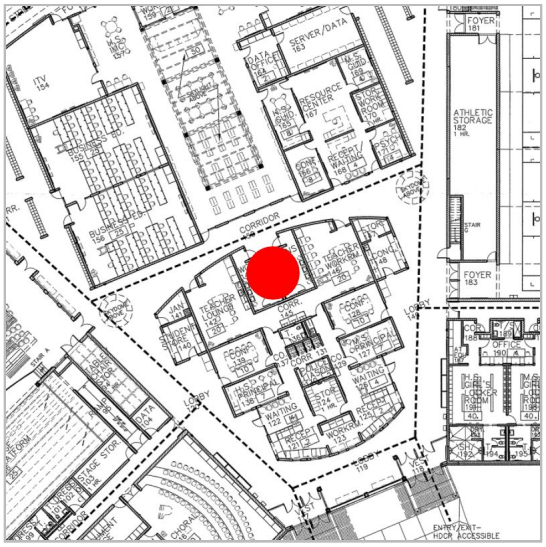
#63: Main toilet

Description	Fair condition
Assigned to	—
Created by	Daniel Sieben
Created on	Feb 16, 2026
Location	—
Location details	—
Due date	—
Start date	—
Placement	HS - Floor Plans.pdf
Root cause	—
