# Webster Elementary School Facility Assessment

March 12, 2026

PREPARED BY DSGW ARCHITECTURE

# PROJECT OVERVIEW

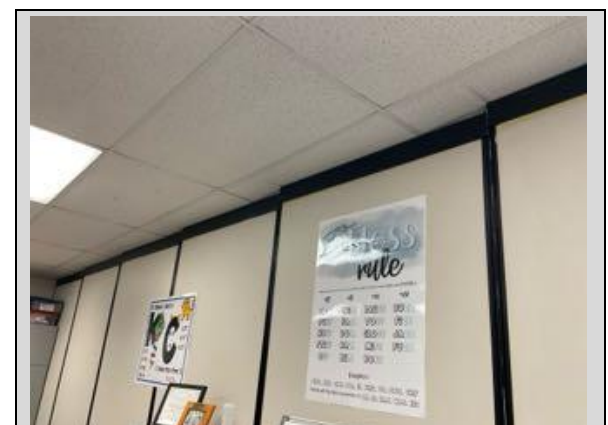
| Doors & Hardware |
|---|
| "Interventionist" room: Operable partition is in poor condition and was misaligned. A teacher noted it was not very secure from tipping over. Superficial damage was observed. Operable partition in "Special Ed"/"Connections" is in good condition. |

Operable partition not aligning.
