WEBSTER SCHOOL DISTRICT

Facility Audit
October 2018

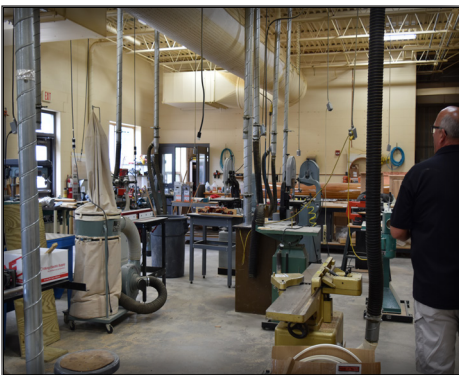
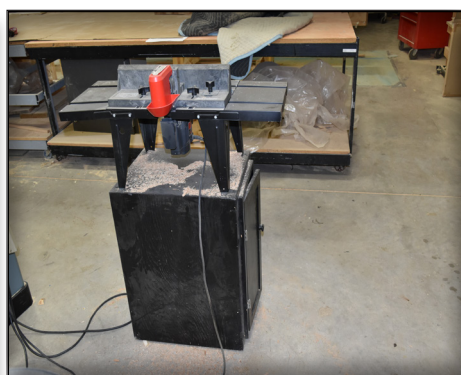
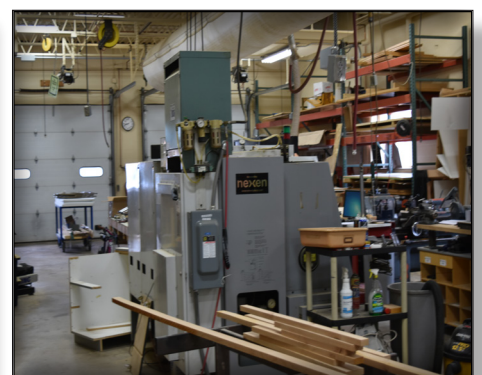
GENERAL DESCRIPTION: Measure ID #HSSA2

CESA FM also noticed excessive dust on the machines during the audit. Excessive dust not only causes fine particles to get in students and teachers lungs, it also causes a slip hazard from the buildup of dust on the Wood Shop floor and a possible impediment of the machine while it is in use. Wood dust is a combustible dust and must be cleaned up per OSHA regulations. The district should clean up the excessive dust from the machines and floor and examine the dust collection system for the shop to ensure it is properly working.

▲ The district should research expanding the shop area to allow for donated equipment. Constructing space for additional storage and future growth should also be considered at this time.

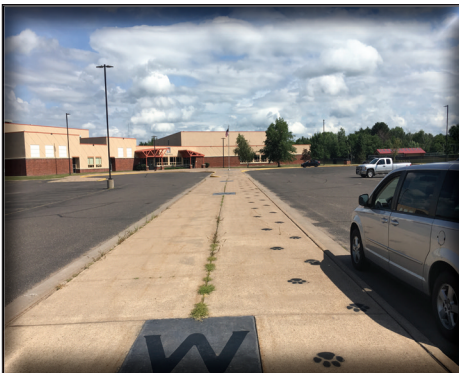
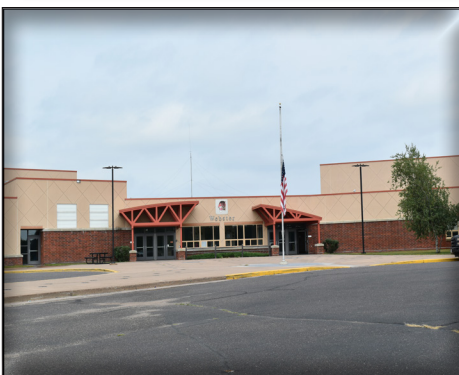
GENERAL DESCRIPTION: Measure ID #HSPL1

▲ The current parking lot offers two entrances, which allows traffic to cross, causing congestion, confusion, and accidents.

After extensive research, the district should pursue a solution that not only eliminates the cross traffic concerns but deals with the drainage issues in the driveway and ditches that are highlighted on page 42. CESA FM recommends either constructing two separate exits to the parking lot. The parent drop off/pick up and student parking lot could exit to the west end of their parking lot, while the district could put a new route through the existing field area back to W Alder Street and the buses could exit to the east of the existing parking lot. This solution would allow for all vehicles to utilize the same entrance, but avoid crossing paths upon exiting the space. Another option would be to extend the concrete divider in the parking lot to the road and widen the entrances on both sides. The district would construct two separate exits through this option as well. This would also alleviate the cross traffic issues the district is currently encountering. The picture below depicts the first option in red and the second option in blue. If the district were to pursue the first option (red) then an extra lane of parking stalls would be constructed as well.

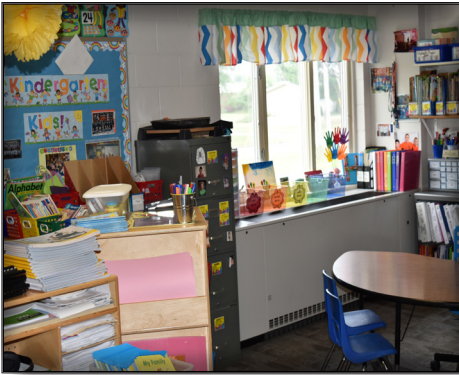
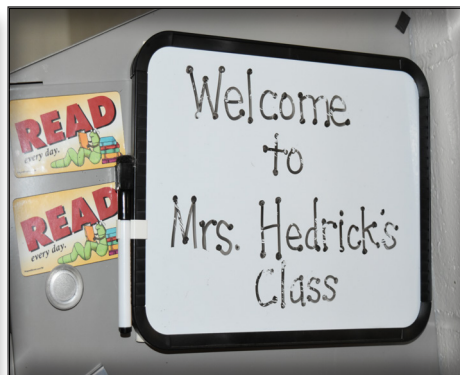
GENERAL DESCRIPTION: Measure ID #ESAC1

There were two rooms with newer HVAC equipment that complained of uncomfortable conditions. After closer inspection, these rooms had their unit ventilators located near the far windows and the thermostats located clear across the room near the door. This distance from one another is making the ventilator pump a lot of air before the thermostat can sense the change. This is leading to uncomfortable conditions for the room occupants.

▲ This project would have a short payback, as the energy saved in HVAC costs would quickly pay for the costs of moving the existing thermostat or installing a secondary one.

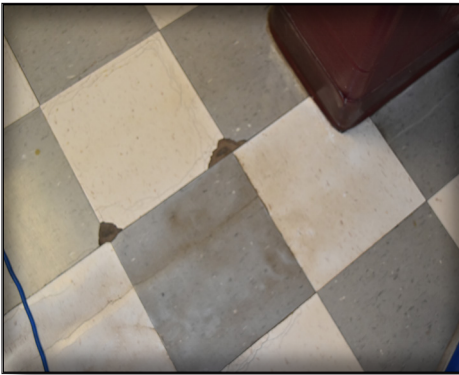
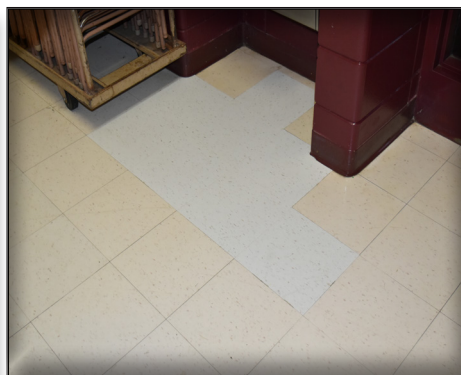
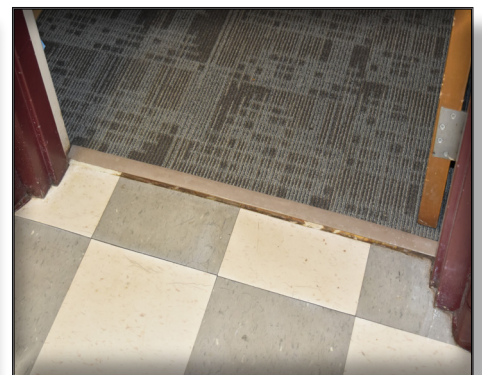
GENERAL DESCRIPTION: Measure ID #ESF1

The current flooring in the main entrance and hallways is aged and cracking in numerous spots. This is especially apparent in doorways and other well-traveled areas.

▲ The current flooring is well past its expected useful life. The district should consider replacing it in the near future.

The district should consider upgrading the flooring as a single project or annual replacement schedule. Many flooring options exist. Costs will vary based on the type of flooring selected.

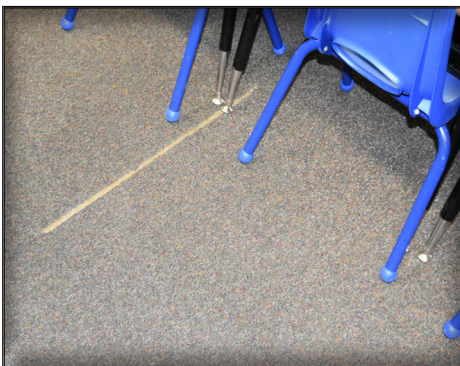
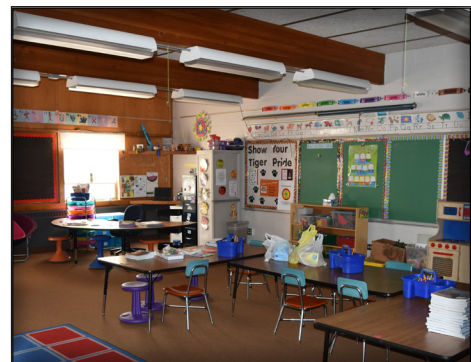
GENERAL DESCRIPTION: Measure ID #ESF2

◀ Since the carpeting is most likely asbestos-containing in the three lower-level rooms, environmental testing and potential issues should be factored into the project budget. ▶

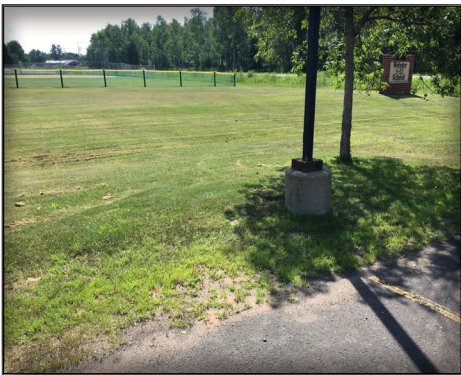
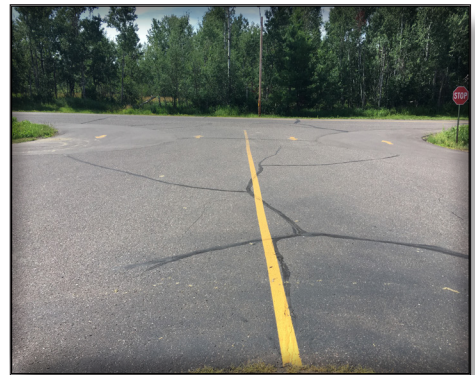
GENERAL DESCRIPTION: Measure ID #HSG1

Drainage issues exist in the driveway and ditches. Standing water is a breeding ground for bacteria, mold, and parasites. Stagnant water can also attract insects and rodents, be a breeding ground for mosquitos, and cause damage to landscaping.

◀ The district should research landscaping options that would help with water absorption and flow. ▶

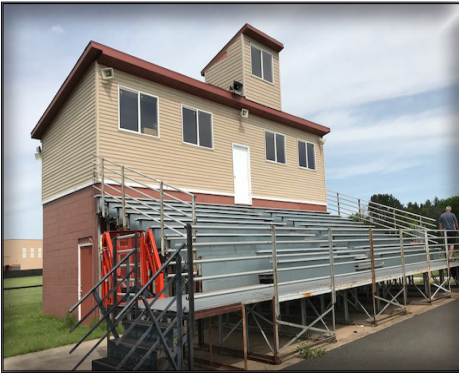
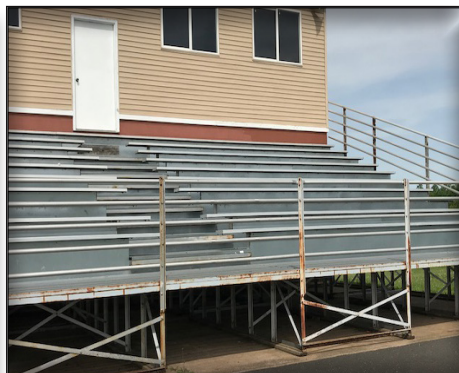
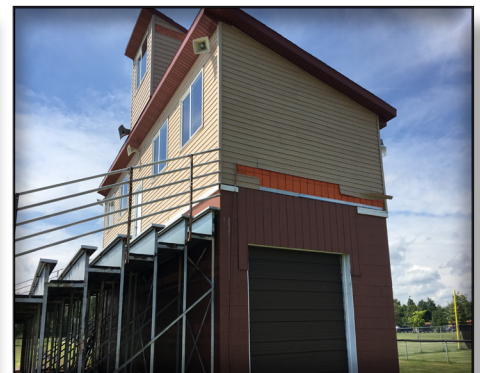
GENERAL DESCRIPTION: Measure ID #HSAF1 & HSAF2

HSAP1	Athletic Field	The football field equipment is aged and showing signs of disrepair. This includes the bleachers/press box and the football field lights and poles. Additionally, the football field light poles are riddled with woodpecker holes. This presents a safety hazard and poses a liability to the district.	The district should update this equipment for safety, accessibility, and improved function. Estimated cost is \$250,000 - \$800,000 based on project scope.	9	8	13	0	0	30
HSPL1	Parking Lot	The high school parking lot has congestion issues. Traffic flow is split into two separate areas, which is causing issues with exiting and entering the parking lot from the road.	Traffic flow needs to be assessed to alleviate this congestion. One recommendation is to move the bus loading and drop off zone to an alternate location. Reducing congestion will also aid in the reduction of accidents on school property. Estimated cost will vary from \$200,000 to \$1,000,000 based on project scope.	9	7	12	2	0	30

▲ The district should purchase a new press box and ADA-compliant bleachers.

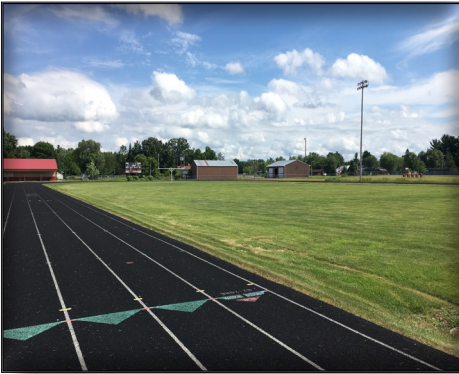
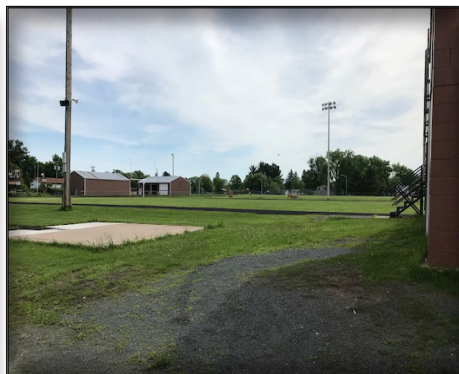
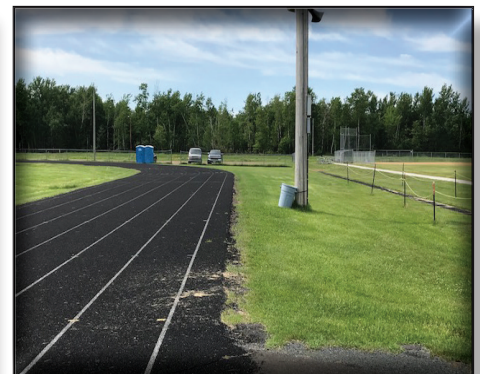
GENERAL DESCRIPTION: Measure ID #HSAF1 & HSAF2

The current track is degraded and ready for resurfacing. Additionally, the track is only six lanes at this time. The required number of lanes for conference meets is eight.

▲ The district should resurface the track and relocate the pole vault and long jump events.

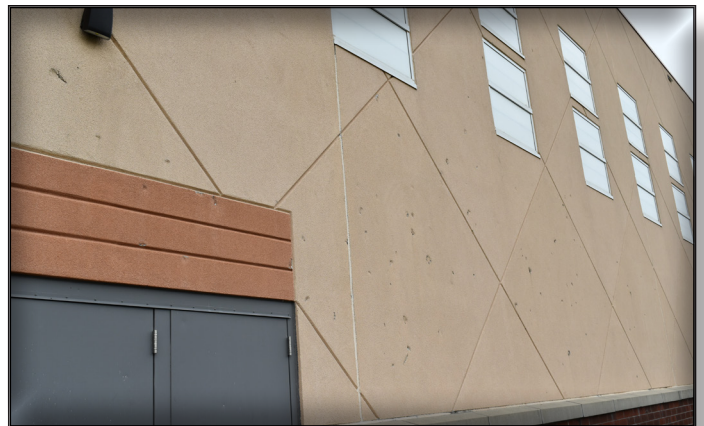
GENERAL DESCRIPTION: Measure ID #HSS1

The high school exterior is made of EIFS. There are several areas where this material is pockmarked and damaged.

Further investigation is needed if this can be repaired or if it needs to be replaced with another material. Costs will vary significantly based on the result of that investigation.

The district should repair the damage or replace these sections entirely.

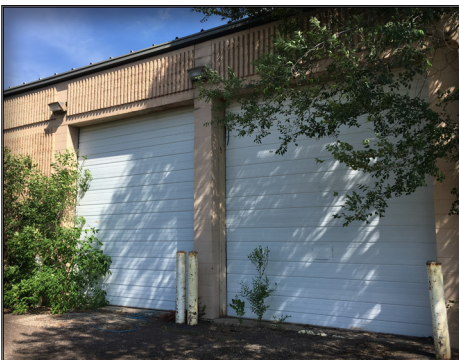
GENERAL DESCRIPTION: Measure ID #DO1

◀ A vacant building can attract rodents as well as provide a hiding area for unauthorized individuals. Plus, the district is paying unnecessary funds to heat this space during the winter months. ▶

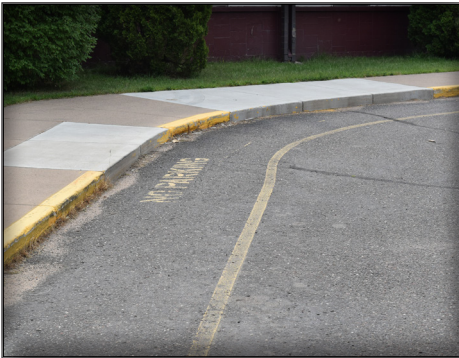
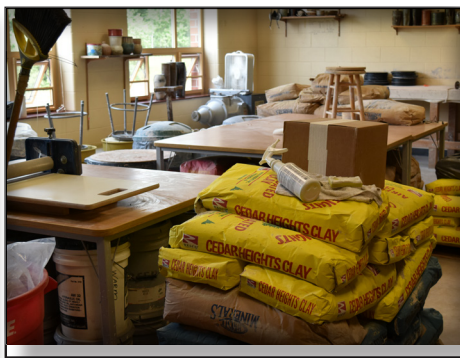
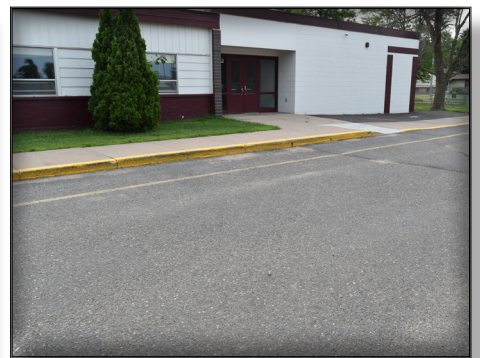
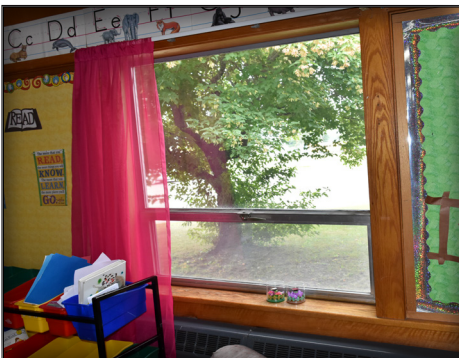
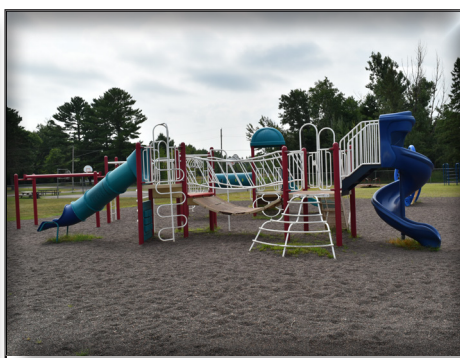
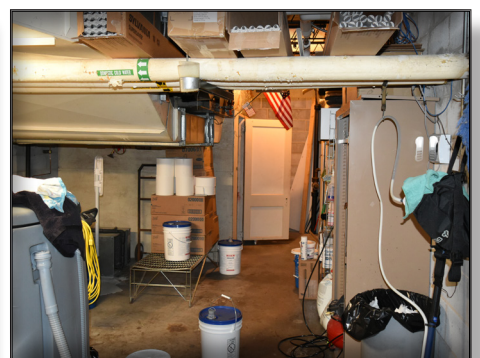
Safety Issue for Consideration	Suggested Action
Art teacher mixing clay	The district stated the art teacher makes his own clay. This fine-powdered dust is messy and can cause respiratory issues when breathed. The district should order pre-mixed clay to improve the indoor air quality for the occupants of this space.
No ventilation in chemical supply room	During the audit, there didn't appear to be any dedicated ventilation exhausts for corrosive chemicals in the chemical supply room. The district should install a dedicated exhaust somewhere in the chemical supply room, preferably in close proximity to the corrosive chemical cabinet.
