# Webster Elementary School Facility Assessment

March 12, 2026

PREPARED BY DSGW ARCHITECTURE

# PROJECT OVERVIEW

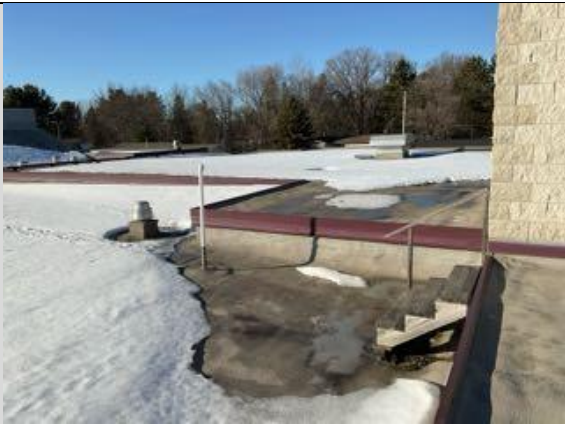
| Roof System |
|---|
| <p>Small pools of water due to inconsistent sloping to drains.</p> |

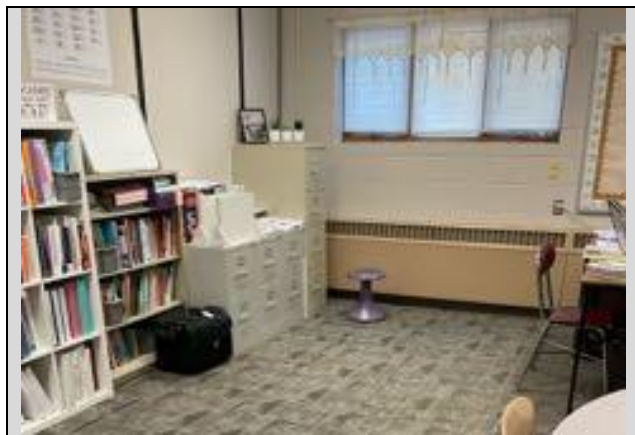
Wood window

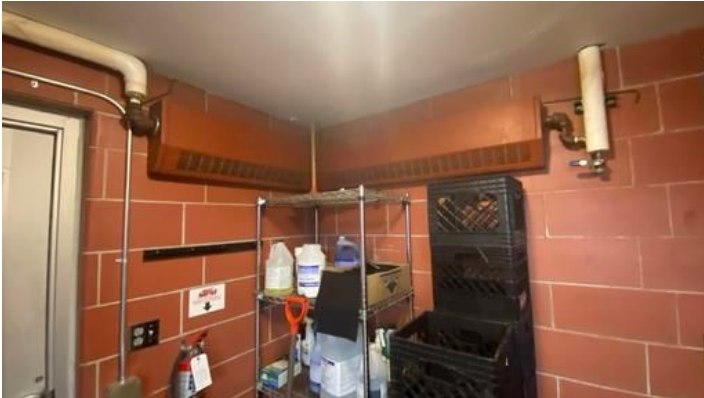
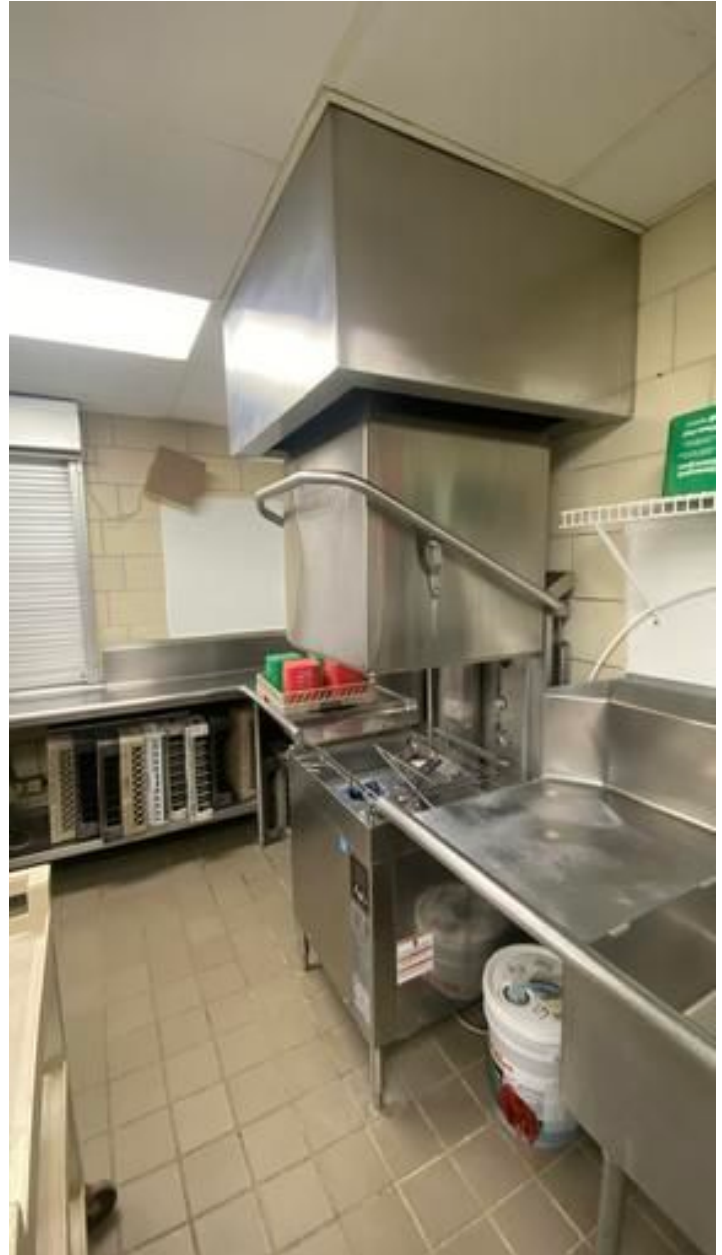
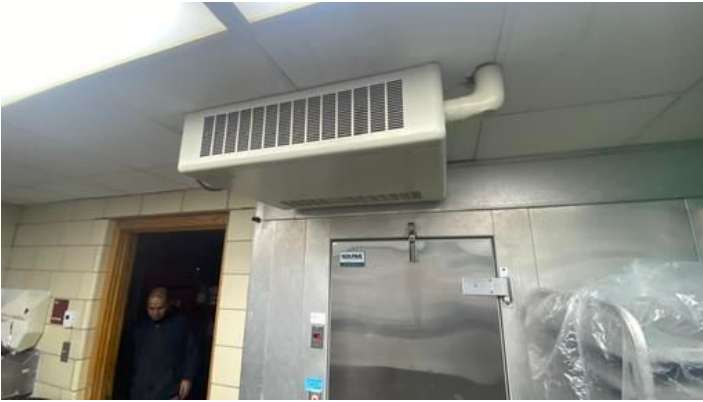
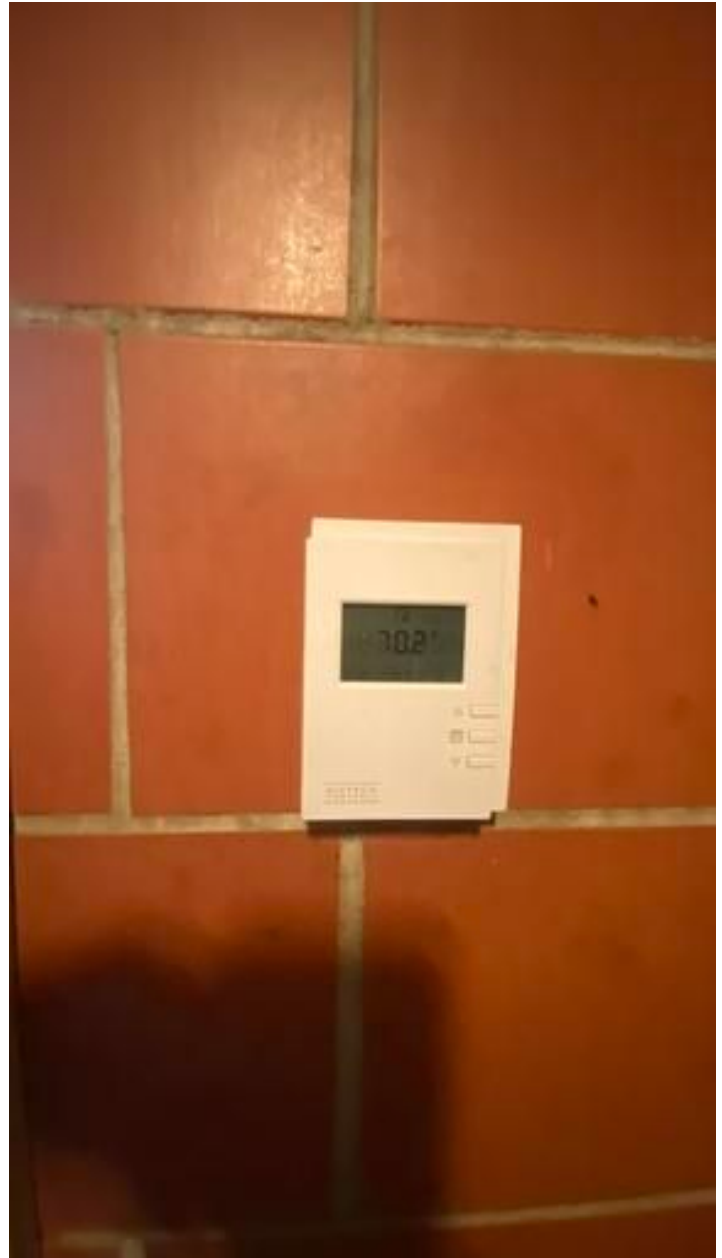
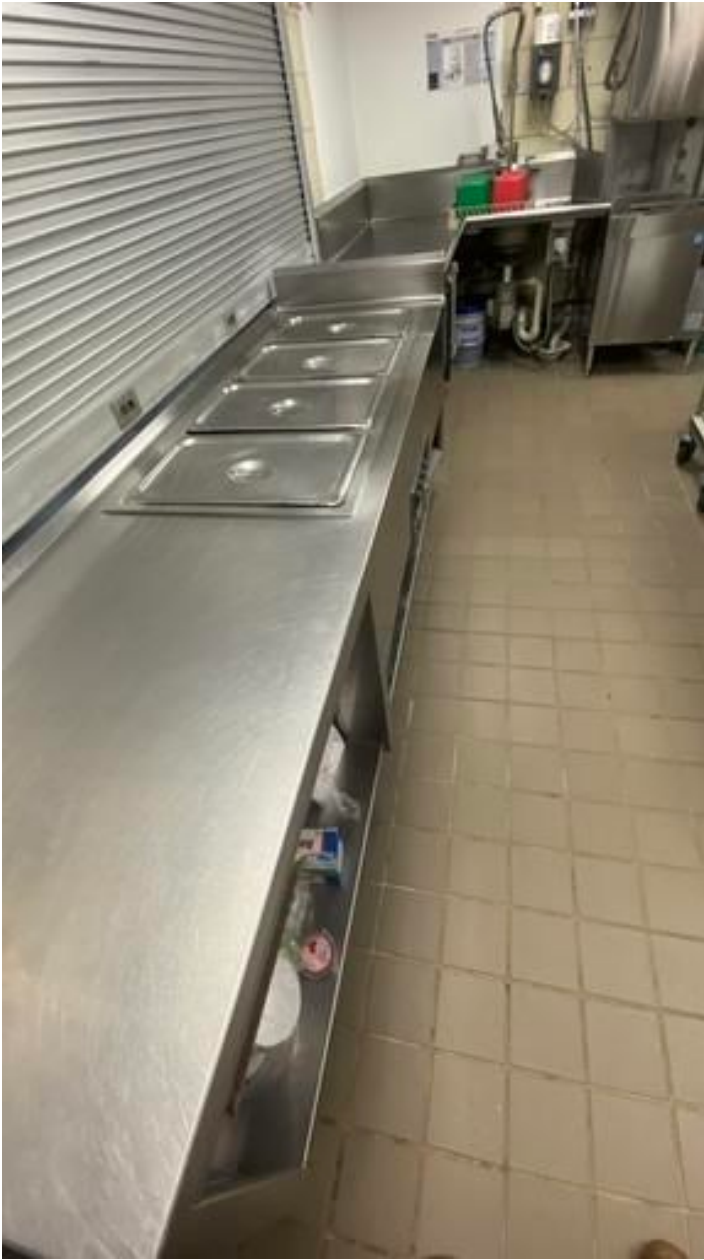
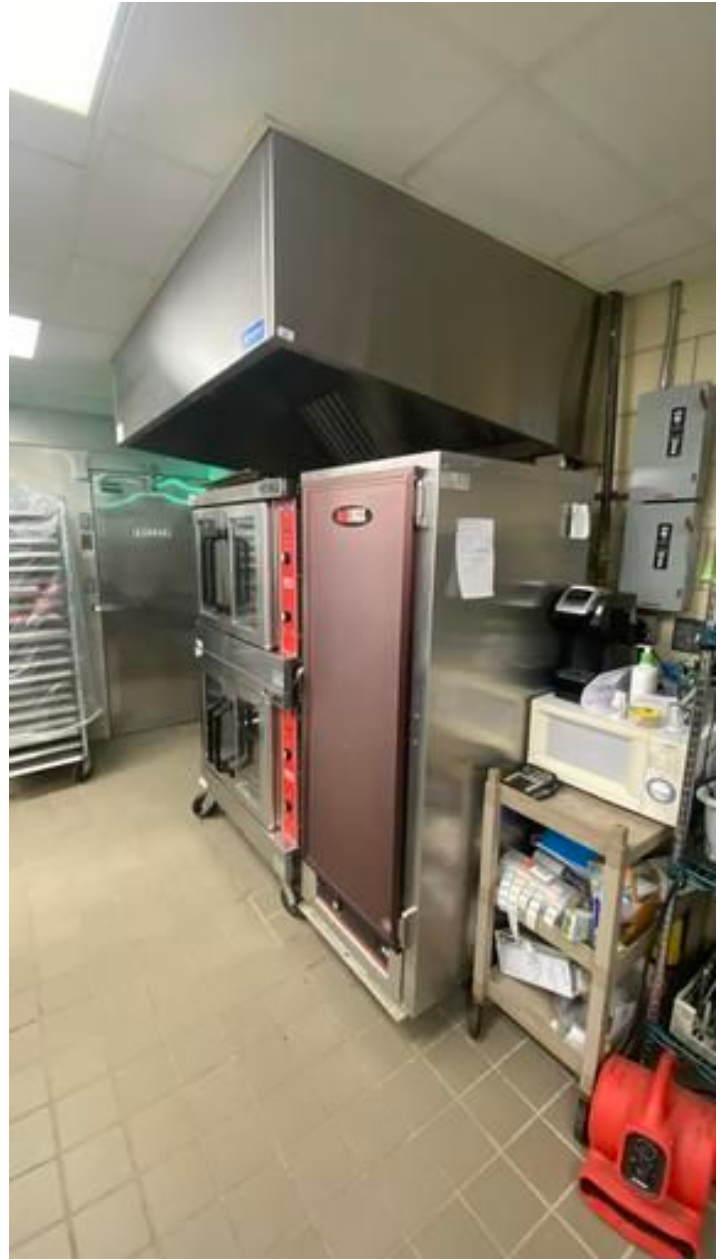
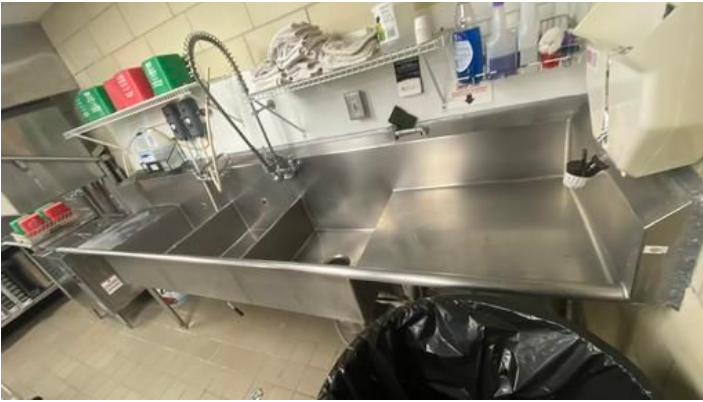
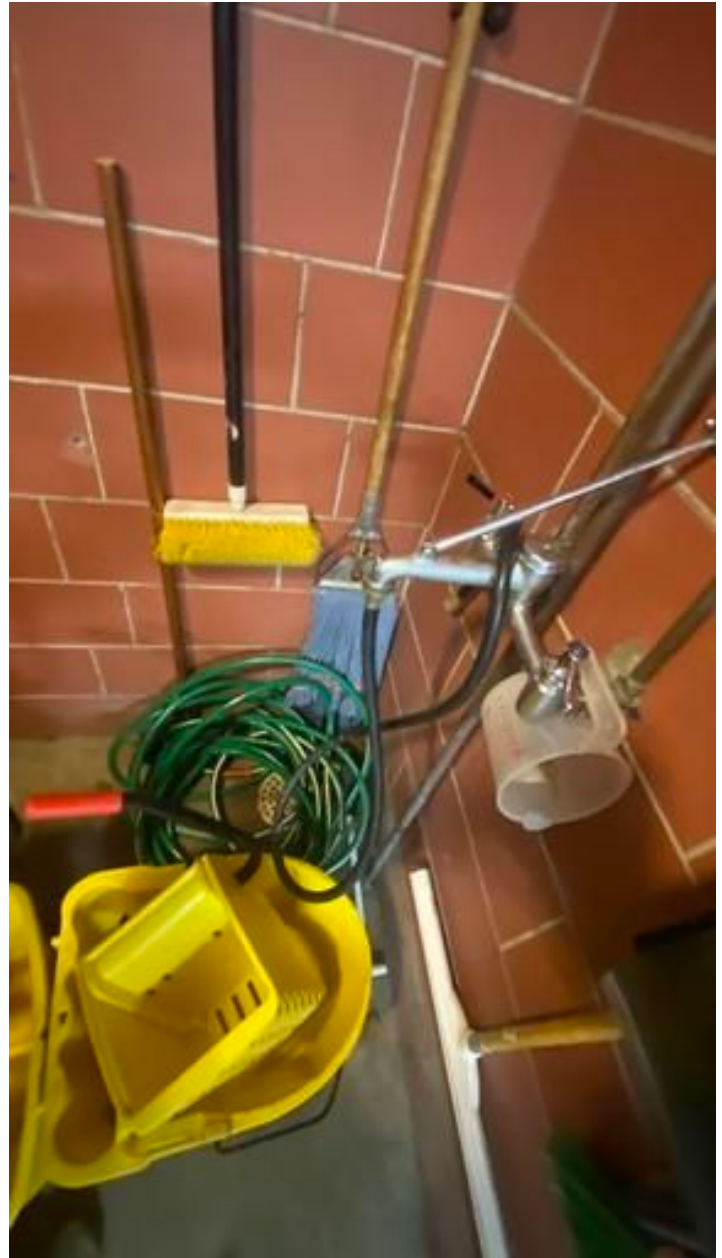
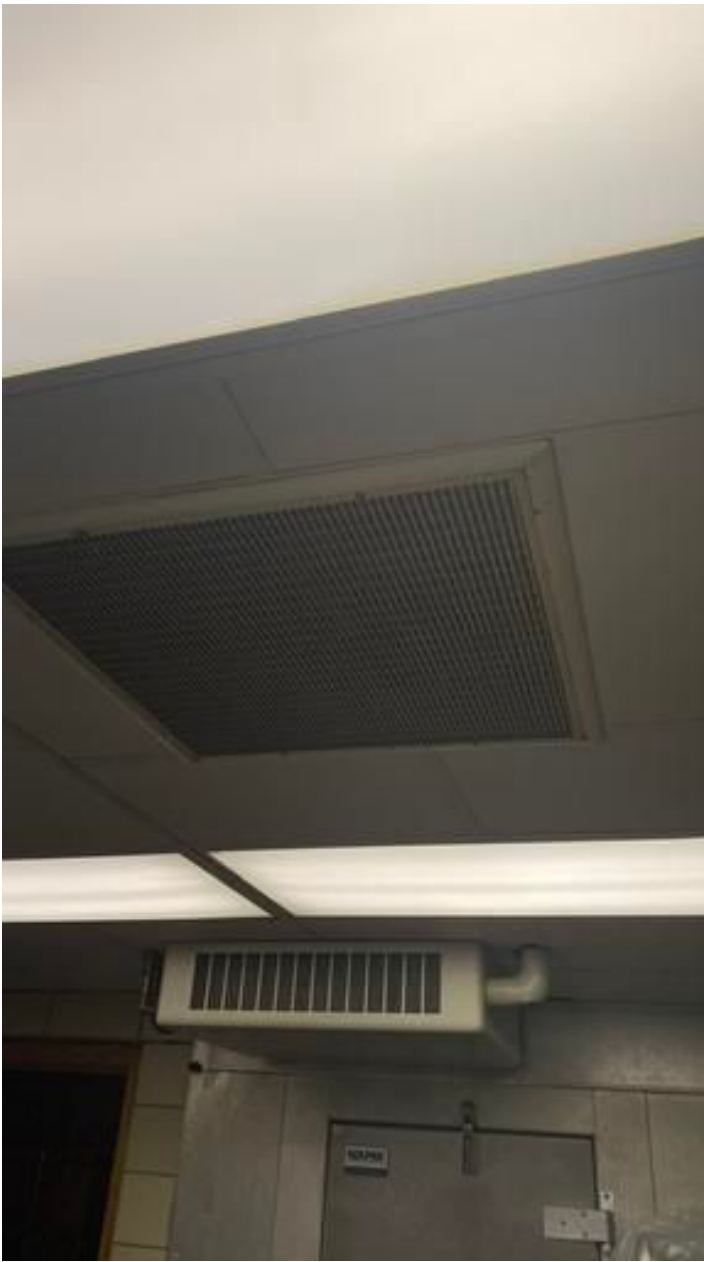
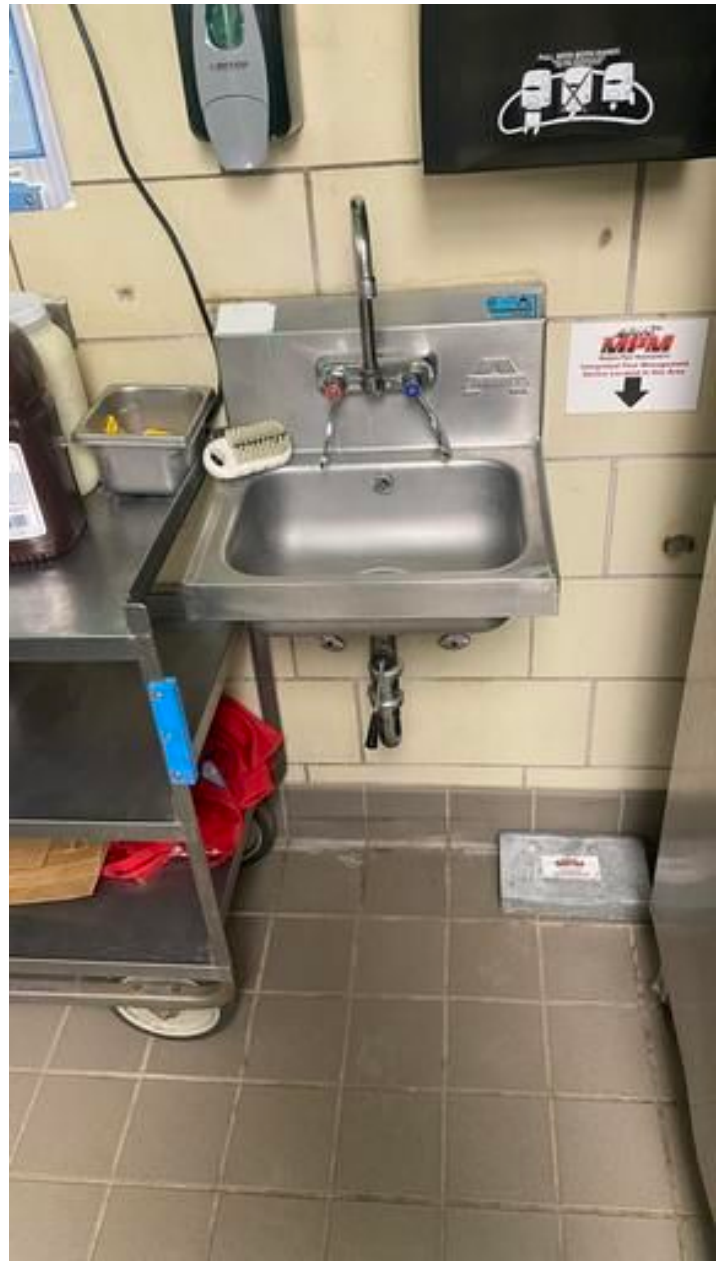
| Description | Fair condition |

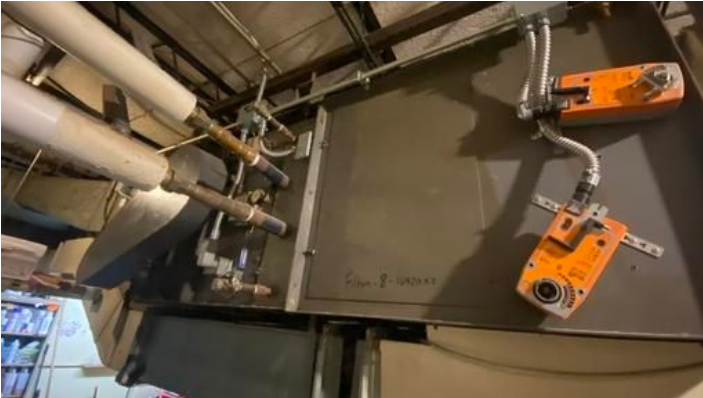
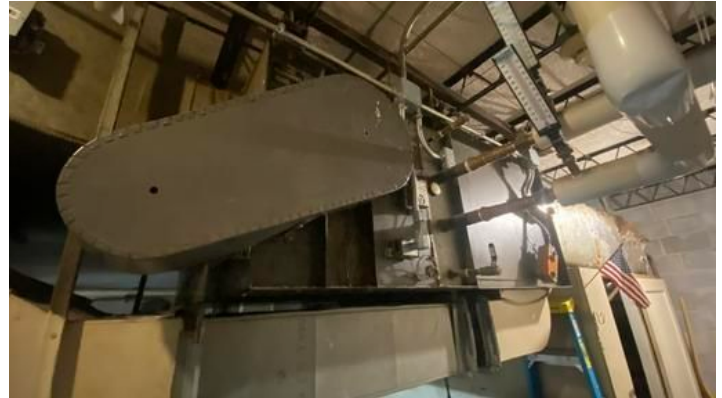
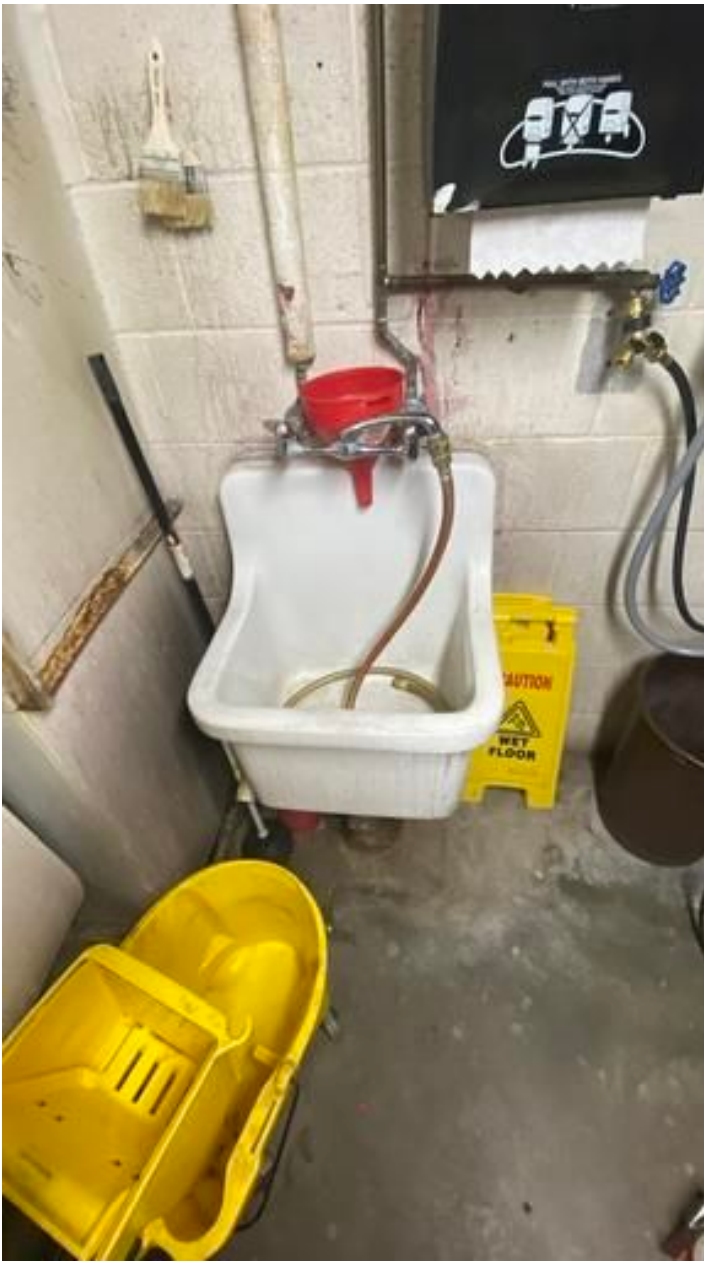
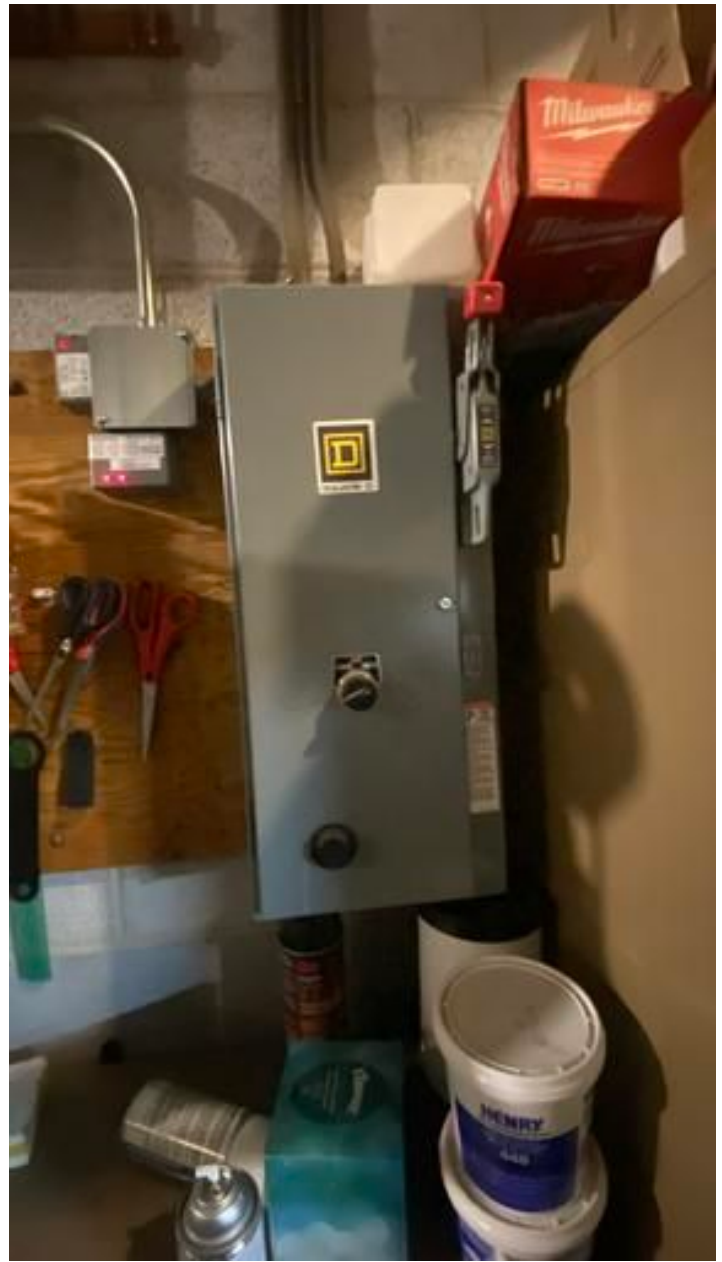
| Description | Poor condition |

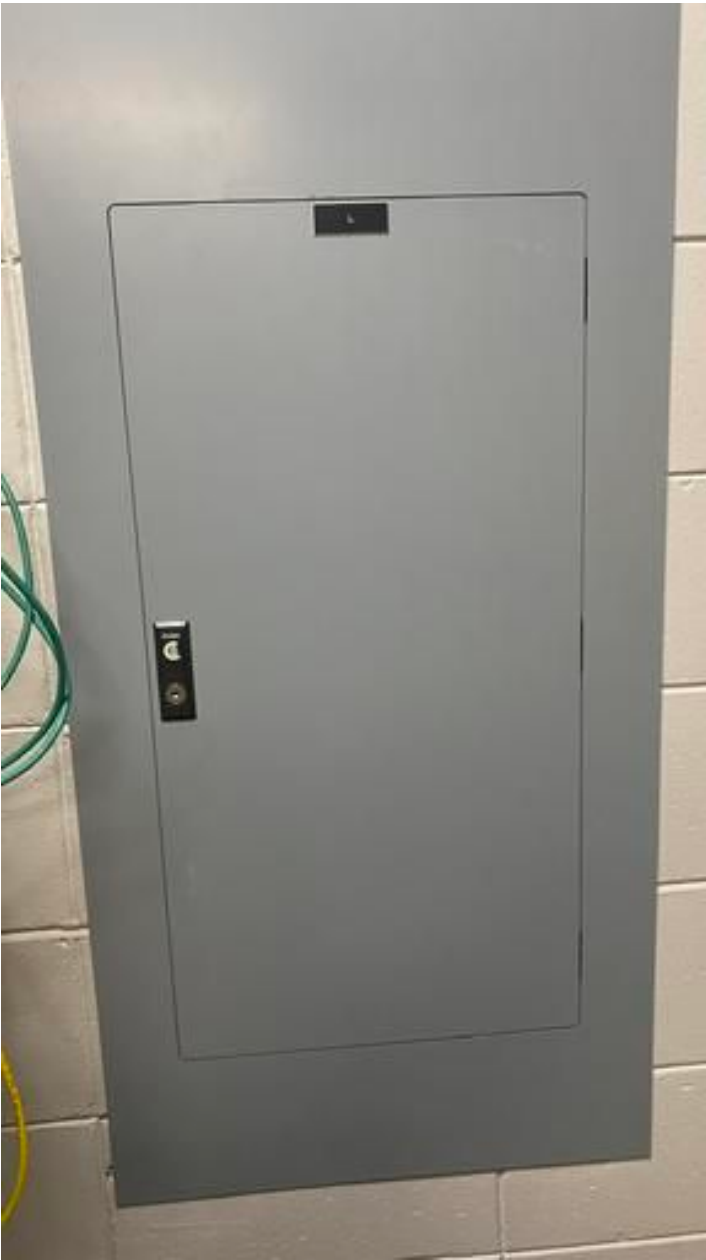
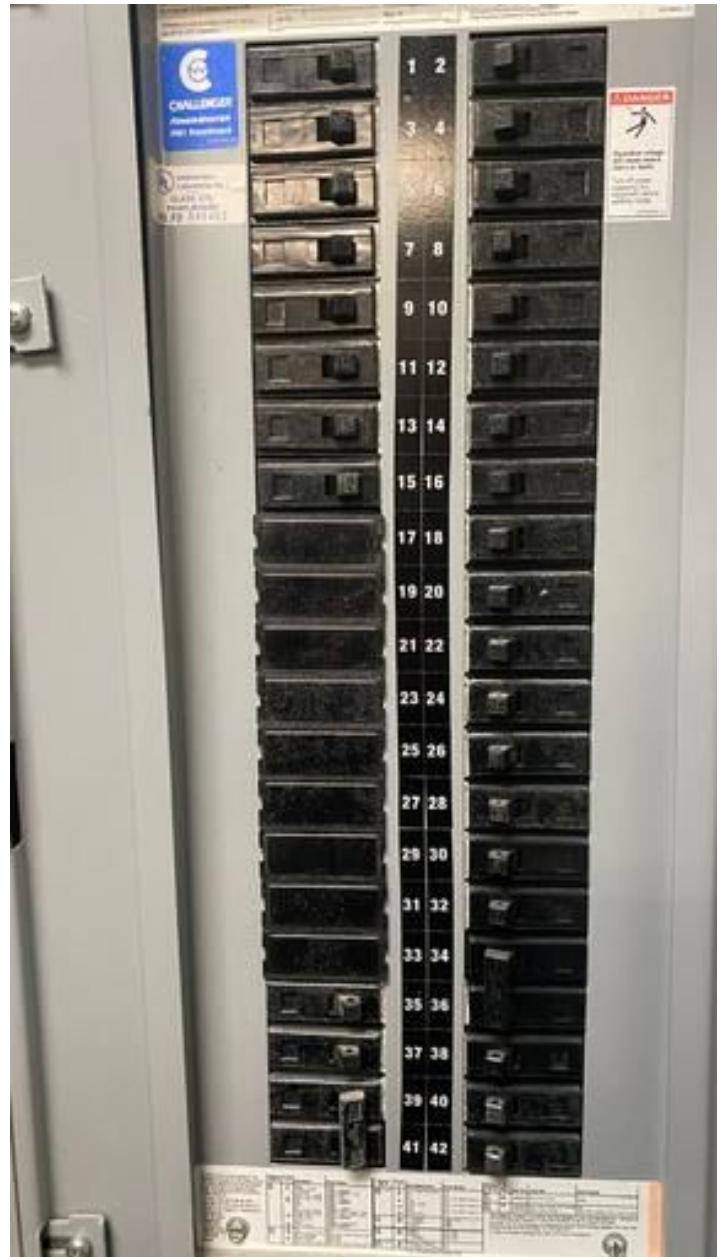
| Description | Fair |

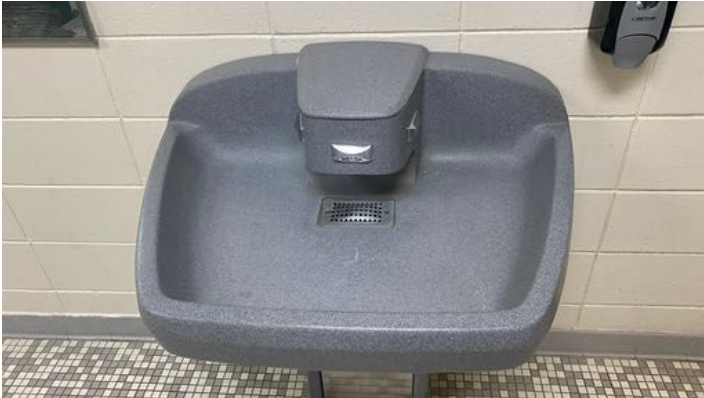
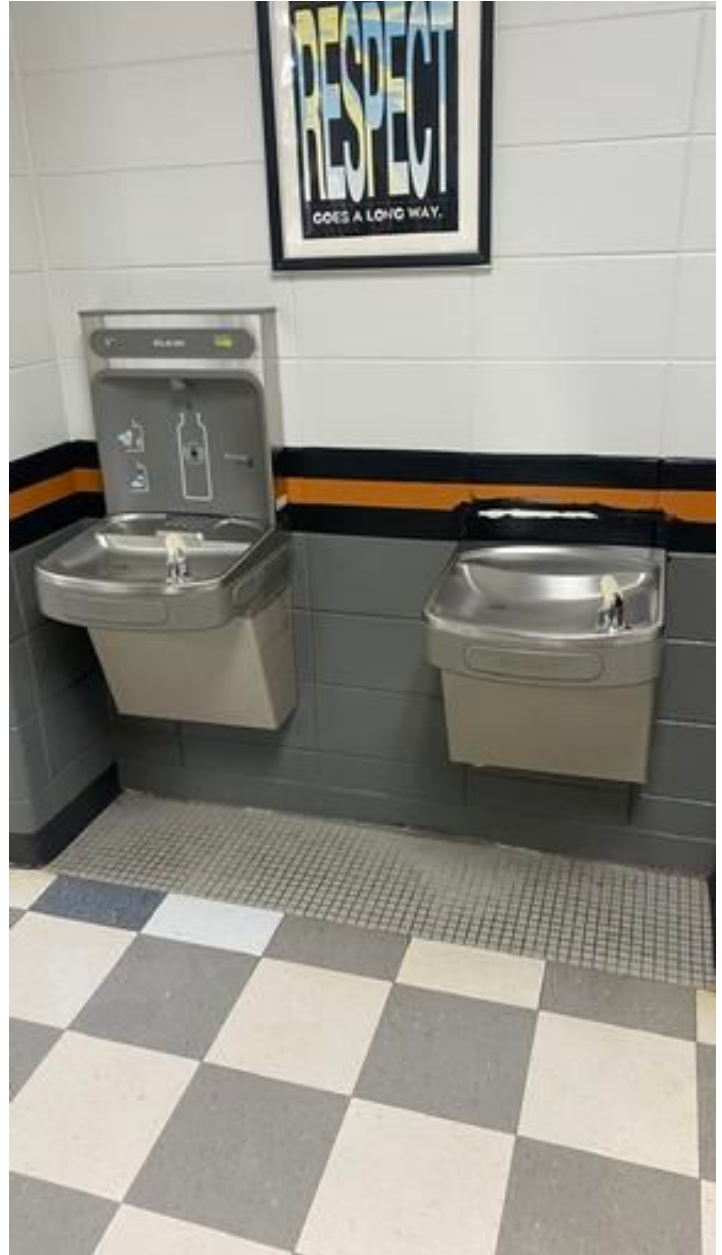
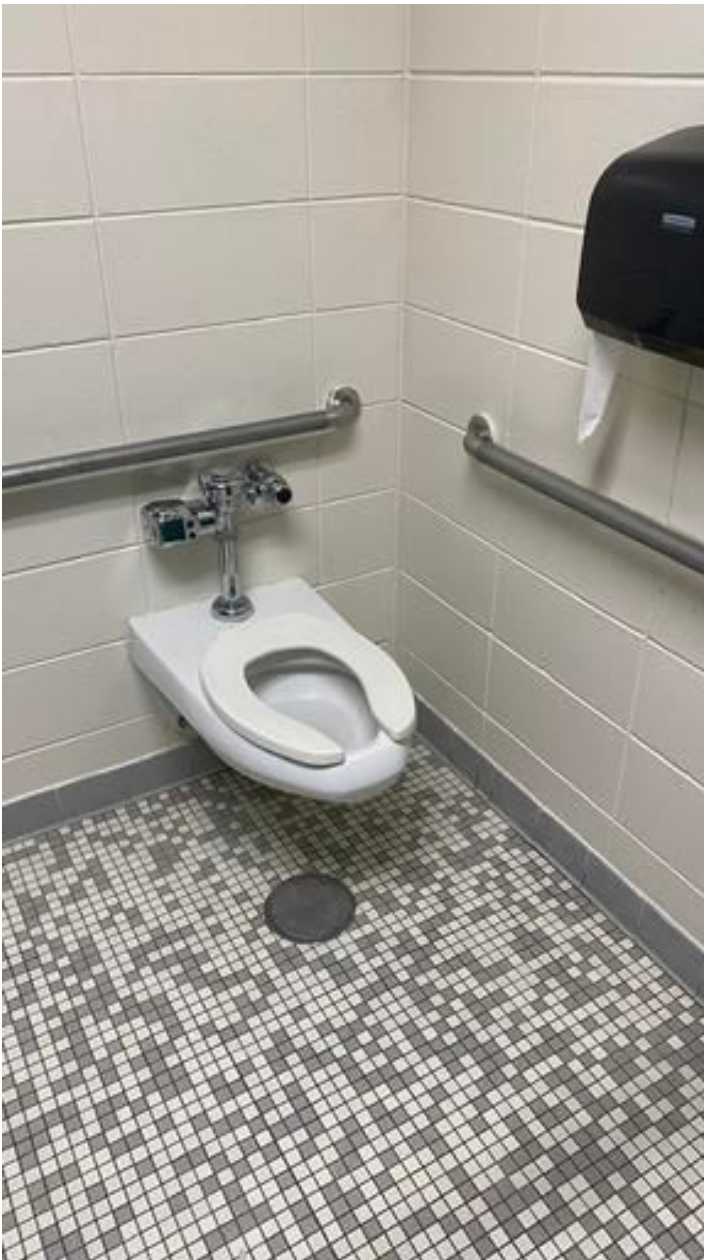
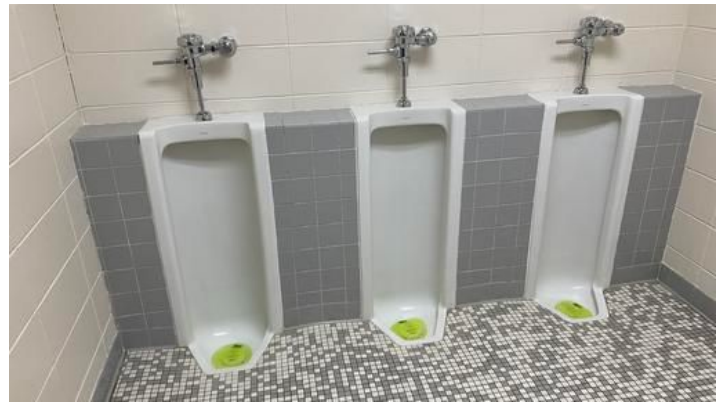
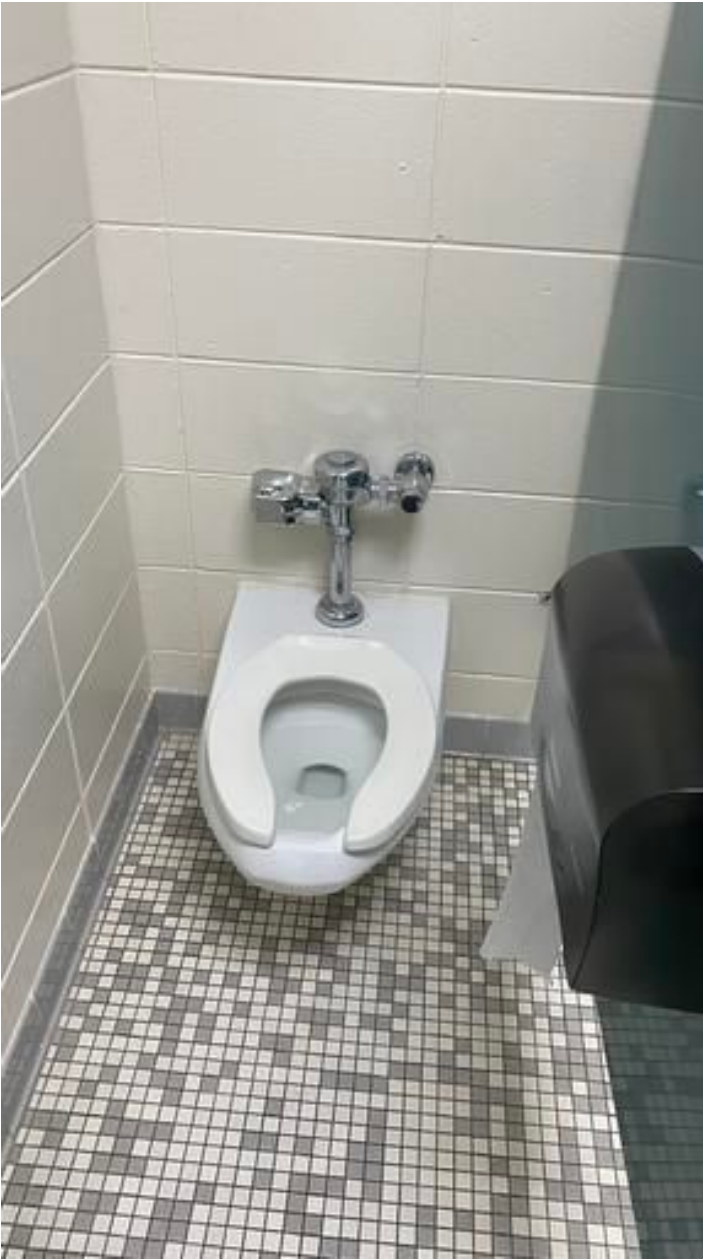
| Description | Good condition |

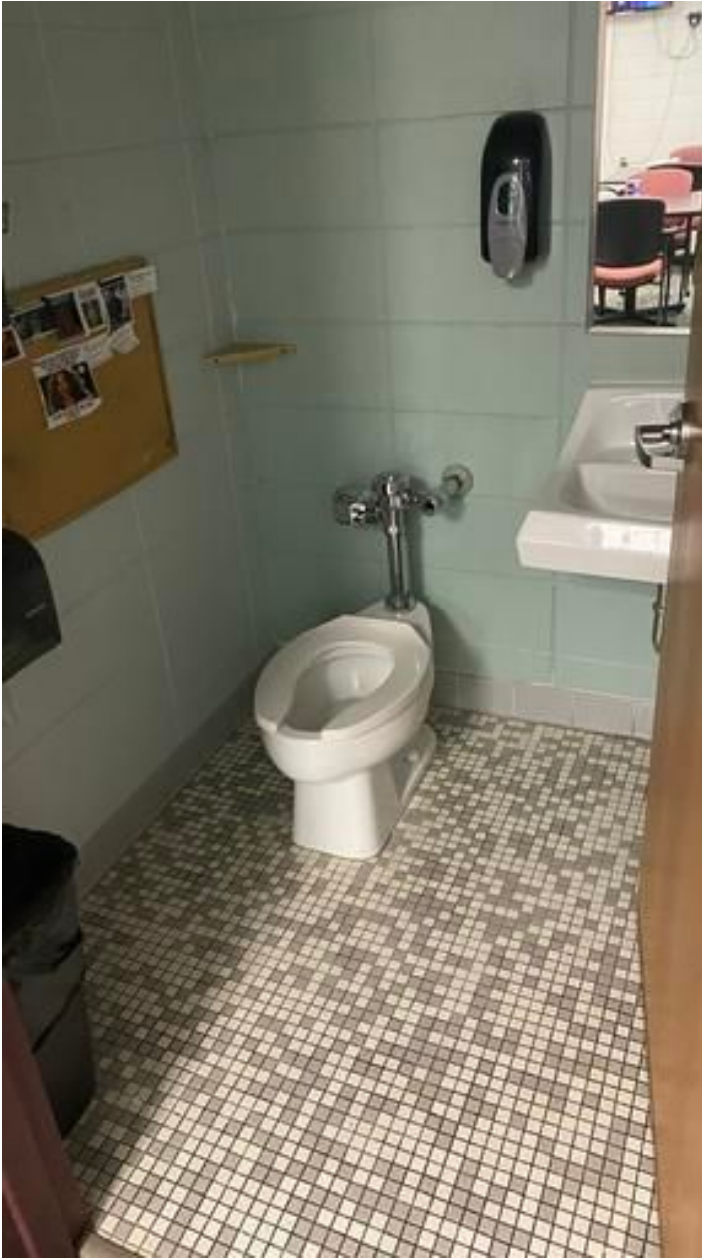
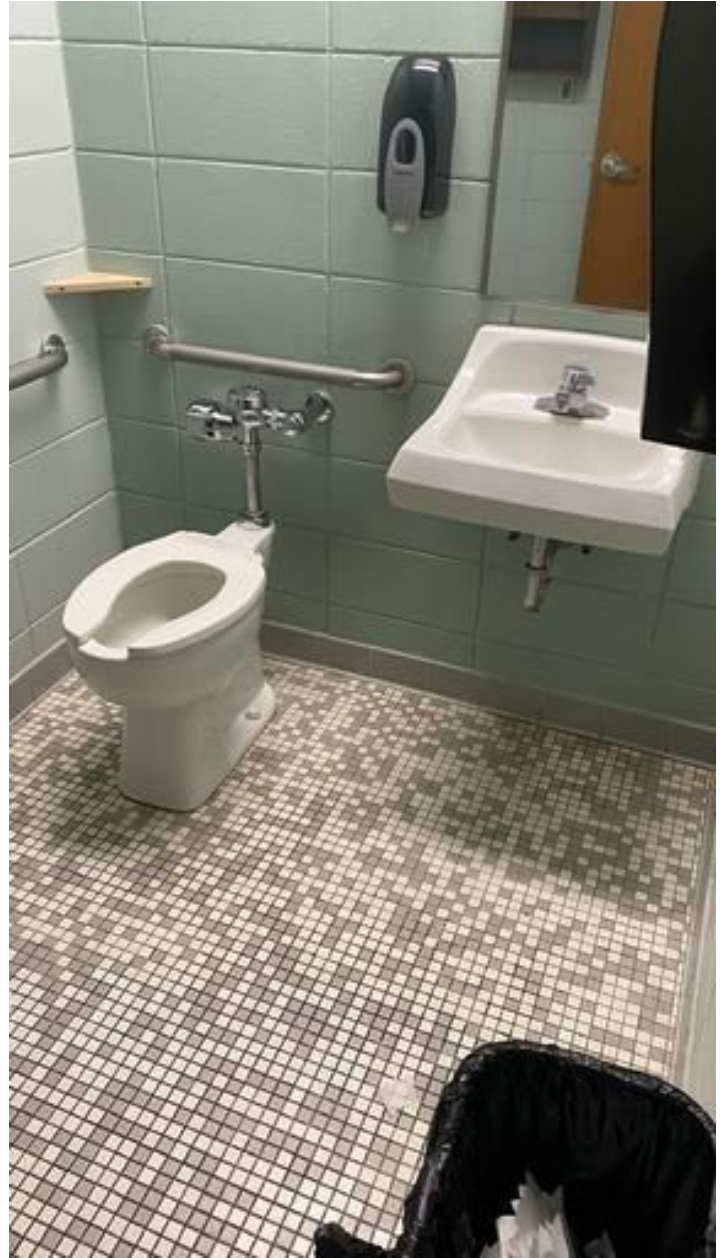
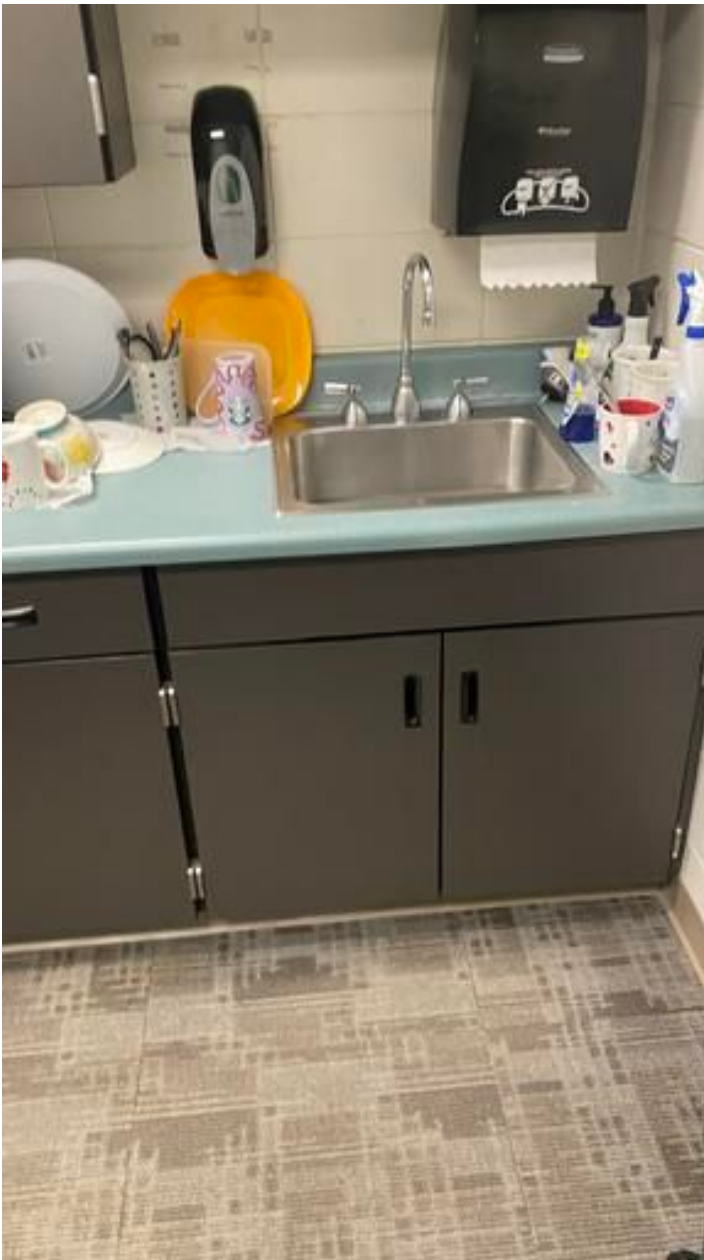
| Description | Good condition |

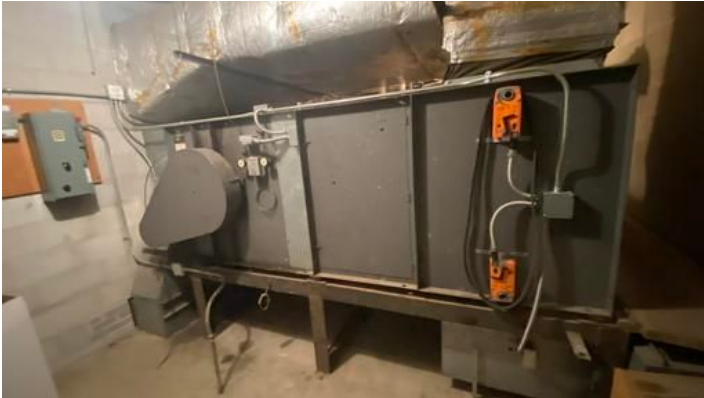
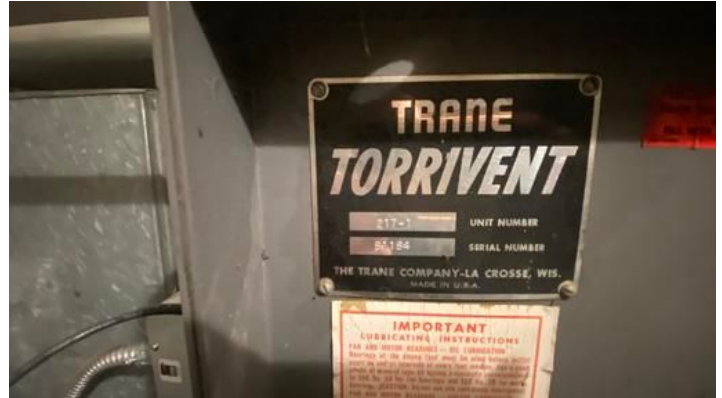
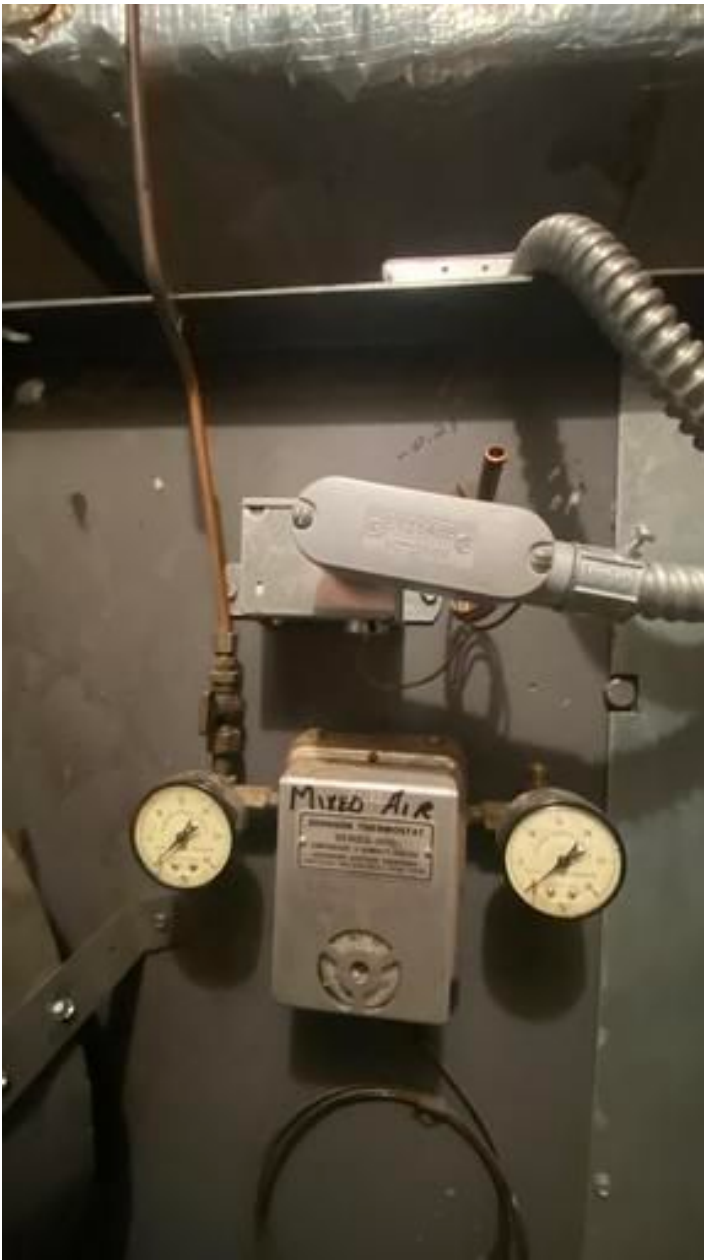
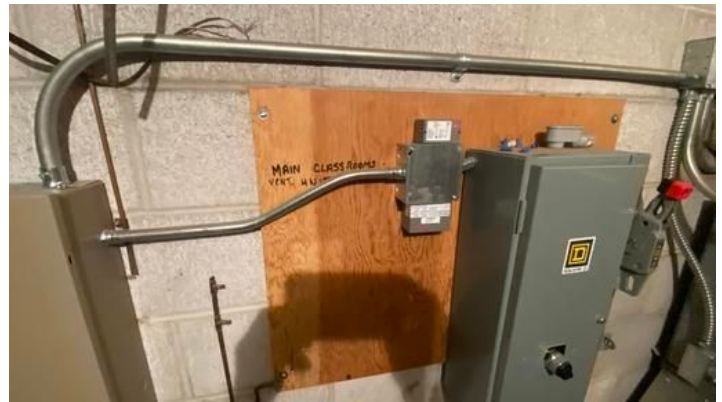
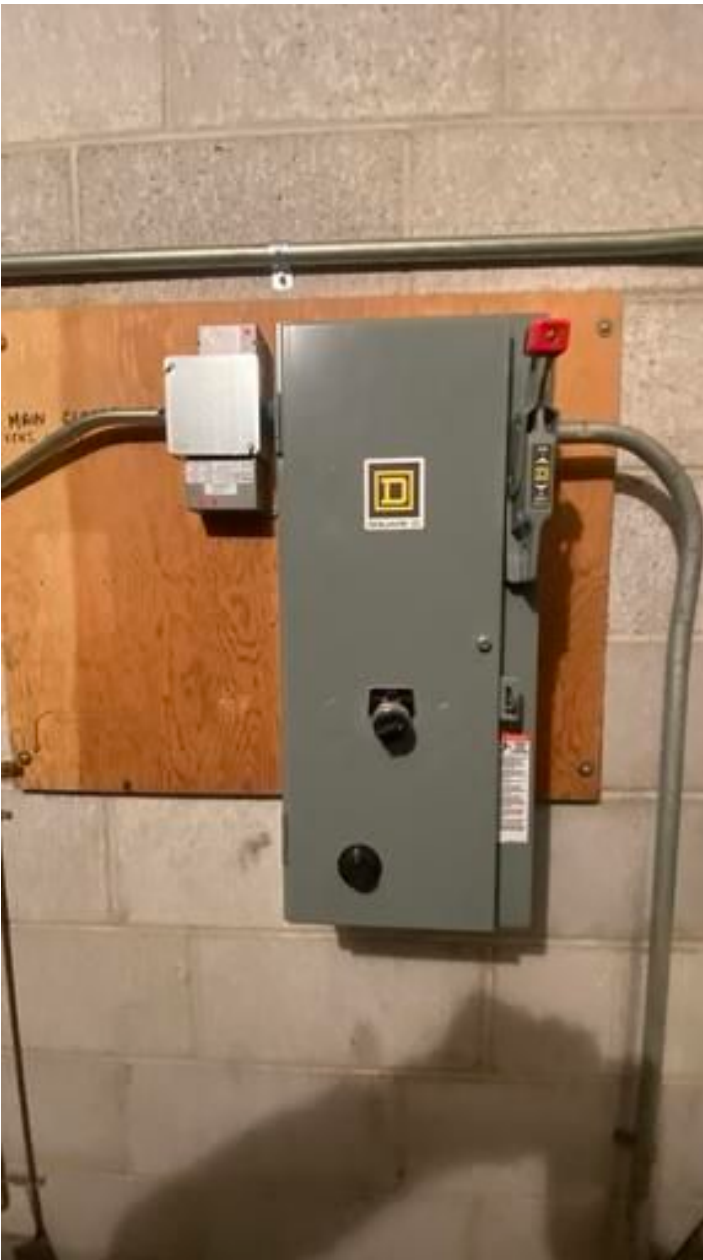
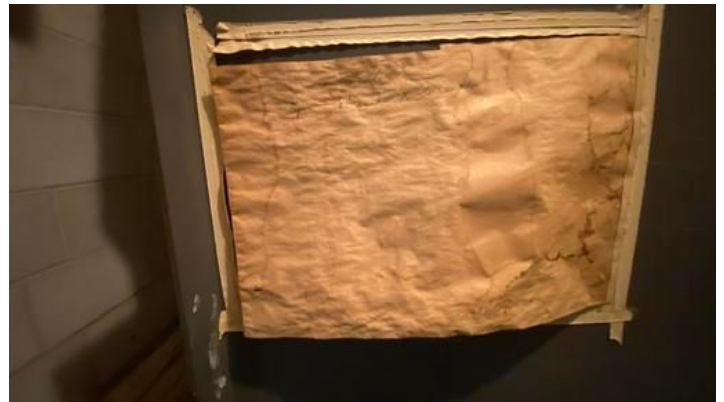
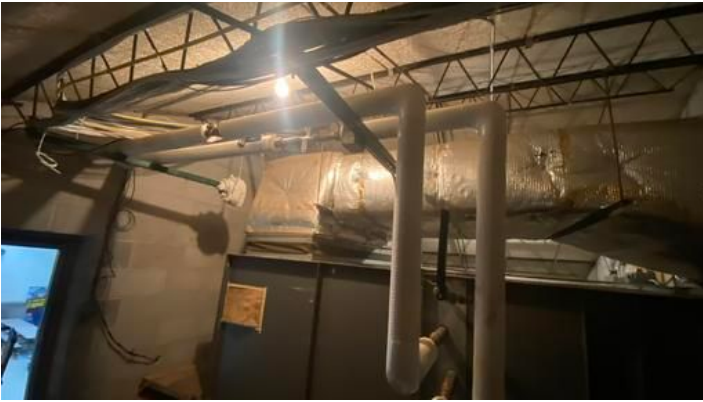
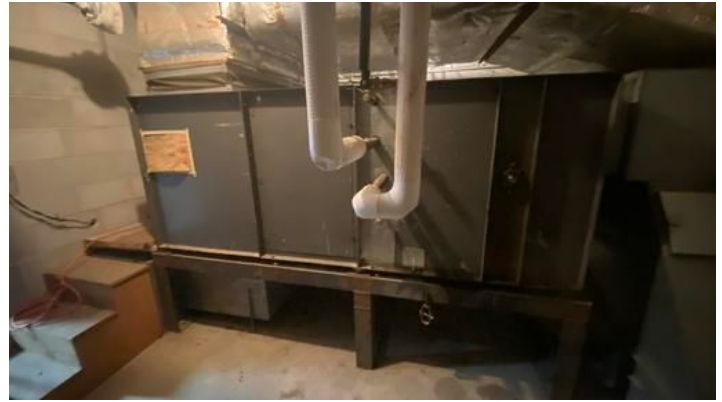
| Description | Poor condition, poor access, heating only, no ventilation |
