# Webster Elementary School Facility Assessment

March 12, 2026

PREPARED BY DSGW ARCHITECTURE

# PROJECT OVERVIEW

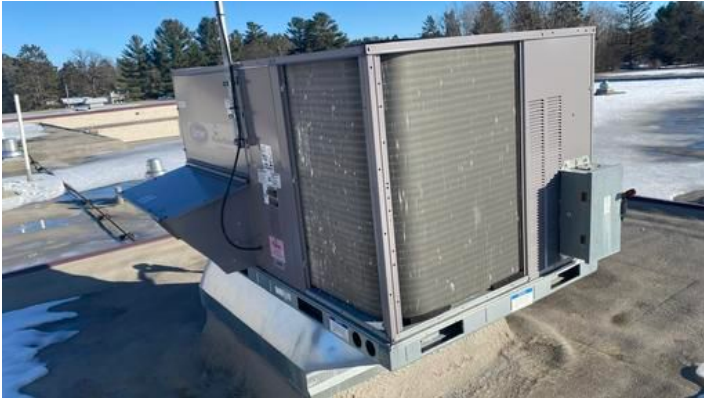
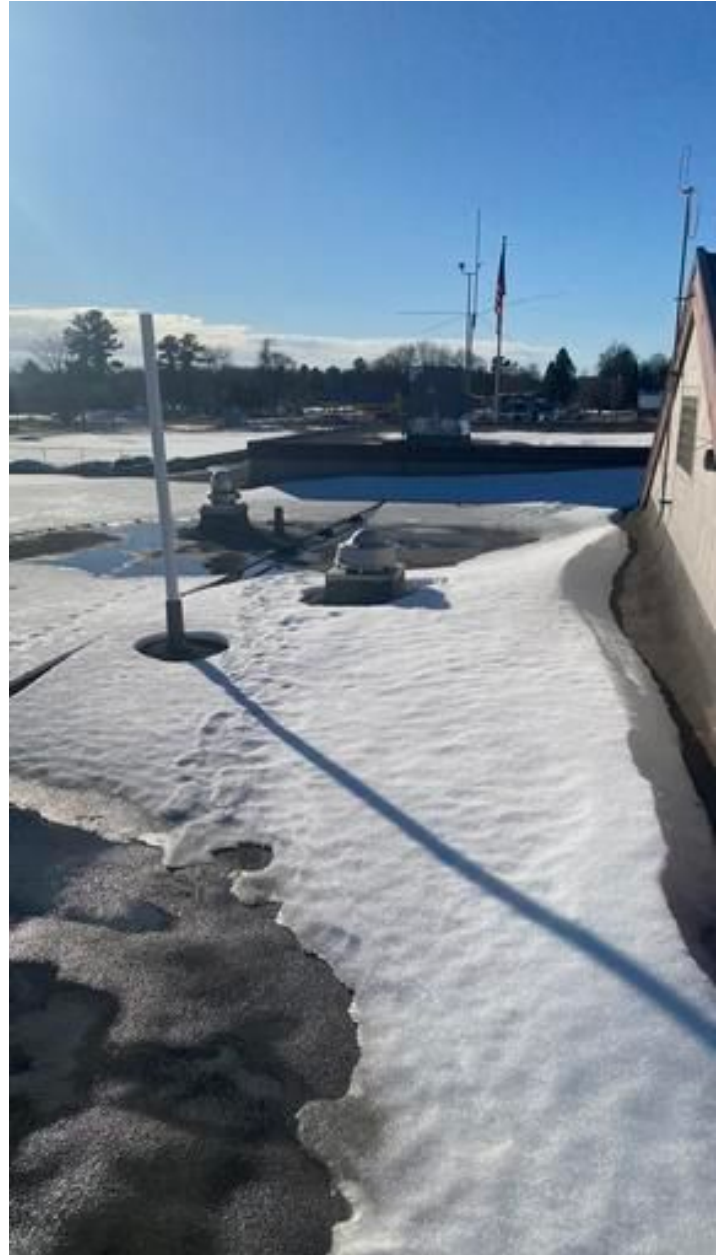
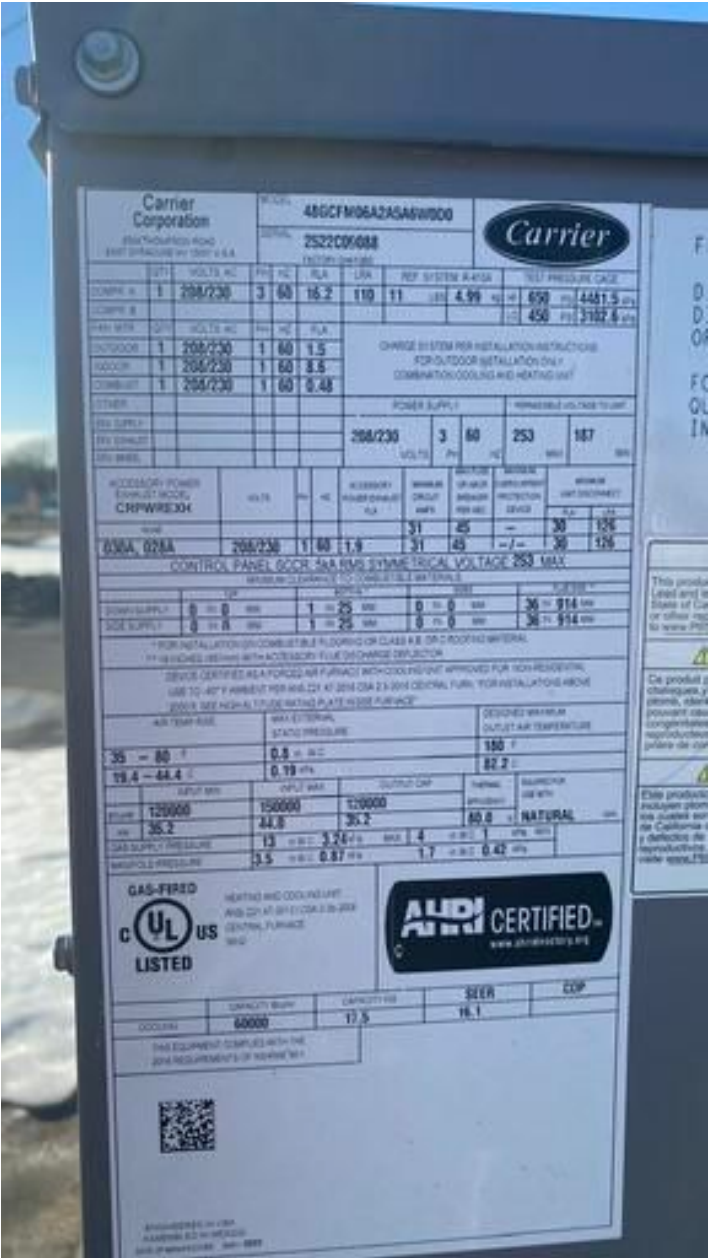
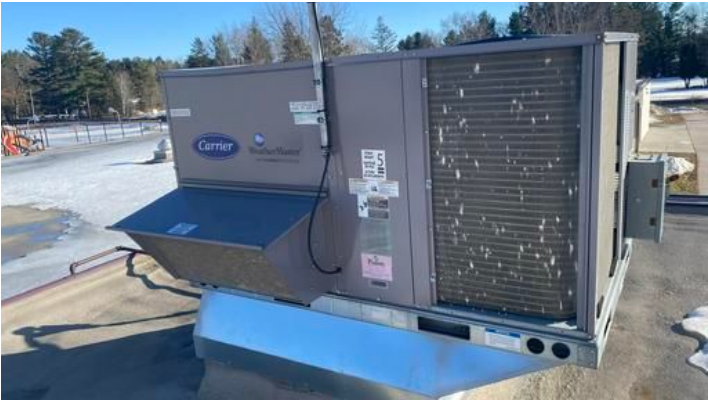
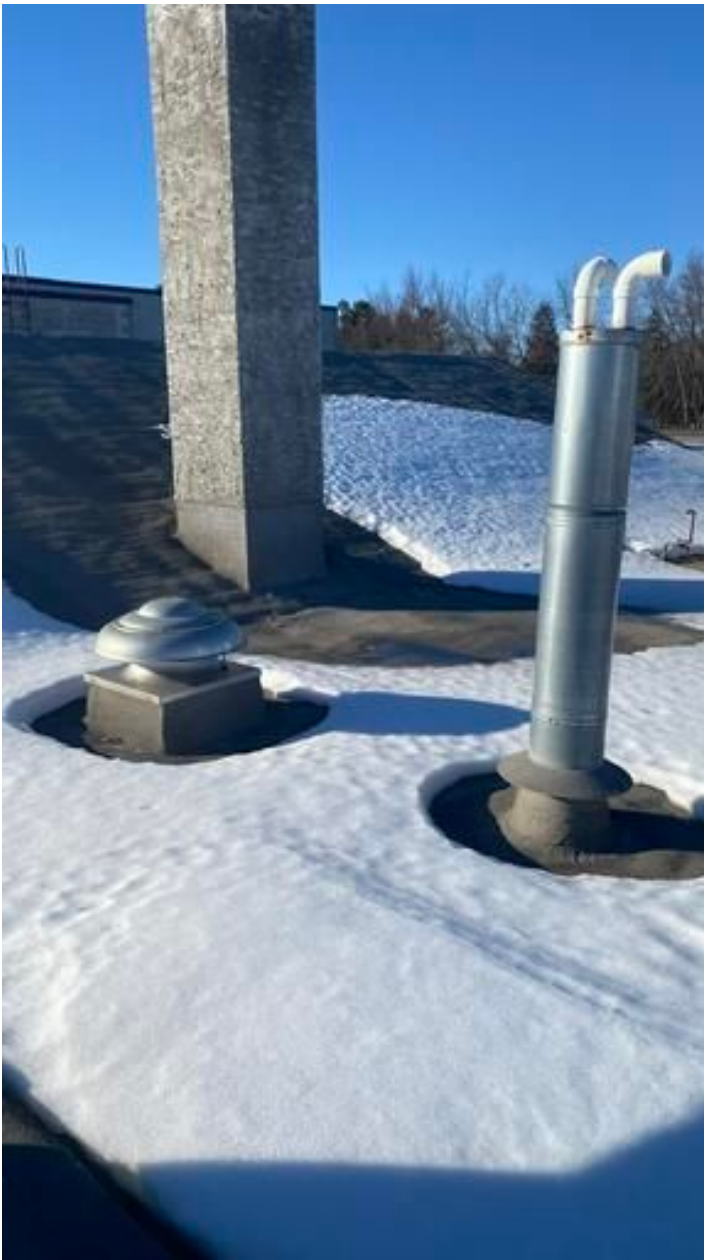
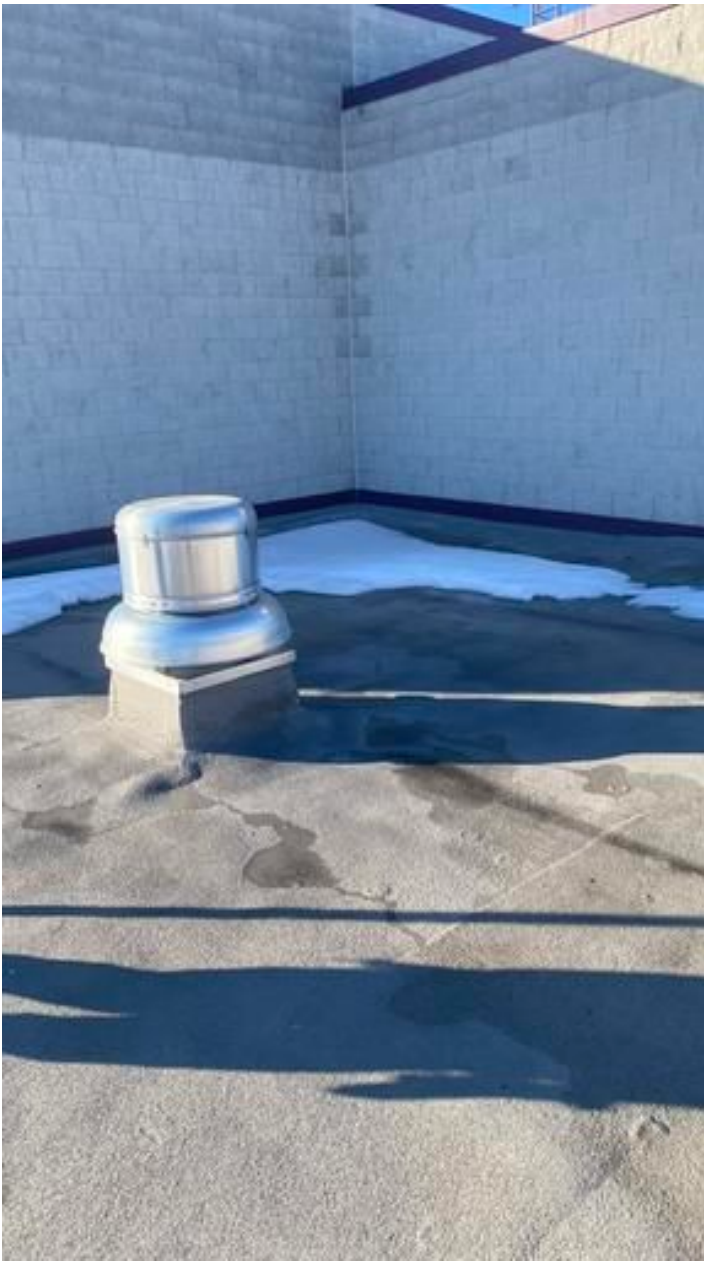
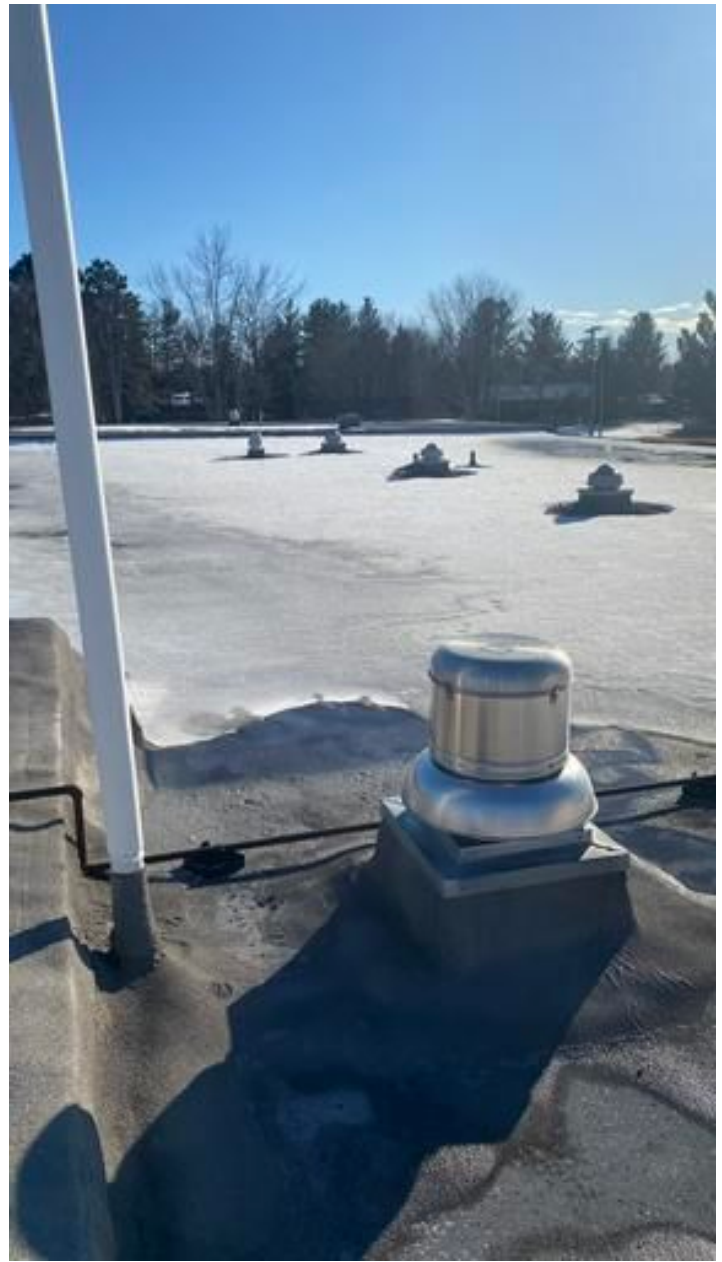
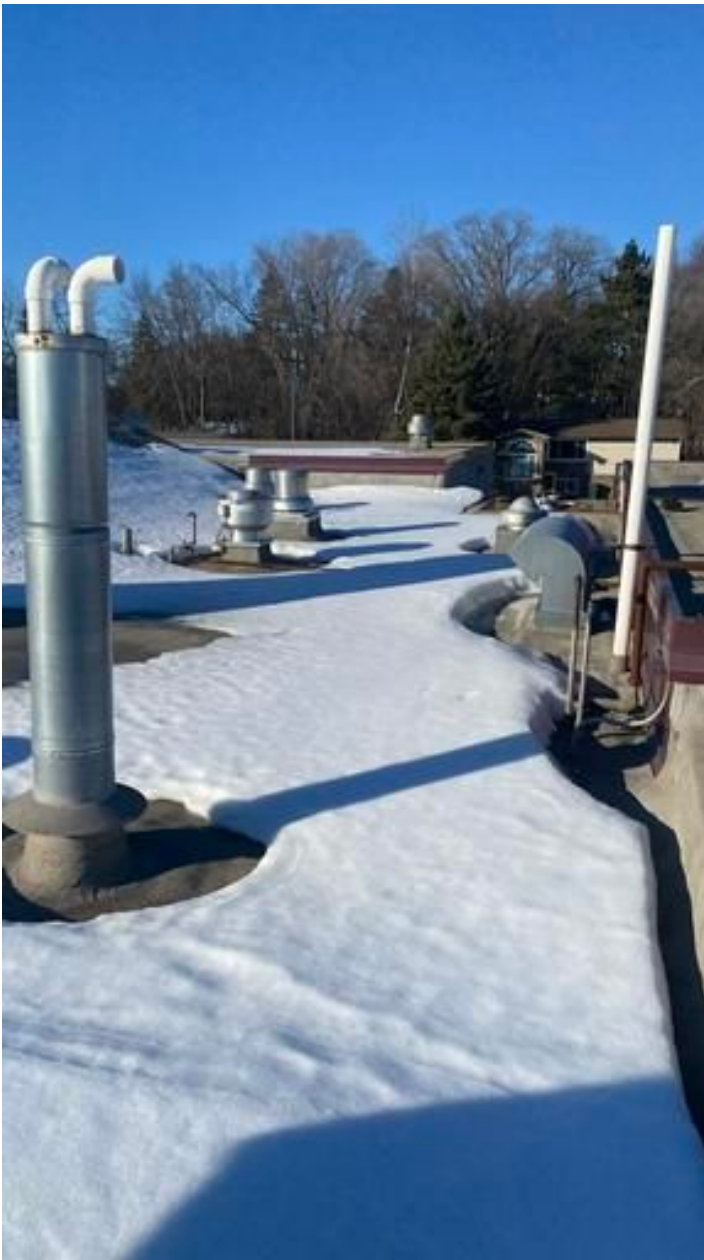
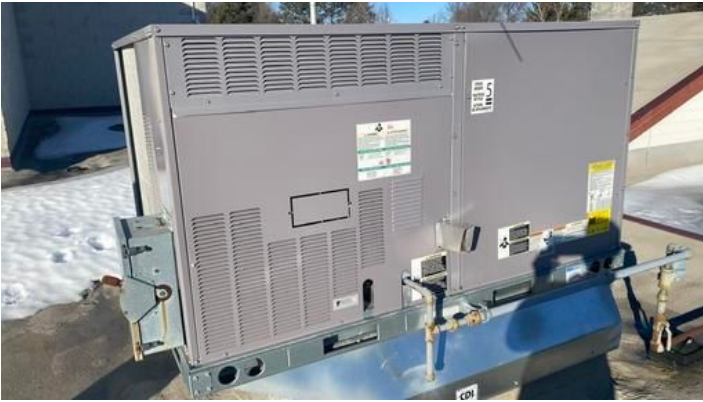
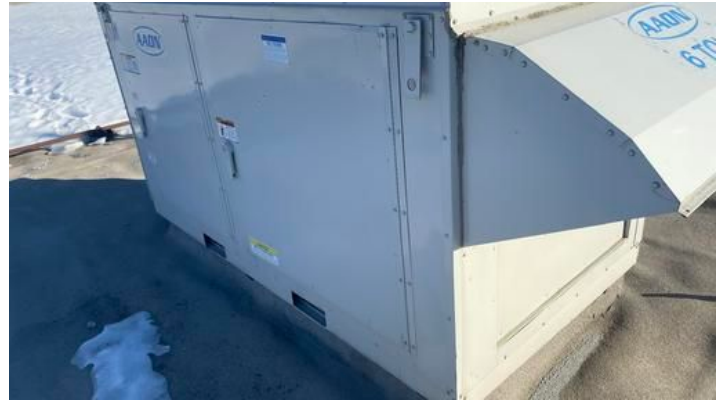
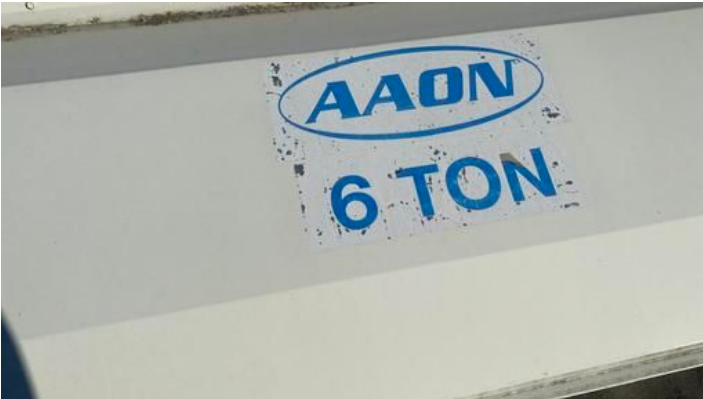
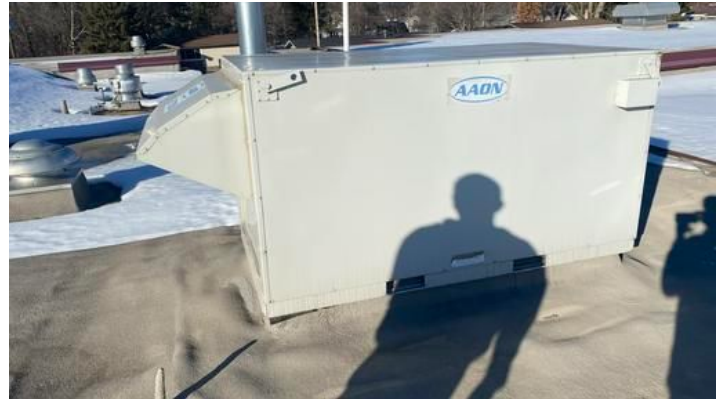
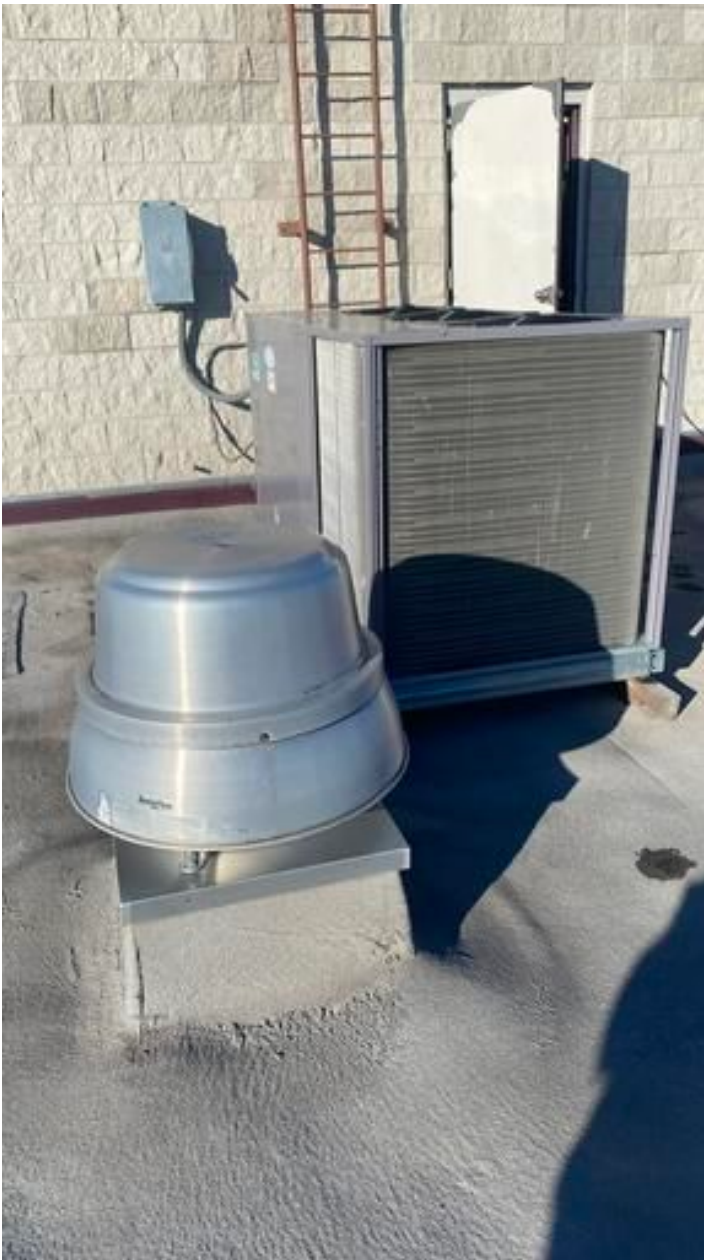
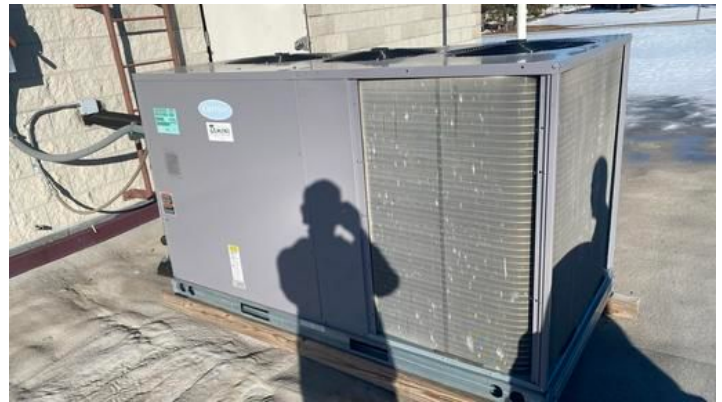
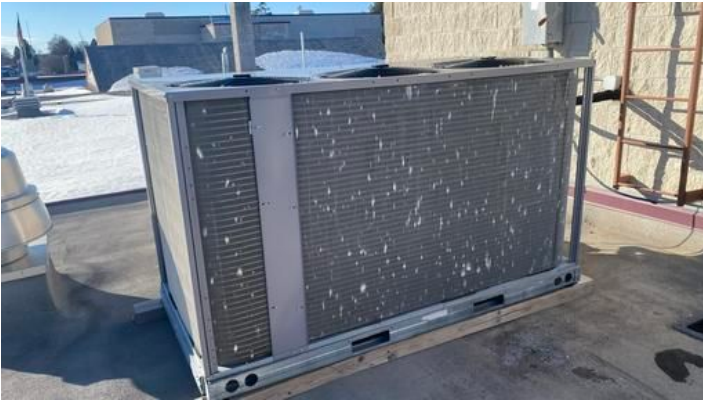
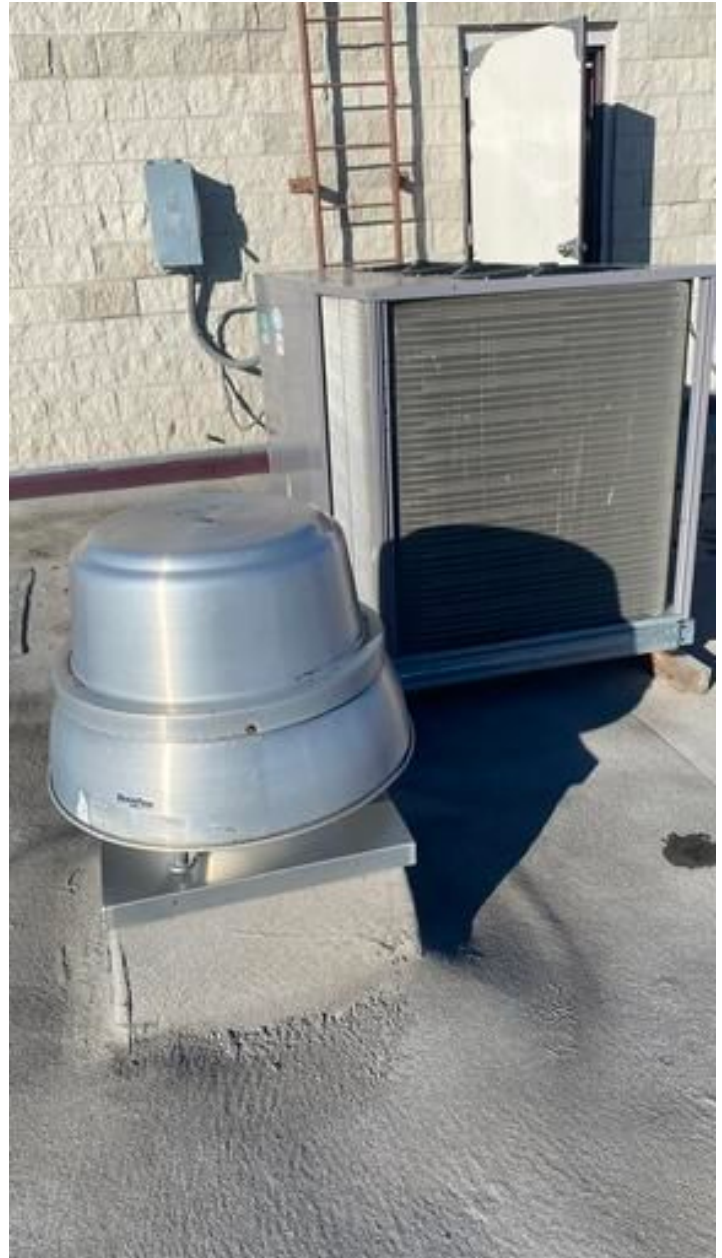
| Description | Fair condition |
